A STUDY OF PROPERTIES OF THE CAP DOUBLE-SKIN BUILDING FACADE

Center for Energy Research / Education / Service
CERES
Ball State University - Spring 2003
Robert J. Koester, Director
Steven R. Cook, B. ARCH May 2003
Robert J. Patton, B. ARCH May 2003

A Study of the CAP Double-Skin Building Facade

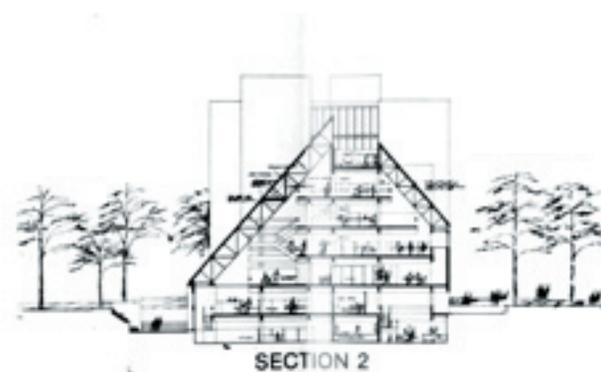
Figure 6.C. Winning competition building section.
(Crumlish/Sporleder and Associates, Indiana Architect, June 1981)

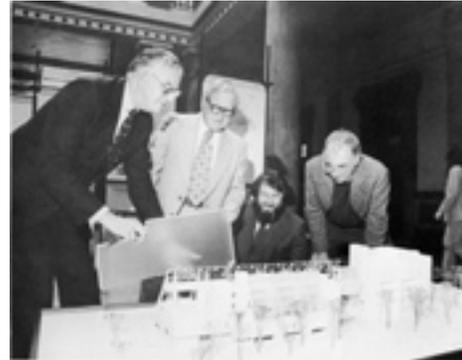
Figure 7.A. Winning competition model. (Crumlish/Sporleder and Associates, Indiana Architect, June 1981)

In the bid documents for the south slope wall, the solar chimney was proposed as an alternate in lieu of a single layer of thermally reflective glazing. (Figure 7.A.) The mechanical equipment for the addition was originally sized with the anticipation of solar gain through the single layer of glazing. This system, although functional, was declined by the university and as a result, the alternate bid solar chimney was selected. The mechanical equipment was then sized to operate under the anticipated extreme climatic conditions without reliance on solar devices or natural ventilation.⁶

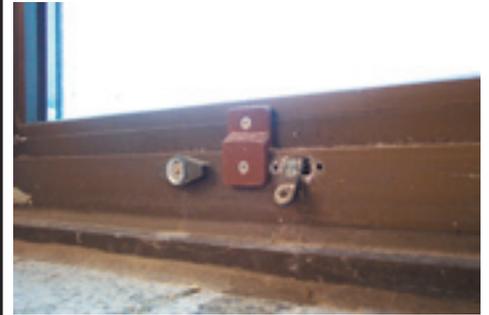
Figure 9.1. Permanently locked studio window.
(Photo by Steven R. Cook, 2003)

Over the building's life span, there have been considerable changes made that have affected the building's original operating schemes. First, the phase change material was removed due to leakage problems. Additionally, the operable windows on the north facade have been sealed due to strains on the mechanical system and misuse. (Figure 9.1.) Currently, the solar chimney remains in its closed position throughout the year and only functions as a thermal buffer; there is no system that coordinates between the mechanical and manual operation methods.

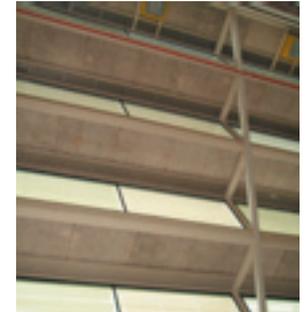
Figure 13.1. Atrium dampers are closed.
(Photo by Steven R. Cook, 2003)

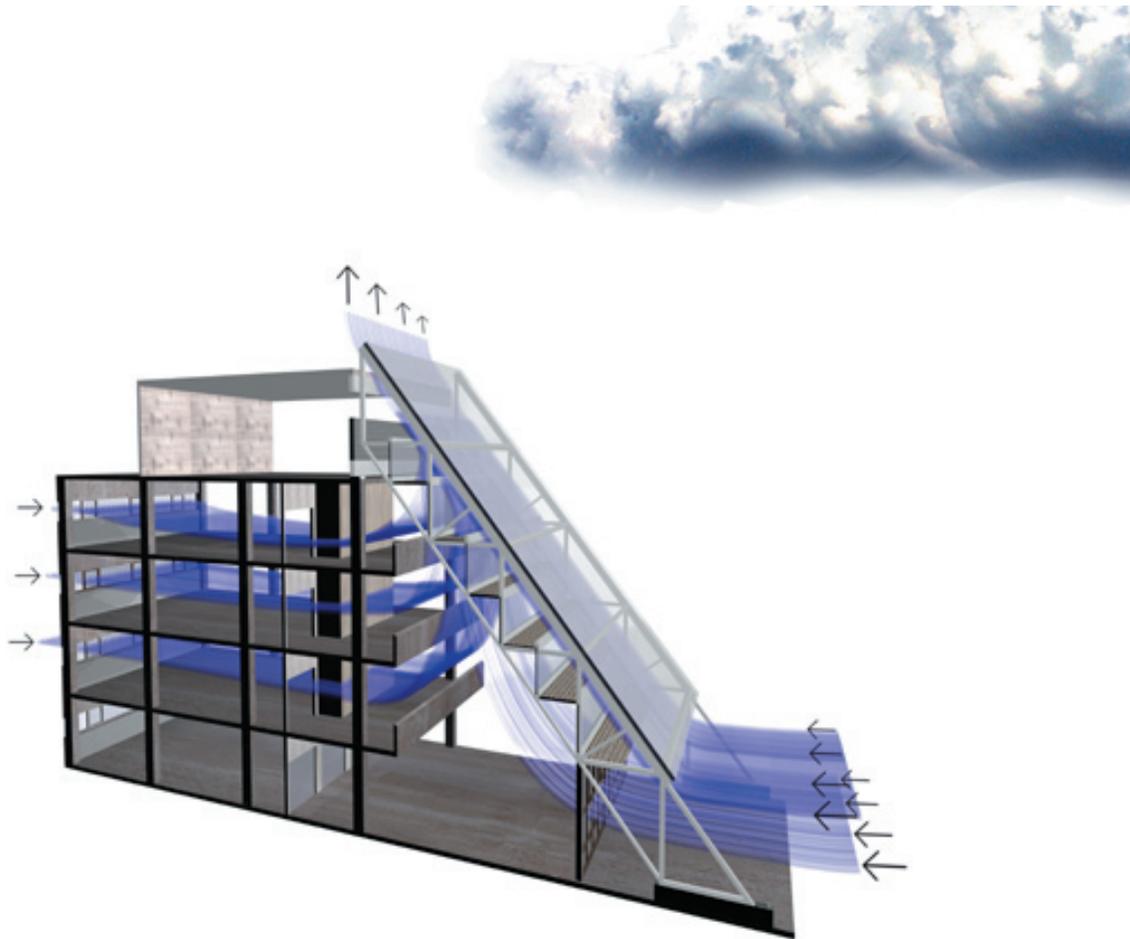
Figure 15.A. Natural Ventilation scheme D.
(Diagram by Steven R. Cook, 2003)

CASE D:	<u>Typical Weather Conditions</u>	<u>Intended Operational Procedure</u>
	Temp. 48 - 80 degrees (Fahrenheit)	Open North Windows
	Wind spd. 6 MPH. 5 Days/Year	Open South Doors
	10 MPH. 34 Days/Year	Open Lower Vent
	16 MPH. 149 Days/Year	Open Unit Dampers

The four original operating schemes required operating louvers, vents, blinds, doors, and windows to maximize the use of natural energy (Figures 14.A., 15.A., 16.A., & 17.A.). Due to the modifications to the building over time, portions of the four original schemes can be resurrected to create two new operation schemes. The first scheme would enable the cavity of the south sloping glass to exhaust any heat gain that would collect on the inner skin of the facade during hot days and full sun (Figure 12.A.). The second scheme would allow the south sloping glass to act as a thermal buffer between the indoor and outdoor air temperatures (Figure 13.A.). These two systems only require minor modifications to update the system.

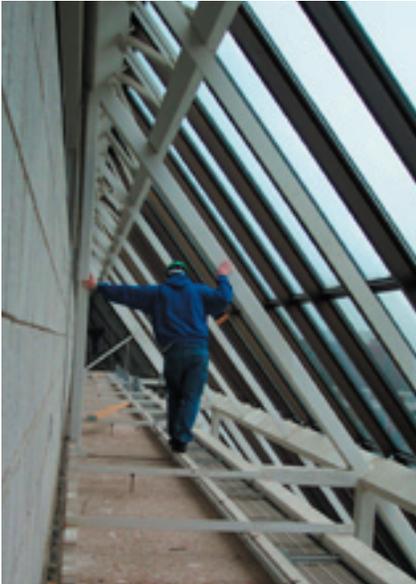
Figure 24.1. Balancing on the walkable area to place the temperature recording devices inside the CAP solar chimney.
(Photo by Robert J. Patton, 2003)

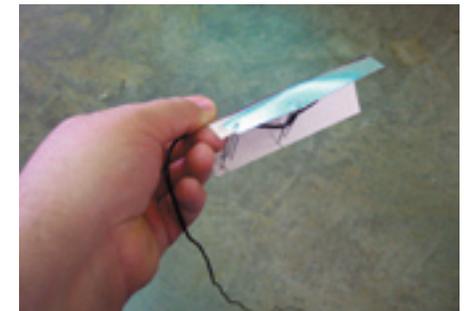
Figure 25.2. Detail of sun shield and wire sensor. (Photo by Robert J. Patton, 2003)

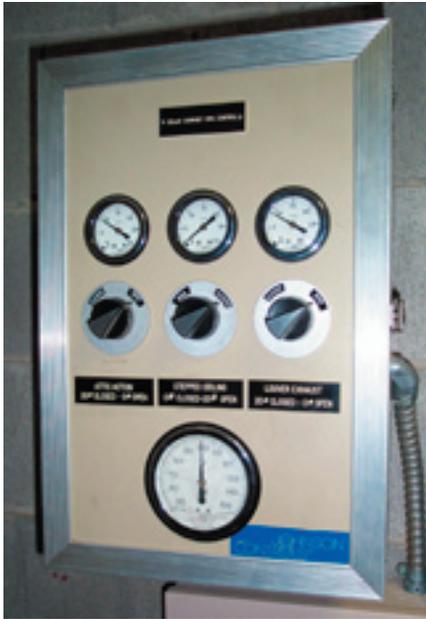
Figure 26.1. Louver control panel.
(Photo by Robert J. Patton, 2003)

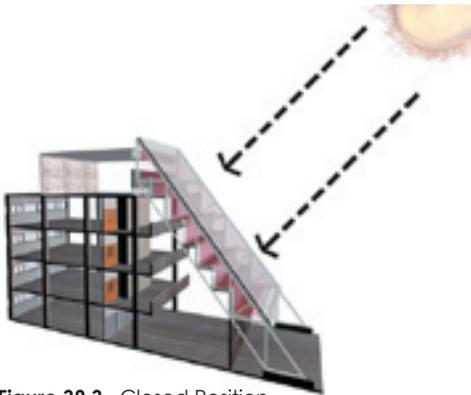
Figure 38.3. Closed Position. (Diagram by Steven R. Cook, 2003)

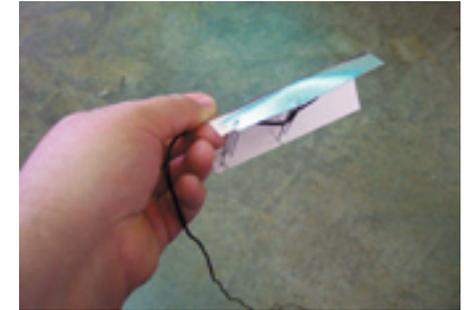
Figure 39.1. Detail of sun shield and wire sensor.
(Photo by Robert J. Patton, 2003)
