**FOUR SCHOOLS
LIGHTING STUDY**

This is a report of a study of the luminous environments of the libraries of four elementary schools in Columbus, Indiana. The schools are Clifty Creek, Fodrea, Lincoln and Parkside

The study was undertaken by the Center for Energy Research/Education/Service (CERES) at Ball State University as part of the nationwide Vital Signs Project. The Vital Signs Project is managed through the Center for Environmental Design at the University of California, Berkeley and is funded by the Energy Foundation, the National Science Foundation, Pacific Gas and Electric Company and the University of California.

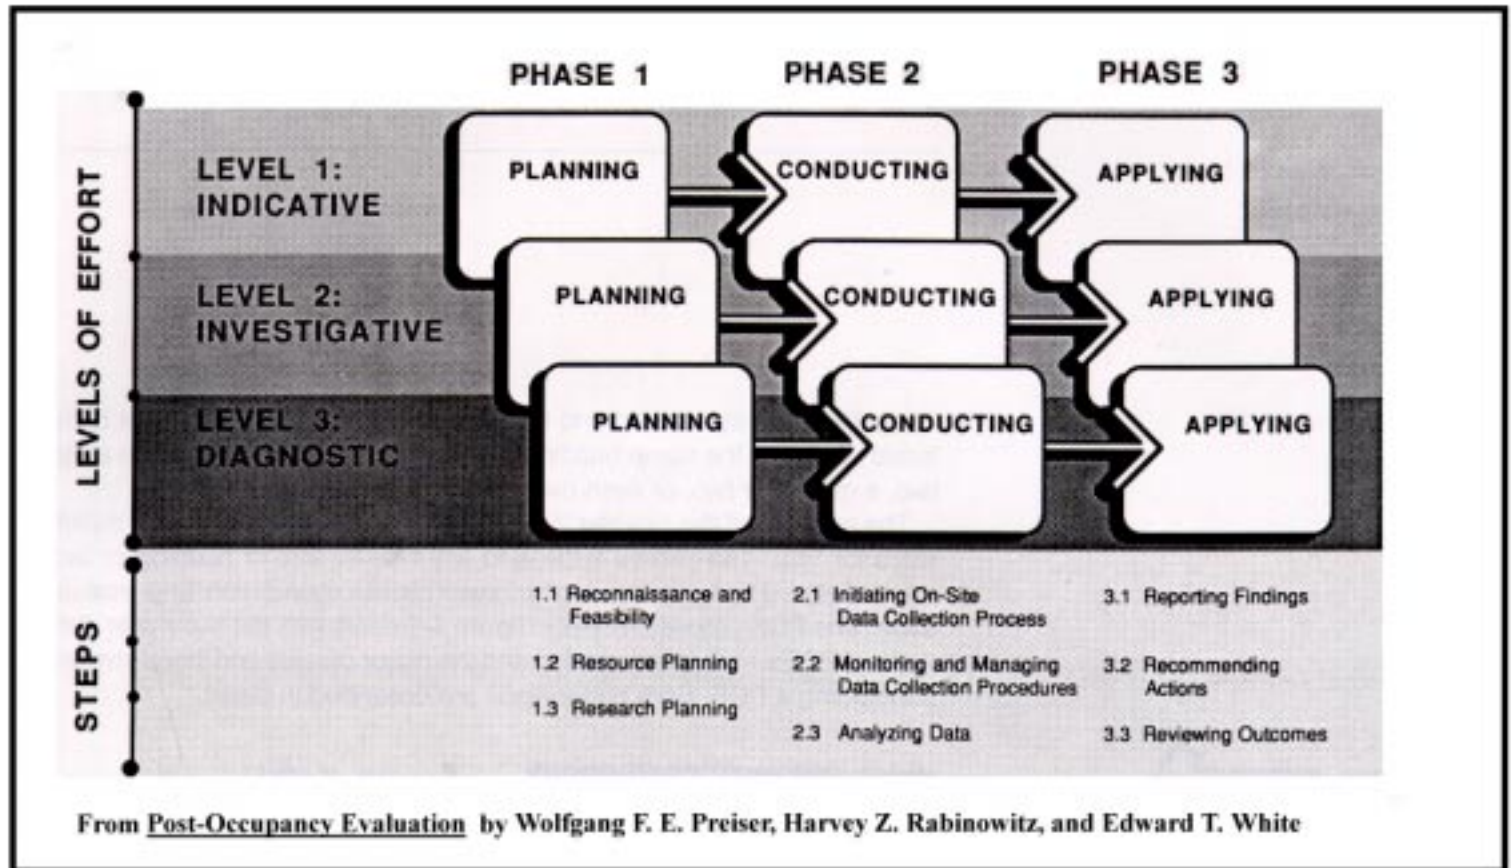
Figure I.1 : Post-Occupancy Evaluation Protocol

This lighting study was conducted under the protocol for post-occupancy evaluation utilized by Professor Wolfgang Prieser of the University of Cincinnati, among others. Under this protocol, the study is advanced in three stages with each successive research stage becoming more exact in its level of measurement and analysis. (See Figure I.1) The three levels are the indicative stage, the investigative stage and the diagnostic stage and typically are applied as in the description which follows.

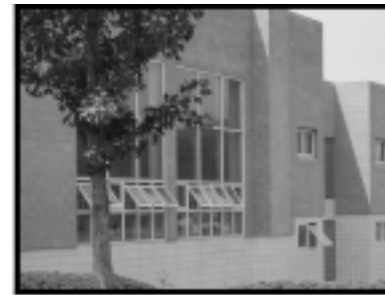
Figure C.3a : North Window, Exterior

Meier makes extensive use of daylighting in the library. A large window occupies most of the north wall (Figures C.2, C.3a and C.3b) and a combination of Kalwall and glass window panels make up virtually all of the south wall (Figures C.4a and C.4b). Electric lighting is provided by recessed 1' x 4' fluorescent fixtures with two 34W cool white supersaver lamps (Figure C.6b) and recessed 4" diameter incandescent fixtures with 100W PAR lamps (See Figure C.6a).

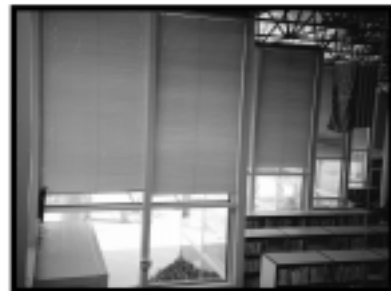
Figure F.2a : Wall Between Library and Community Concourse, Interior

The resulting floor plan of the school (See Figure F.1) is roughly a “hollowed-out” pinwheel, comprised of the L-shaped (open-plan) classroom block, the multipurpose/art/music block and the cafeteria/kitchen block with an administration/community education element spanning the main entrance area and joining the multipurpose wing with the classroom wing. These elements enclose a rectangular area which contains the “Community Concourse” and is also occupied in part by the triangular Material Resources Center that rests in the internal vee of the L-shaped classroom wing. This “sharing” of the same area by the Material Resource Center and the “Community Concourse” coupled with floor-to-ceiling glass between the two uses makes them visually co-occupants of the same space (See Figures F.2a and F.2b).

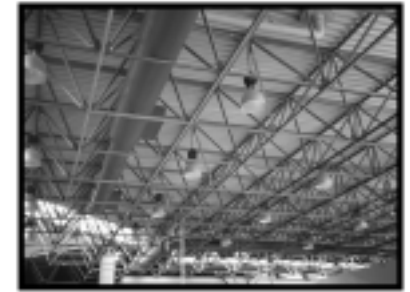
Figure F.4a

Electric light is provided predominantly by 400W HID lamps in lensed, parabolic reflector fixtures placed within the Unistrut roof structure at every second module, a spacing yielding luminaires ten feet on center within the five foot structural grid (See Figure F.4a). The only exception to this pattern is where a column occurs at a module where a light should have been located. In this case, four 75W metal halide lamps in parabolic reflector fixtures arranged in a square pattern around the column replace the large luminaire (See Figure F.4b). Under the mezzanine, electric lighting is provided by recessed two lamp fluorescent fixtures and can fixtures with 50W lamps. (See Figure F.5).

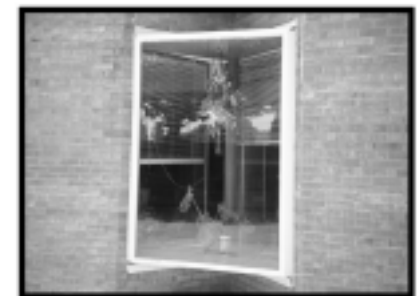
Figure L.3 : Exterior of "Vee" Window

The building is structured in two parts with the outer ring of rooms and corridor structured separately from the multipurpose room. This approach allowed Birkerts to insert a continuous clerestory between the two structures, a device that is used to maximum effect to provide daylighting to the multipurpose room, both corridor floors and, in some cases, to the outer ring of rooms (See Figure L.2). Daylighting at the exterior of the building is provided almost exclusively via recessed windows; recessed windows that, in some locations, are more inventively configured than in others. In these locations, what appears from the exterior to be a single window conceals two windows configured in a concave vee at the wall between two rooms, with one window of the vee lighting each room (See Figure L.3).

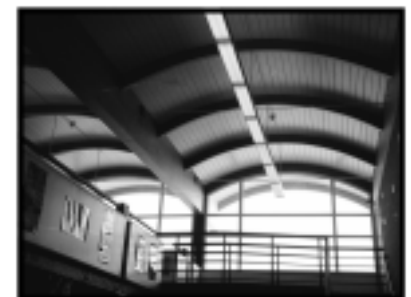
Figure P.5c : Interior View: North Window and Ceiling Fixtures
