A Lighting Study of the
Ball State University
Alumni Center

Vital Signs III

Deon Hoang
Derek Gerow
May 1998

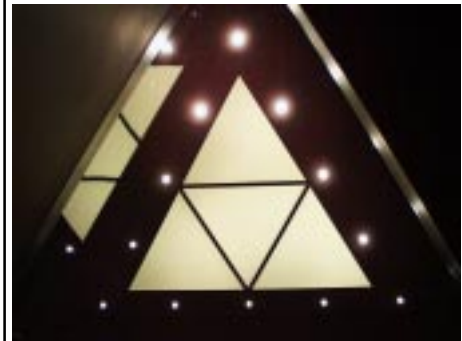
5. Detail of lights in stairwell.

The artificial lighting throughout the building is achieved largely via compact fluorescent and low voltage halogen luminaires. The conference rooms have compact fluorescent fixtures with simple on/off control. The meeting rooms also have compact fluorescent fixtures in addition to halogen spotlights, and there is some control over which fixtures are on or off at any given time. The board room and the auditorium have the widest range of fixtures and electric lighting control. The lighting can be modified from a very low, soft level of illuminance to a more intense, bright level.

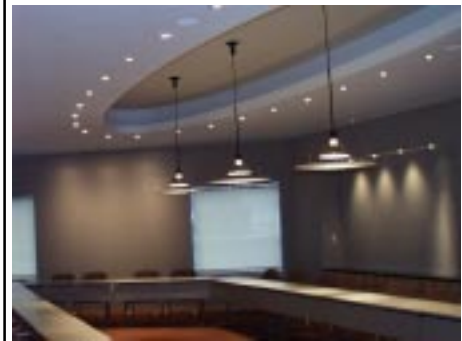
6. View of board room.

The conference rooms located at the southeast corner of the building make use of a combination of both natural and artificial light. Punched windows along the east wall admit a good amount of natural light, up to 76 fc on an overcast morning. The boardroom has the most flexible lighting control and fixture variety of all the conference rooms. Halogen lights surround the conference table and are adjustable to create a variety of different settings.

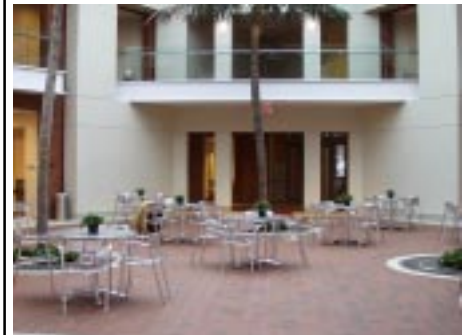
7. View of conservatory.

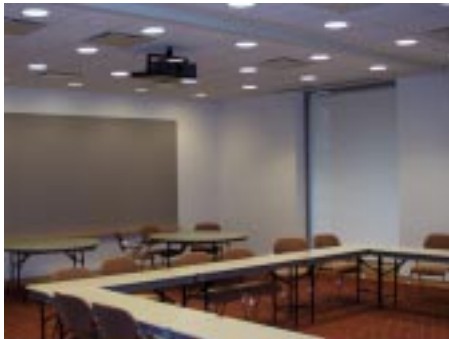
10. View of typical meeting room.

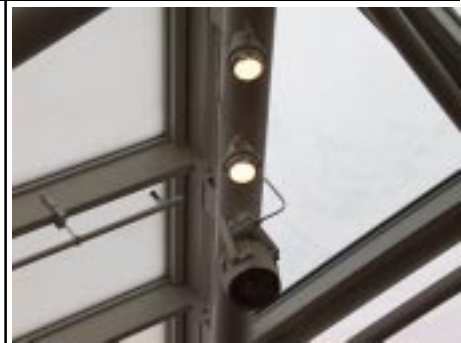
12. Detail of spotlights in conservatory.

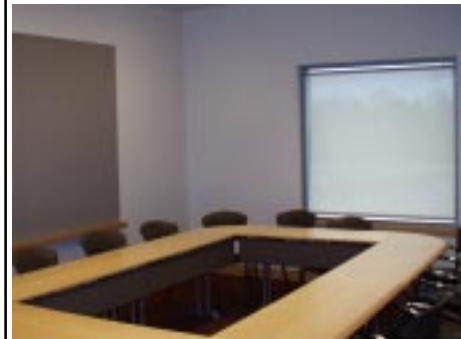
13. View of typical window treatment.

Throughout the building there is a similar use of window treatment. The window blinds, which for the most part are kept in full cover position in the conference rooms on the first floor and varying cover in the offices on the second floor, are made of a mesh material that screens light, yet are still transparent enough to see through to the outside.

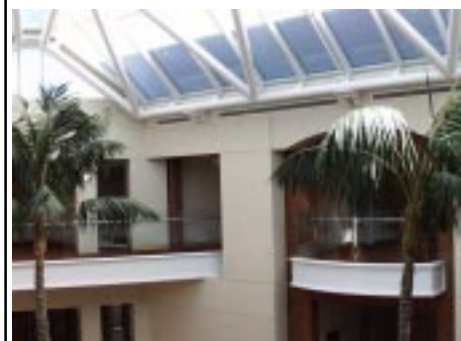
15. View of balconies on second floor.

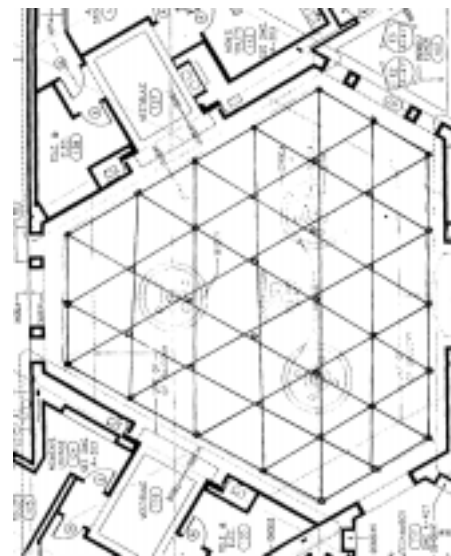
17. Grid of points for isolux map.

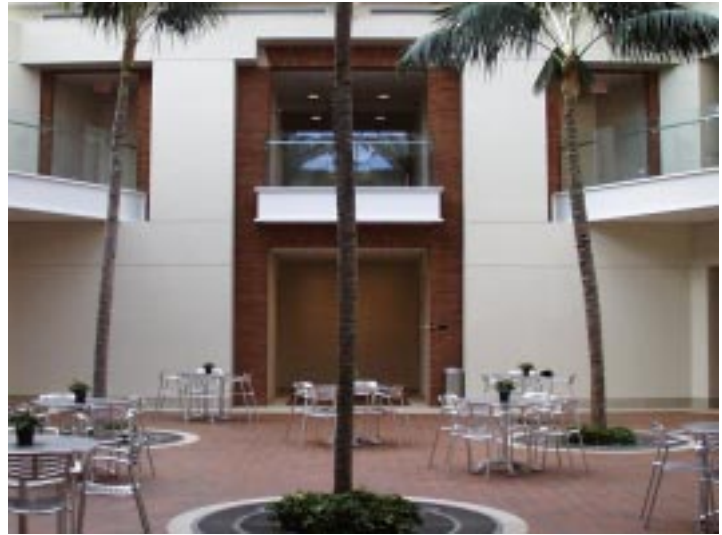
VIEW #1: sunny day

24. Original photograph of conservatory taken around 4:00 p.m. on a sunny March afternoon.

Step 4 of the research methodology resulted in measurements directly related to the visual comfort in the conservatory. View #1 (fig. 24) is of an interior facade in the conservatory that is within the “normal visual field.” Foot Lambert readings taken within view #1 on a mostly sunny day at 4:00 p.m. revealed levels ranging from 21 fL to 319 fL (fig. 27). This results in an overall ratio of 15:1. Readings of the same view #1 taken on a cloudy day at 4:00 p.m. revealed a range of 6 fL to 66 fL which results in a ratio of 11:1 (fig. 31). Both ratios are well within standard for

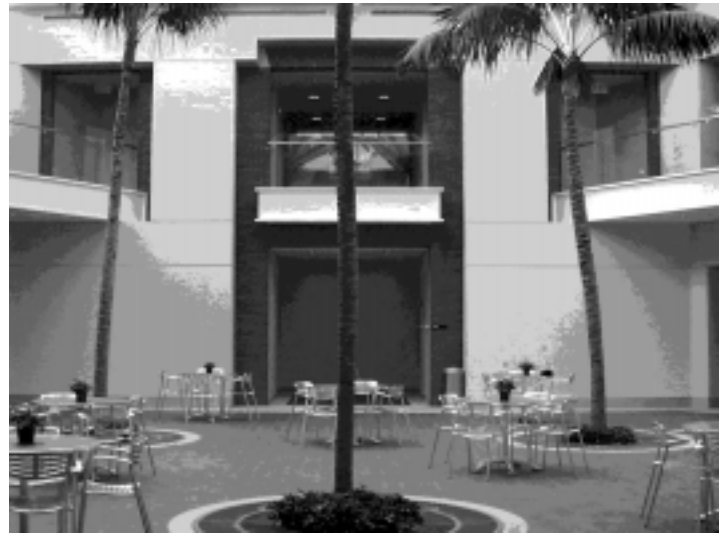
25. Image modified in Photoshop. The total colors were limited to ten, and the image was then grayscaled in order to exaggerate the contrast within the view.

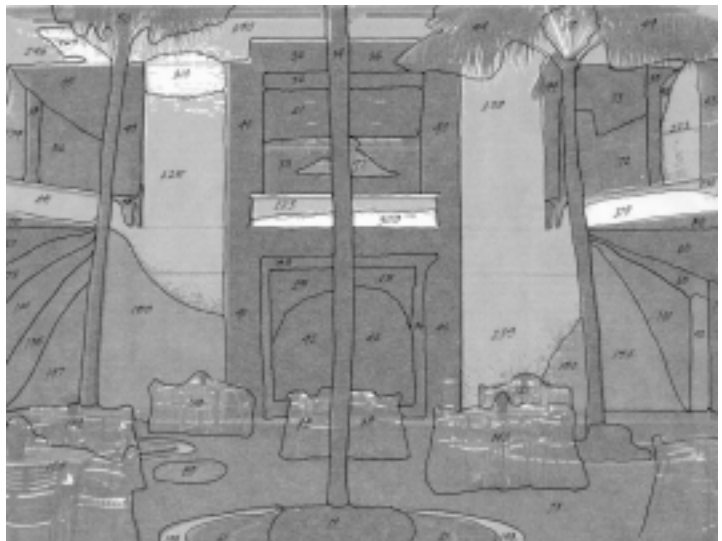
26. Tracing of the major areas of brightness within the view overlaid on the grayscaled image. Spot readings of the outlined areas are indicated in foot Lamberts.

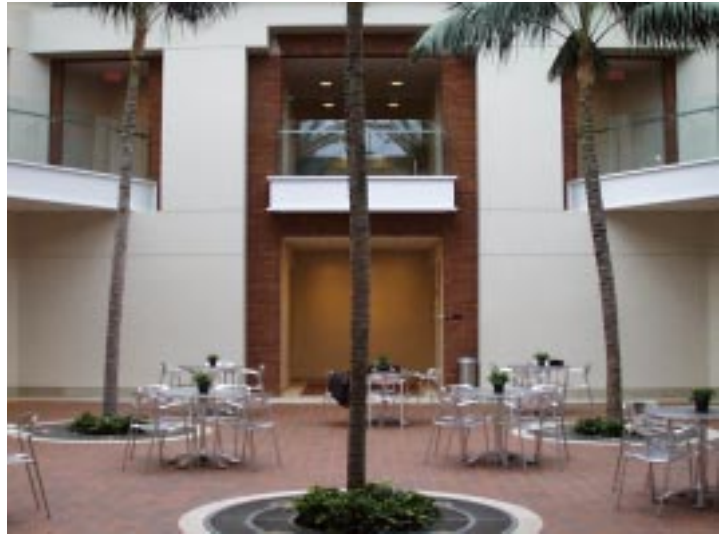
VIEW #1: cloudy day

28. Original photograph of conservatory taken around 4:00 p.m. on an overcast March afternoon.

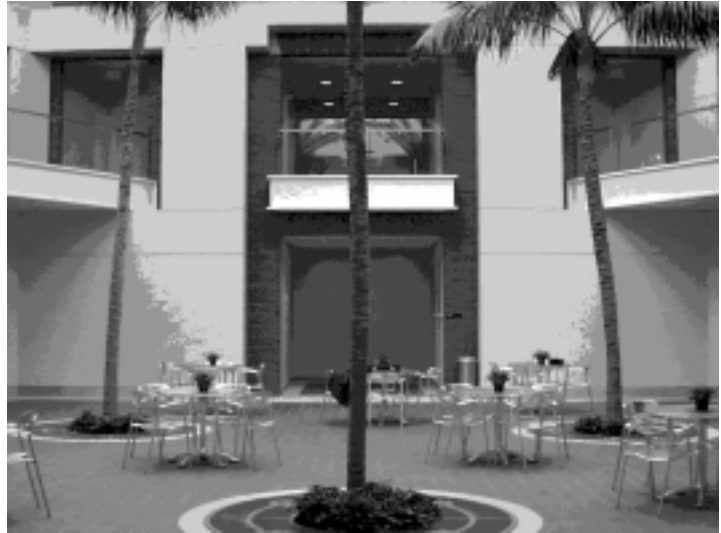
29. Image modified in Photoshop. The total colors were limited to ten, and the image was then grayscaled in order to exaggerate the contrast within the view.

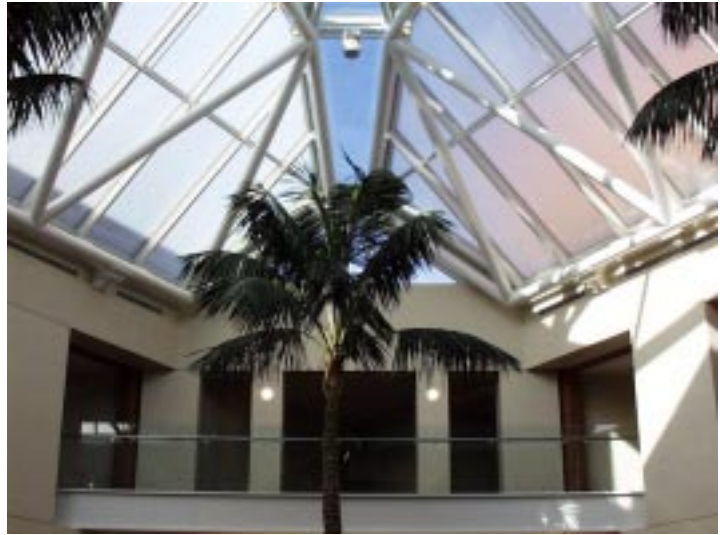
VIEW #2: sunny day

32. Original photograph of conservatory taken around 4:00 p.m. on a sunny March afternoon.

acceptable visual contrast. View #2 (fig. 32) is looking up to the balcony that surround the conservatory and reveal a large portion of the skylight. The middle strip of glass is transparent and the remainder is translucent. Foot Lambert readings within view #2 taken on a sunny day at 4:00 p.m. range from 32 fL to 2795 fL (fig. 35). The resulting ratio is 87:1. Readings taken within view #2 on a cloudy day at 4:00 p.m. range from 5 fL to 931 fL which result in an overall ratio of 186:1 (fig. 39). As the field of view is focused upwards towards the skylights, the contrast ration moves towards 100:1, and on an overcast day the ratio is well above 100:1. However, ratios within the “normal field of view” are low.

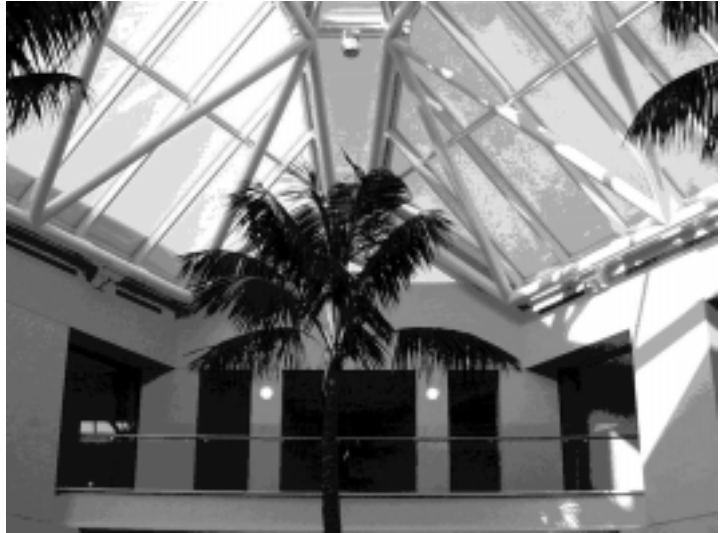
33. Image modified in Photoshop. The total colors were limited to ten, and the image was then grayscaled in order to exaggerate the contrast within the view.

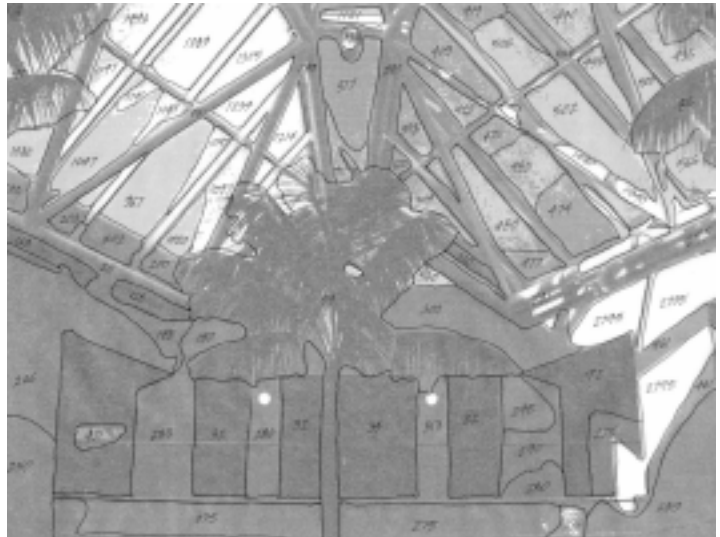
34. Tracing of the major areas of brightness within the view overlaid on the grayscale image. Spot readings of the outlined areas are indicated in foot Lamberts.

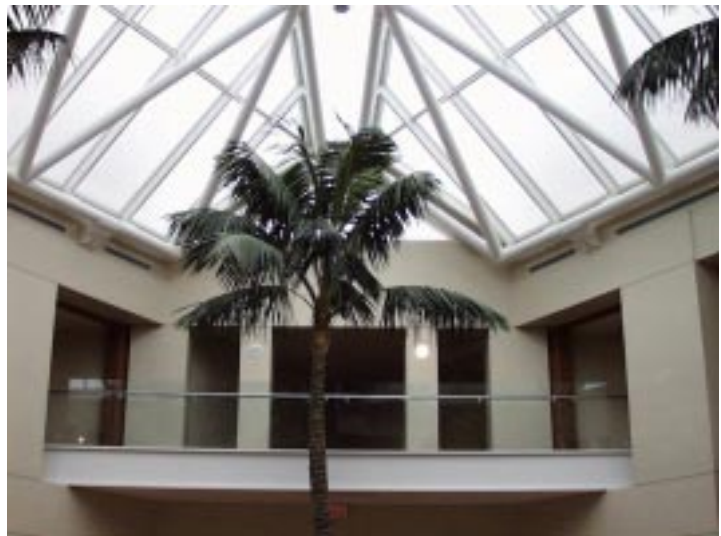
VIEW #2: cloudy day

36. Original photograph of conservatory taken around 4:00 p.m. on an overcast March afternoon.

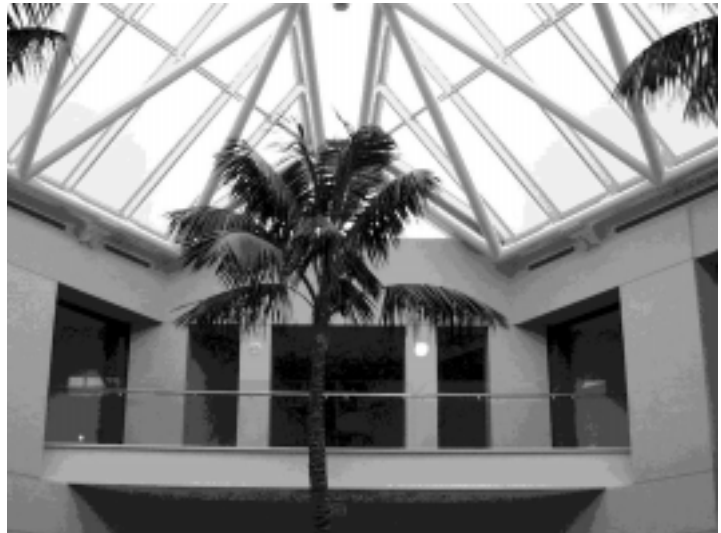
37. Image modified in Photoshop. The total colors were limited to ten, and the image was then grayscaled in order to exaggerate the contrast within the view.

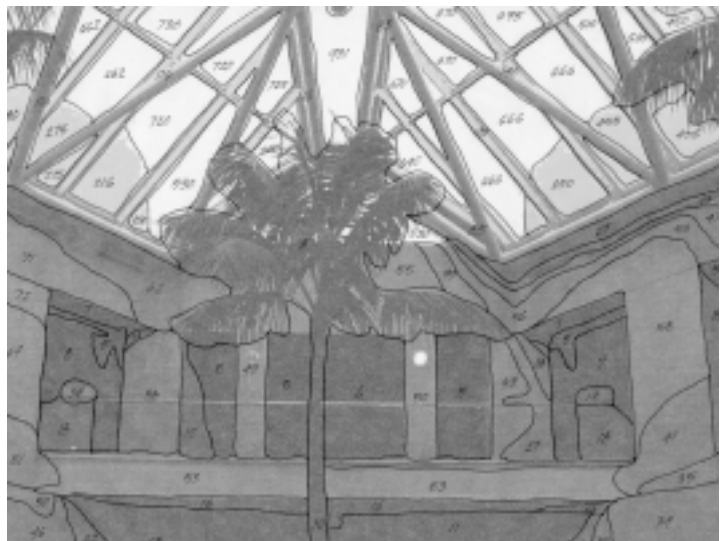
38. Tracing of the major areas of brightness within the view overlaid on the grayscale image. Spot readings of the outlined areas are indicated in foot Lamberts.

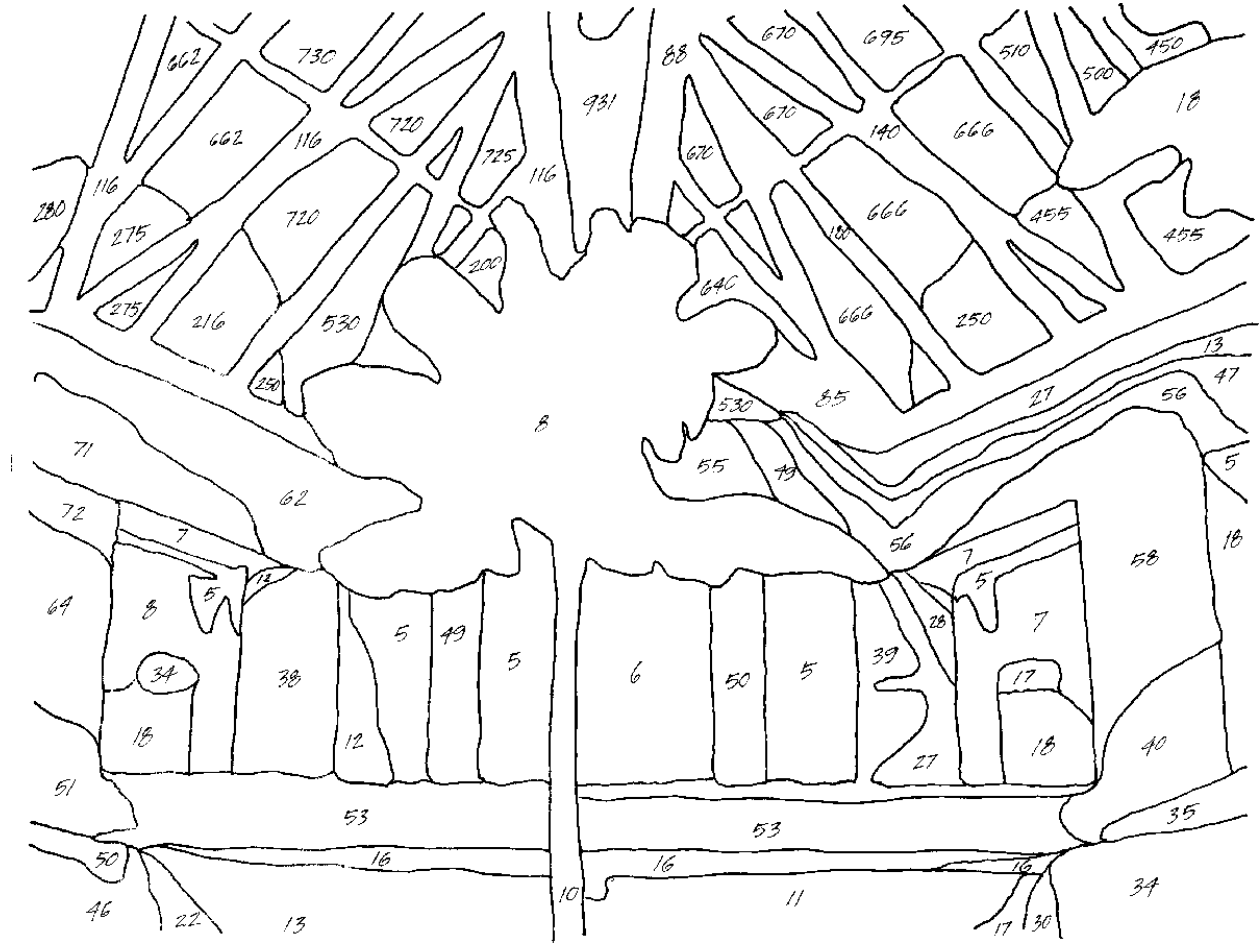
VIEW #2: cloudy day

39. Visual field map of View #2 on a cloudy afternoon.

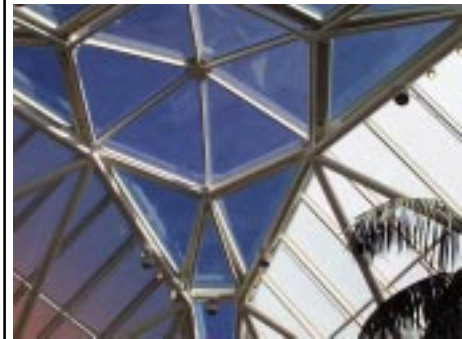
41. View of skylight in conservatory.

The skylight in the conservatory consists of two types of glass. The majority of the skylight facets are covered in translucent glass primarily for the purpose of screening views to the three mechanical towers. The remainder of the glass in the skylight facets is transparent.

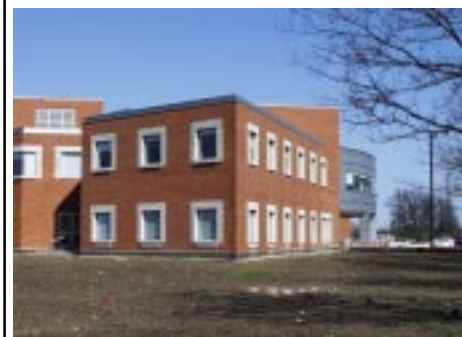
42. View of exterior window details.
