**A
BUILDING
WORKUP**

CLEO ROGERS MEMORIAL LIBRARY

COLUMBUS, INDIANA

SUBMITTED BY
THE
VITAL SIGNS CLASS
CERES STUDENT SCHOLARS
CENTER FOR ENERGY RESEARCH/EDUCATION/SERVICE
BALL STATE UNIVERSITY

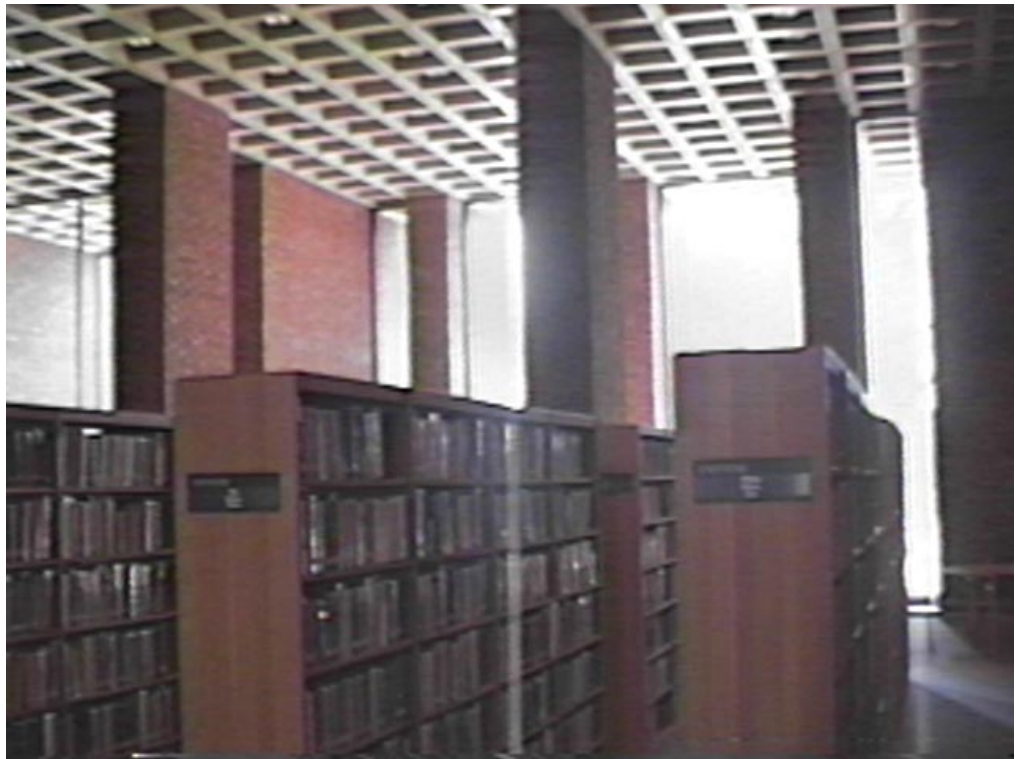
Cleo Rogers Memorial Library Assessment
facility description

The Cleo Rogers Memorial Library was designed by IM Pei. It was commissioned in 1963 and occupied in 1967. The building comprises brick-clad, waffled-pan, fixed-glazing construction technologies with centralized floor-integrated air supply/return using terminal distribution and capture at window mullions. The floor construction includes a secondary concrete slab located above the primary (waffled) structure. Metal baffles placed between these slabs are used for patterning air supply and air return pathways. Waste heat from the incandescent lighting fixtures, placed within the structural pan coffer, is designed to provide a substantial portion of the winter-time space heating.

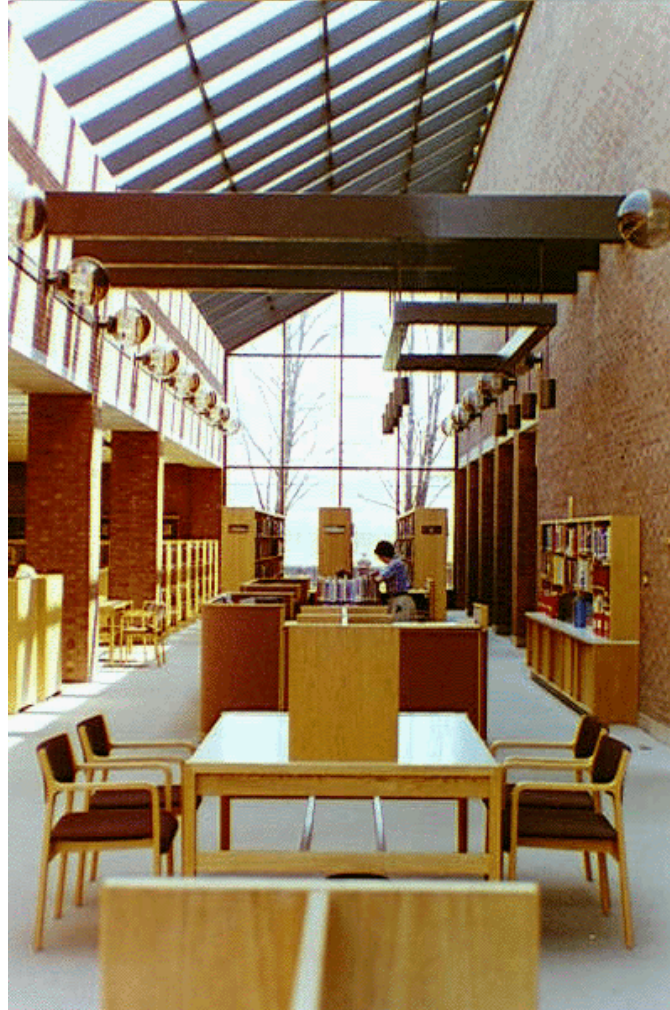
Figure 2 Interior view of galleria looking east, showing glazing system, and globe and track lighting fixtures.

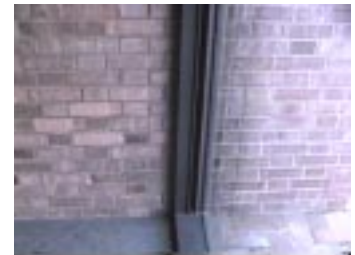
Figure 5 Fixed glazing mullion with integral air supply/air return channel.

The original building employed $\frac{1}{2}$ " thick full height single pane fixed glass panels, set in steel mullions. These mullions have integral air supply and air return slots which bathe the glass in a continuous horizontally flowing air stream. The mullion air shafts are supplied by vertical duct runs set within the structural brick piers of the building. The glass is not spectrally selective and no attempts were made to insulate the "air slot" mullion against thermal loss to the outside ambient air.

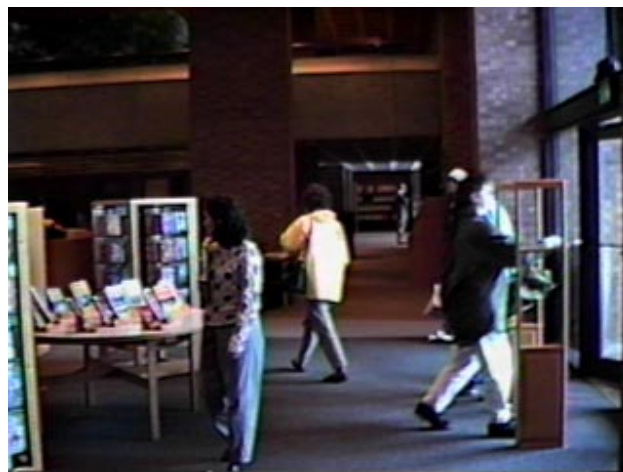
Figure 14 Main lobby space looking east.

The sequence of space illumination studies for the main area/lobby of the library, are summarized in this section; they are detailed in **Appendix A**. The isolux map (**figure 15**) illustrates that the majority of the space contains illumination levels which fall below IES recommendations for reading--between 35 and 50 footcandles. The areas adjacent to the windows provide substantially more illumination during the daytime only. During the evening hours and when natural daylight is not entering the room, the entire space contains fairly uniform but low illumination levels. This finding is supported by data samples taken across the building sections. Two plots, taken near the west wall of the space are illustrated. The first chart (**figure 16**) is from a sunny day, March 30, where natural light was filling the space. The second chart (**figure 17**) was taken during an overcast day, March 31, when natural light was minimal. It is safe to say that the data for March 30th and 31st are dramatically different due primarily to outside weather conditions.

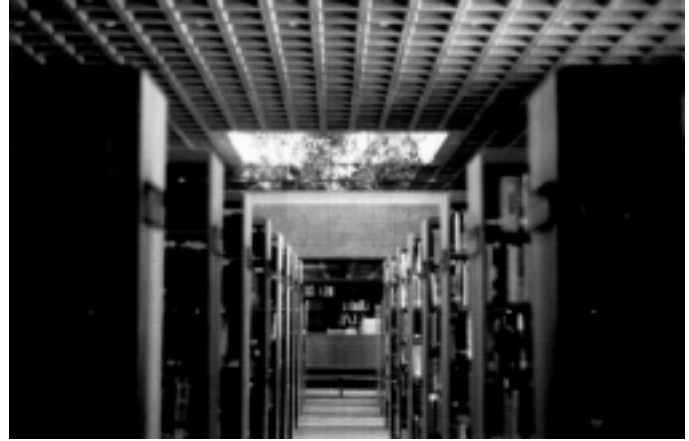
Figure 18 Stacks and the skylight of the mezzanine area.

The study of the mezzanine level, as detailed in **Appendix B** is summarized below. A primary issue addressed is the illuminance recommendations from the IES for 'finding and reading' books. Illuminance readings were taken throughout the stack area. Sample measured values on the surfaces of 'west to east' and 'north to south' book stacks are presented in **figures 19** and **20**, respectively. These display considerable variations from the top to the bottom of the stacks. Clearly the lighting in the space is not sufficient to evenly illuminate the entire area. It is interesting to note that the ends of the stacks nearest the light well (west in **figure 19** and north in **figure 20**) generally have a higher footcandle reading than do the opposite ends of the same stacks. This illustrates that the light

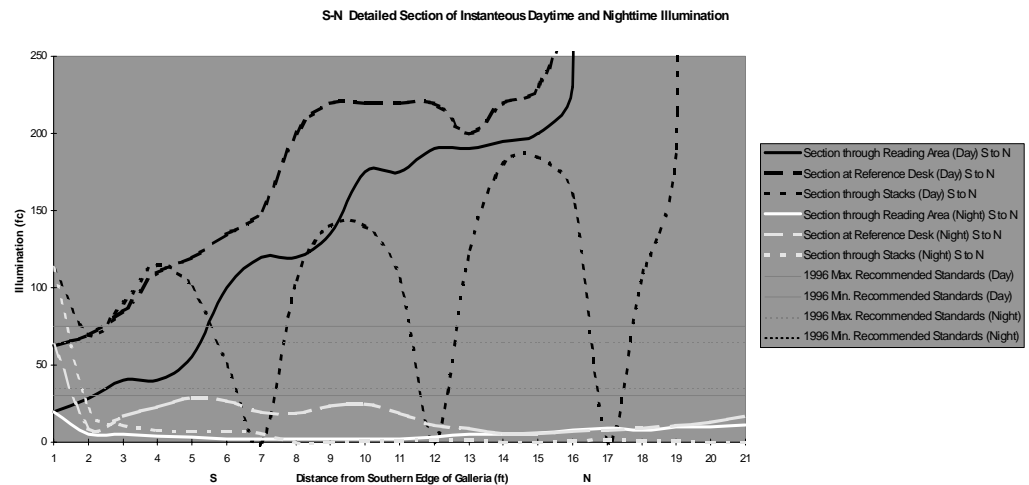
Figure 23 Illuminance measurements from a section that runs the width of the galleria.

The instantaneous daytime illuminance readings taken on a south/north axis as shown in **figure 23** provide more information regarding the effect of daylight on the space. Starting on the south end, where the galleria connects with the *original building*, and working across the 20 foot long galleria to the *new*

addition, readings were taken every foot. This was done at three spots--the reference stacks on the east end, the reference desk in the center, and the study carrels on the west end. In all three cases the readings showed remarkable consistency for the first 14 feet from south to north; then, at the 15 foot mark, the readings jump to over 250 footcandles for the study carrels and reference desk, and the reference stacks show a similar increase at 18 feet. This can be explained by the steep angle of the skylight; the sun is in the south portion of the sky, and the north-facing skylight is angled to present a smaller surface to the south. This restricts much of the sunlight; however, the angle does allow direct sunlight to come in and fall on the north edge of the galleria, accounting for the high readings in that section.

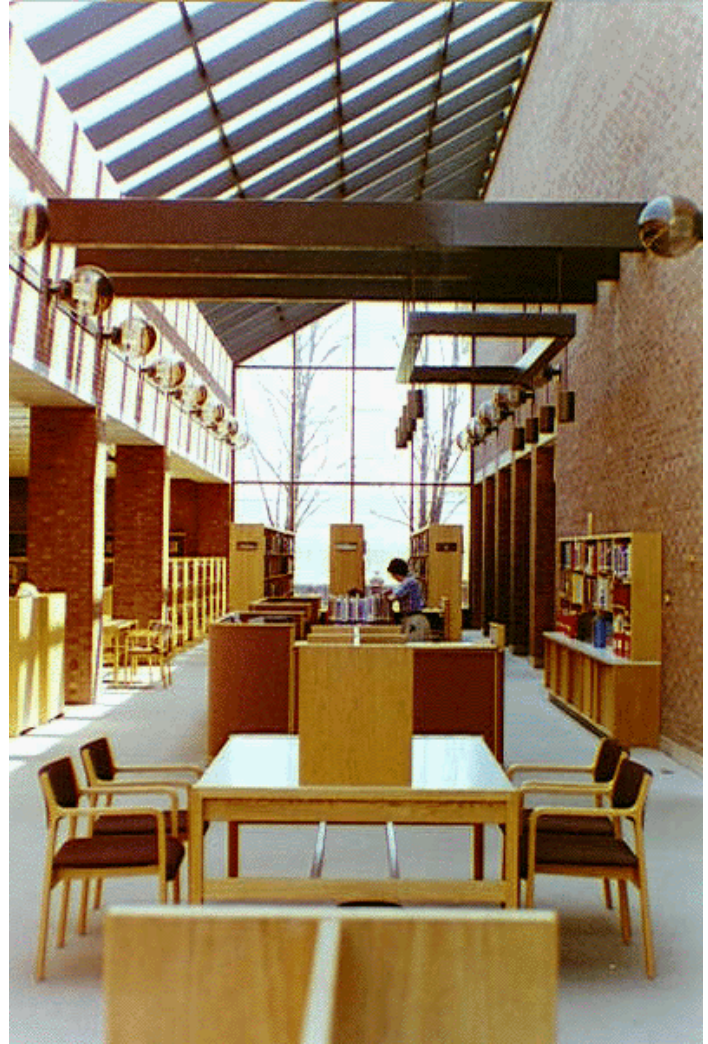
Figure 24 Looking east in the galleria space.

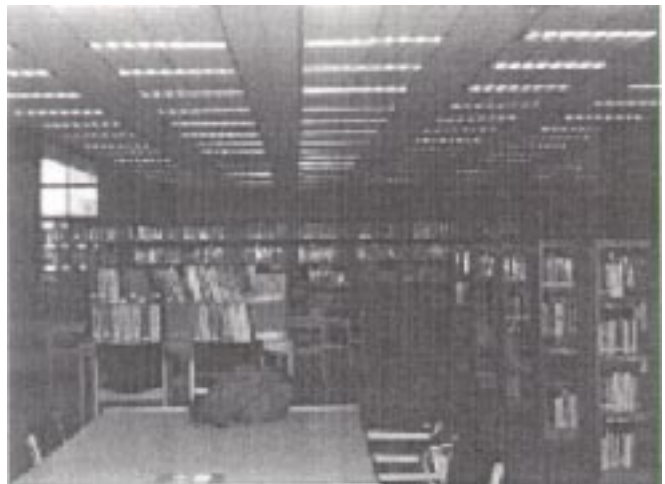
Figure 27 View of the stacks in the addition.

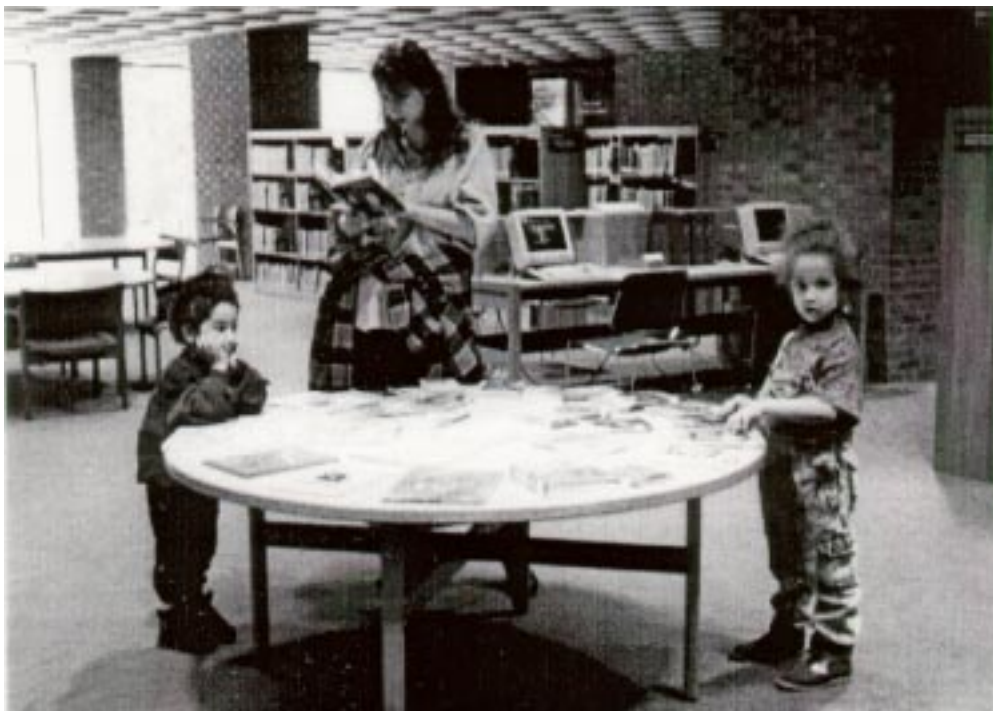
Children's Library

The children's library study is detailed in **Appendix E**. This space is on the lower level and was part of the *original building*; it has an external sunken plaza, below street level to the north. This is the direction from which the majority of natural light enters the space. However, it was found that the natural lighting does not reach far into the space. **Figure 29** shows that daylight contributes significantly to the illumination of the children's library but for only about a five foot depth into the space. Throughout the space, illumination levels are barely above the minimum IES recommendations. The 3-D isolux graph shown in **figure 30** illustrates the low illumination levels as well as the variations across the depth of space.

It was also discovered that the electric lighting in the space creates variations in illumination levels at different working heights throughout the space. The coordination of patterning of the lighting fixtures with the waffle slab structure of the ceiling, and the light distribution characteristics of the 'can' fixtures, causes a pooling of cones of light to be produced which yields noticeable variation in the intensities of light -- 'cold' and 'hot' spots occur at eye level. At the operational task level of 24", however, these blend to produce a more uniform illumination.

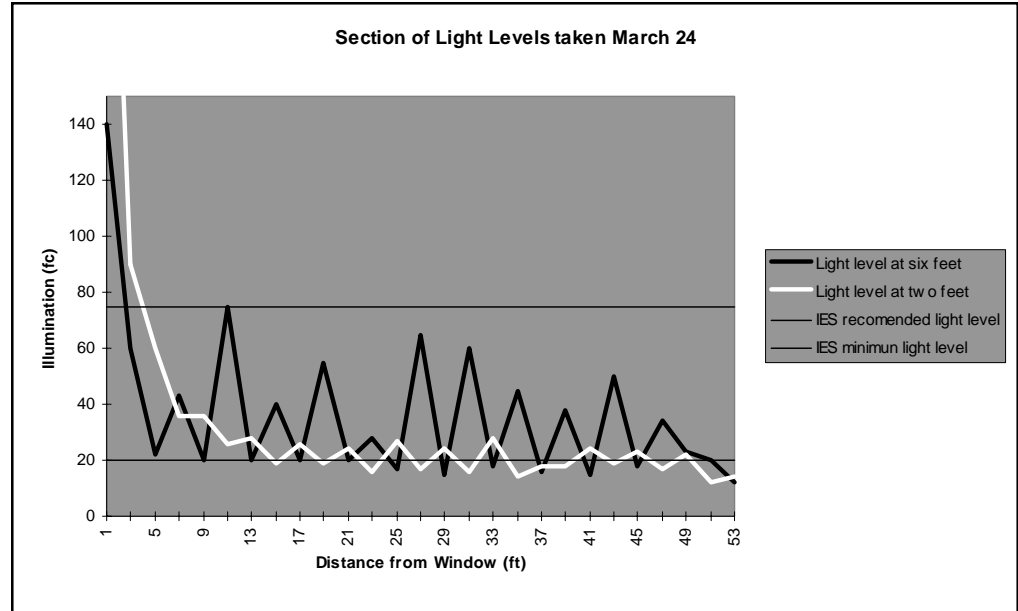
Figure 29 Illuminance measurements taken from a single section through the space.

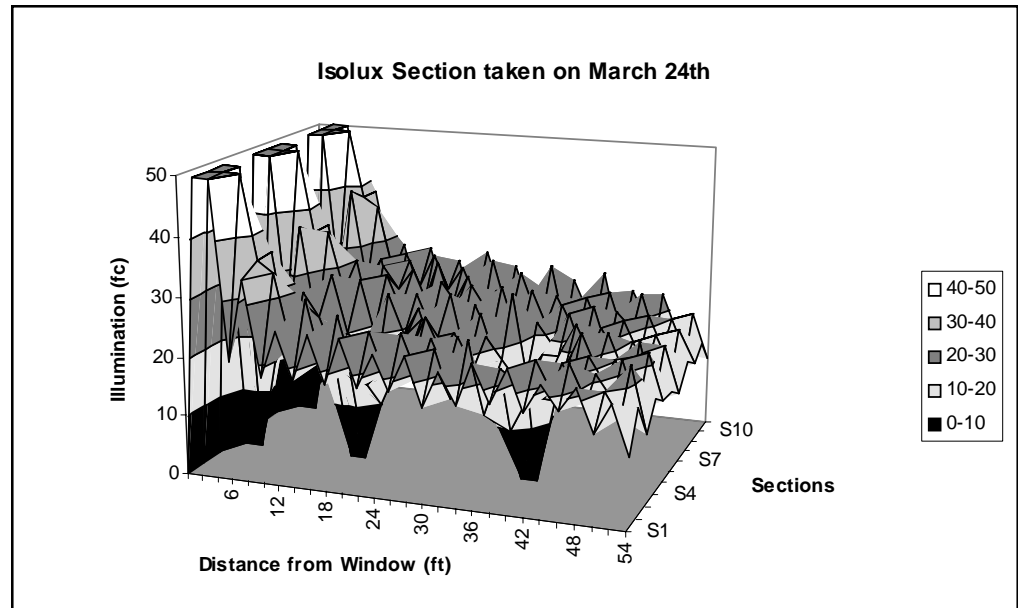
Figure 30 Isolux taken across a broader band of sections through the space at 24" task height.
