# **The Distribution and Effects of Borrowed Daylight in the Atrium of the Van Nuys Medical Science Building**

Vital Signs VII  
Center for Energy Research, Education, and Service

Ball State University  
Fall 2002

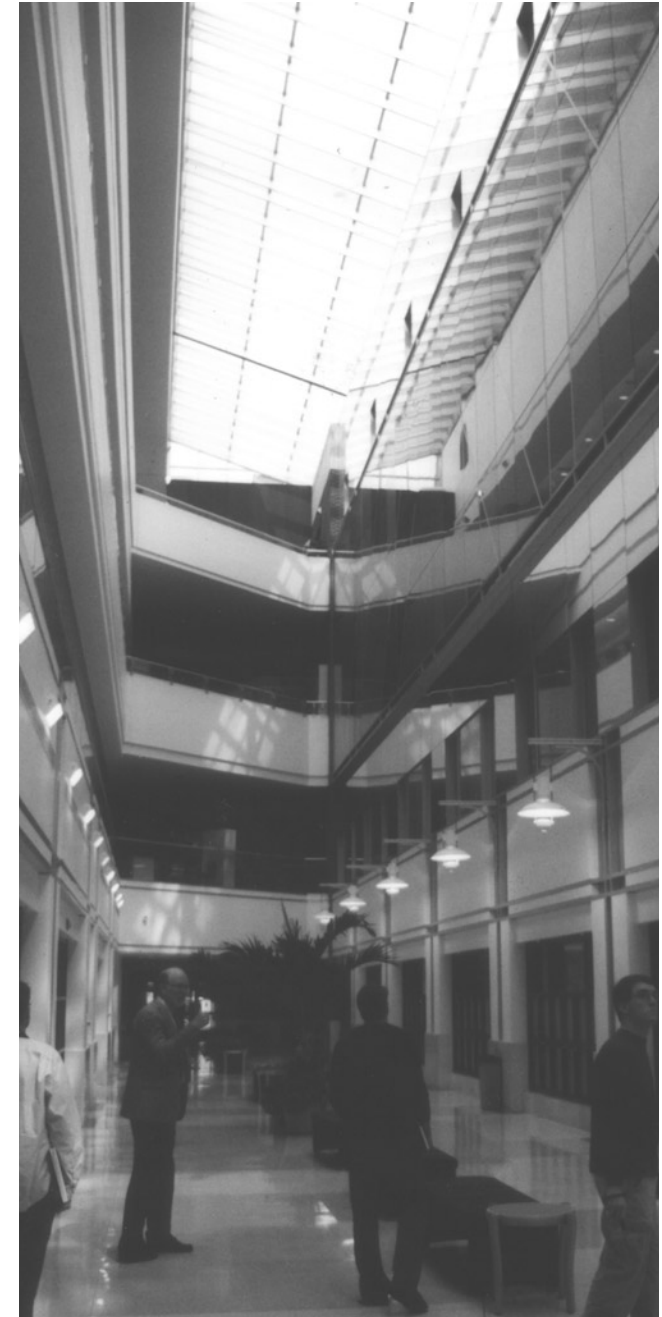
*View through atrium facing north*

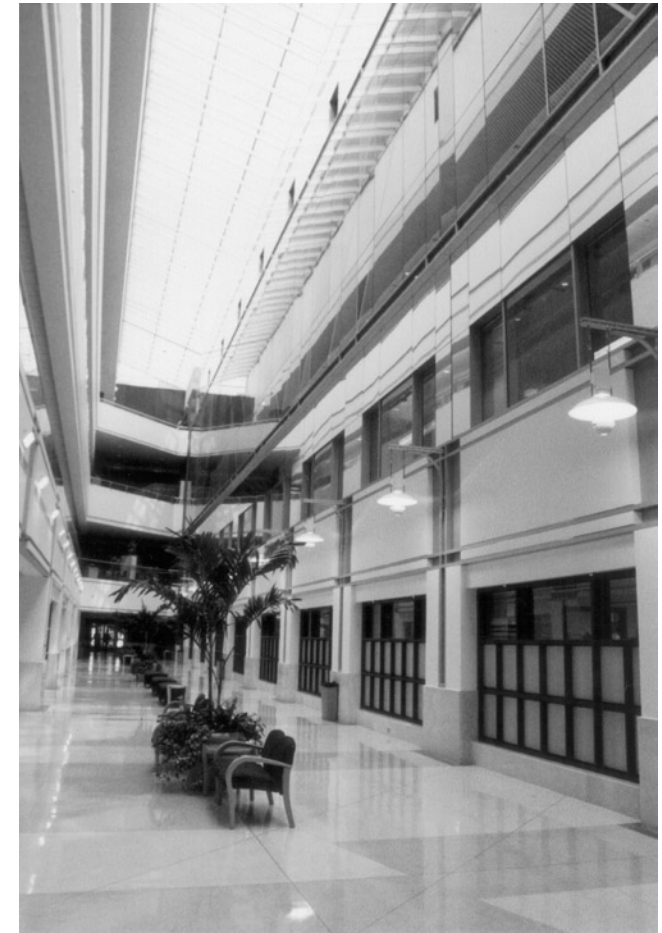
*Image from first floor showing mirror wall*

Our first impression of the atrium of the Van Nuys Medical Science Building was that it was a bright, well-lit space, even in overcast sky conditions. A large, 90% reflective mirror mostly covered the east wall, the ceiling was completely glazed, and most of the finishes in the space were light colored. The mirror wall gave a broken reflection of the wall opposite to it. There was some concern that the mirror could cause a glare problem due to its west facing orientation. A number of offices adjacent to the atrium had some form of visual filter or barrier such as black felt cloth placed in the glazed apertures.

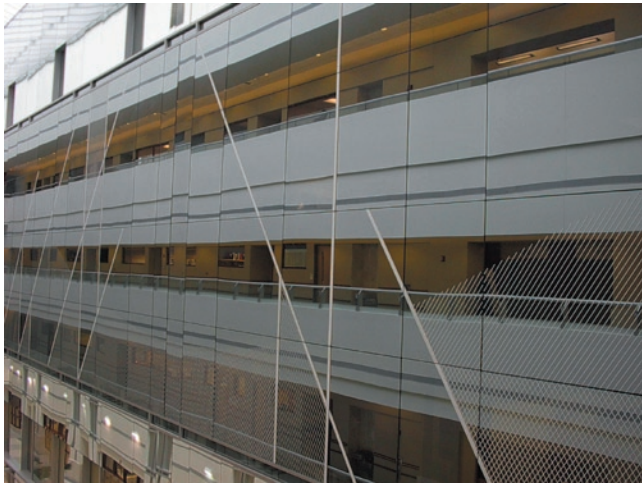
*Image showing detail of mirror wall*

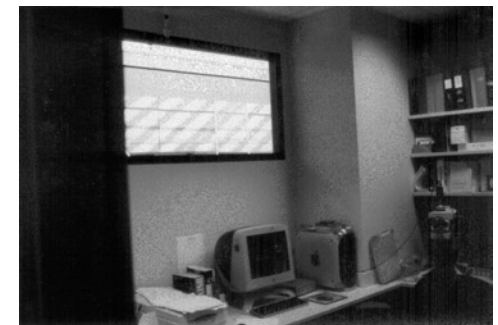
*View of apertures from inside office*

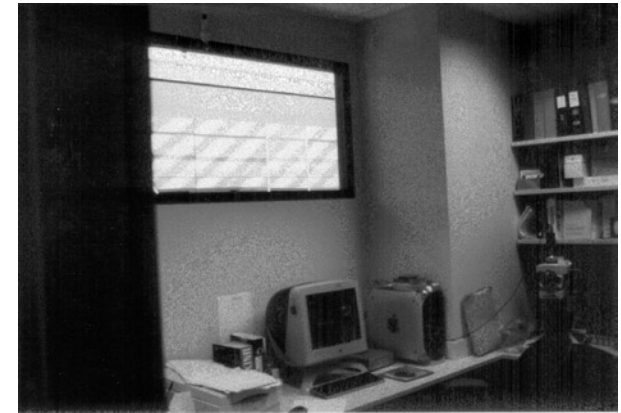
*Image showing office C with the lights on*

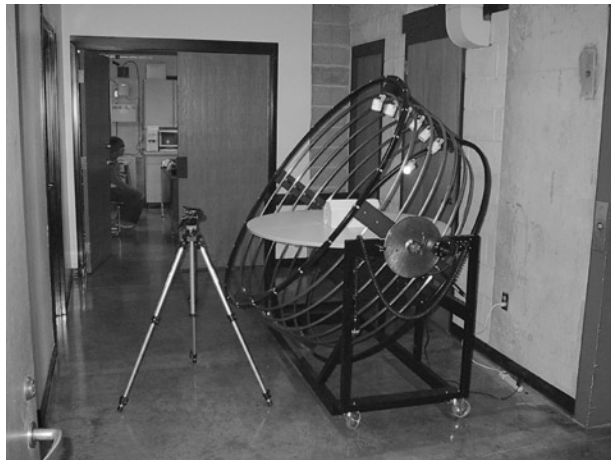
*Image showing the heliodon, model placement, and tripod location*

In order to study how beam light illuminated the atrium and caused glare throughout the year, a 1/16" = 1'-0" model was constructed. The model was restricted to this size because the heliodon used required it to fit within a 12"x12"x6" rectangular volume. The reason for the size restriction is because the beam light produced by the multiple reflector lamps used on the heliodon are not as parallel as the beam light from the sun, and the test results of any model exceeding the size restrictions will be distorted. An 84% reflective crescent board was used to represent the white painted gypsum board walls of the space, and a 95% reflective chrome foil was used to represent the mirror.
