# **W. D. Richards Elementary School**

## **A Study of the Lighting Conditions in the Music Instruction Space**

Vital Signs VIII  
Center for Energy Research, Education, and Service

Ball State University  
College of Architecture and Planning  
Fall Semester 2003

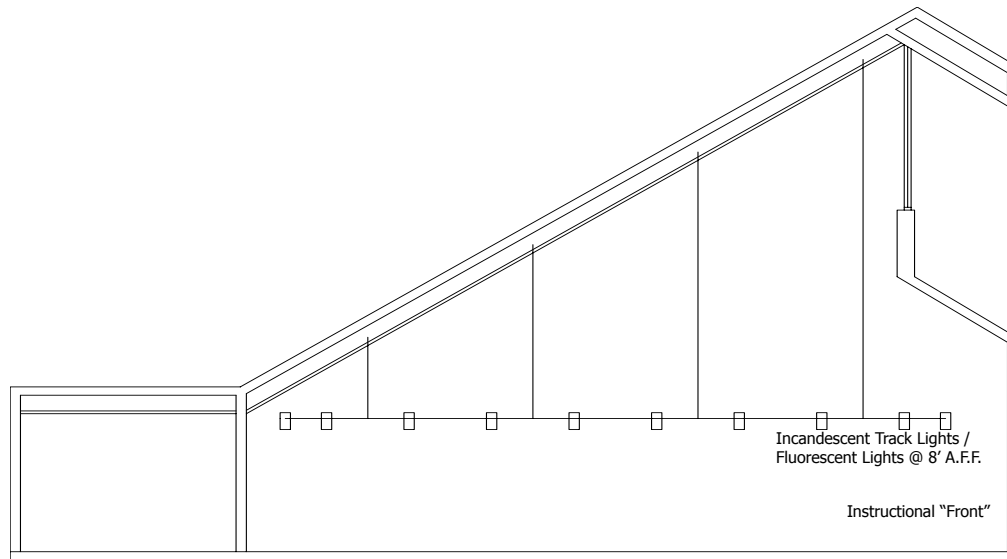
**Figure 2.2**  
**Music Instruction Room Section**

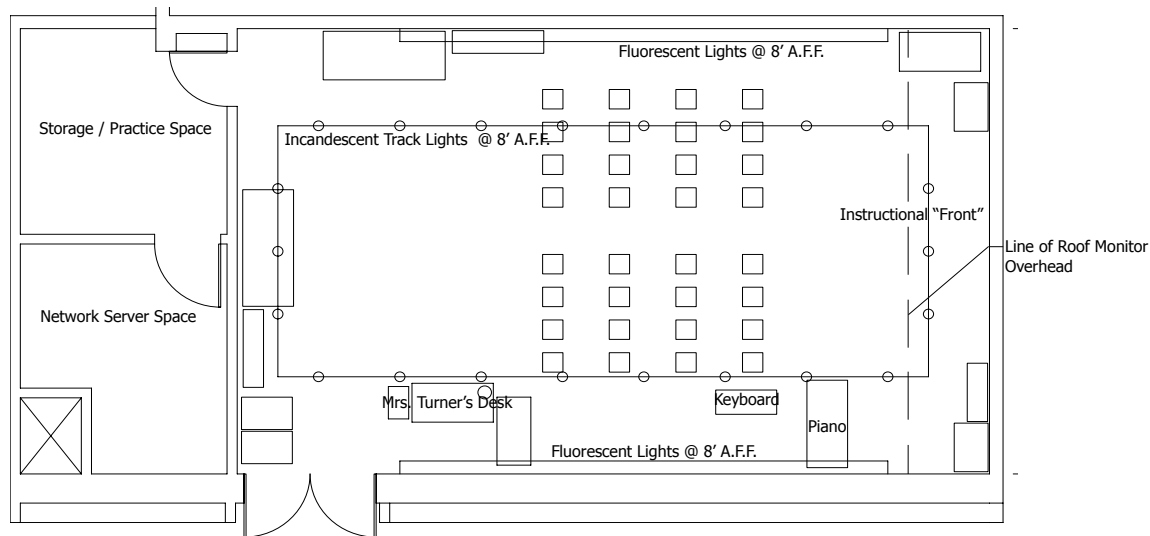
**Figure 2.3**  
**Music Instruction Room Floor Plan**

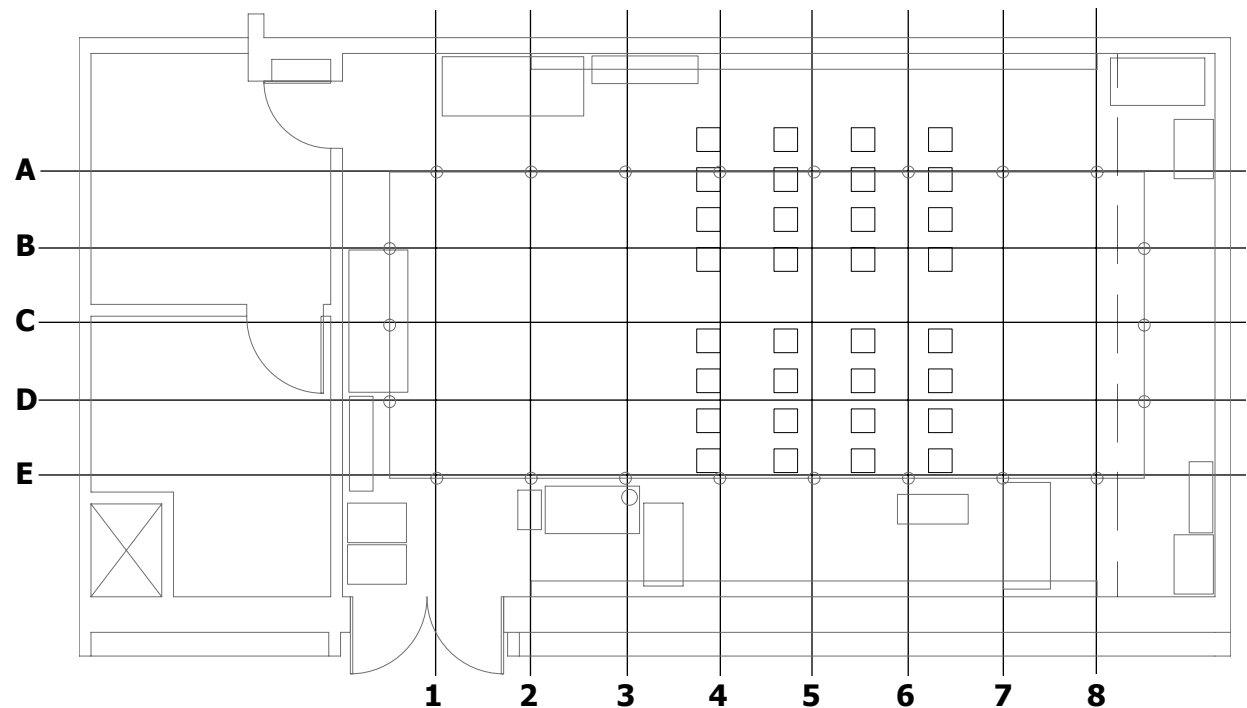
**Figure 3.1**  
**Reference Plan - Locations for Measurement of**  
**Instantaneous Illumination Quantities**

To gain a better understanding of the general lighting conditions in the Music Instruction room, we took instantaneous illumination measurements using a G.E. Illumination Meter (see Appendix D for instrument abilities and limitations).

We were interested in the illumination quantities over different parts of the day which corresponded to the different classes using the room. Measurements were taken at 8 a.m., just minutes prior to Mrs. Turners first class of the day. A second measurement was taken at 11 a.m. following the final morning class. The third measurement was taken at 1:00 p.m. prior to the first afternoon class.

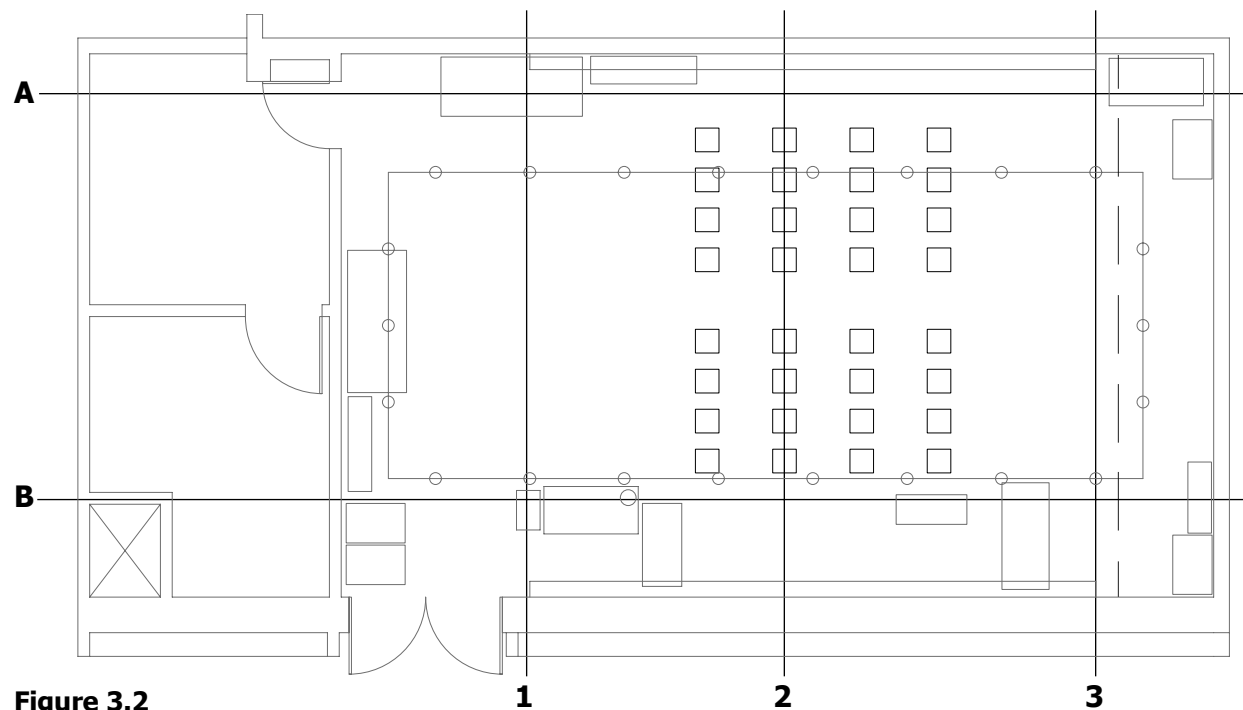
**Figure 3.2**  
**Reference Plan - Locations for Measurement of**  
**Illumination Quantities over Time**

We sectioned the room off into thirds measuring the west third, central third, and east third of the Music Instruction room. One set of instruments was placed near the north wall, the other near the south wall in order to measure any differences in reflected illumination due to the east-facing roof monitor.

We were able to isolate the fluorescent lighting on Thursday morning, the incandescent lighting on Friday morning, and the natural lighting over the weekend. These isolated measurements allowed us to develop more accurate representations of the contribution from each light source.

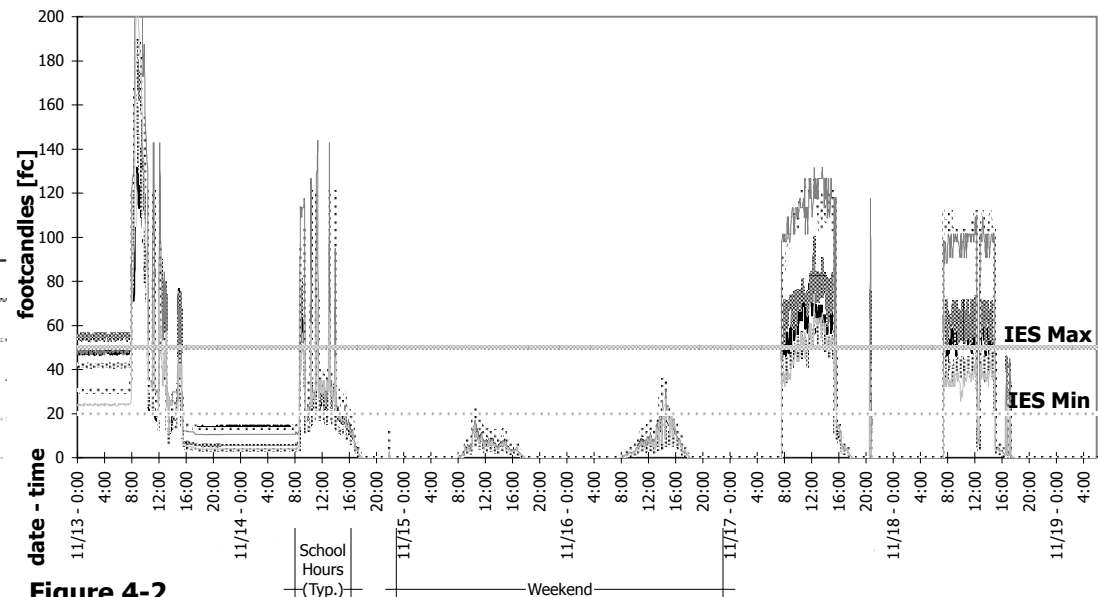
**Figure 4-2**  
**7 Day Composite**

Figure 4.2 represents the composite measurements from the all six of the illumination data loggers. Discrepancies between the illumination levels were assumed to be due in part to the varied distance of the instruments from the north or south walls. The data represented also take into account the multipliers for color correction (see Appendix D). See Appendix C for the individual components of the composite graph.

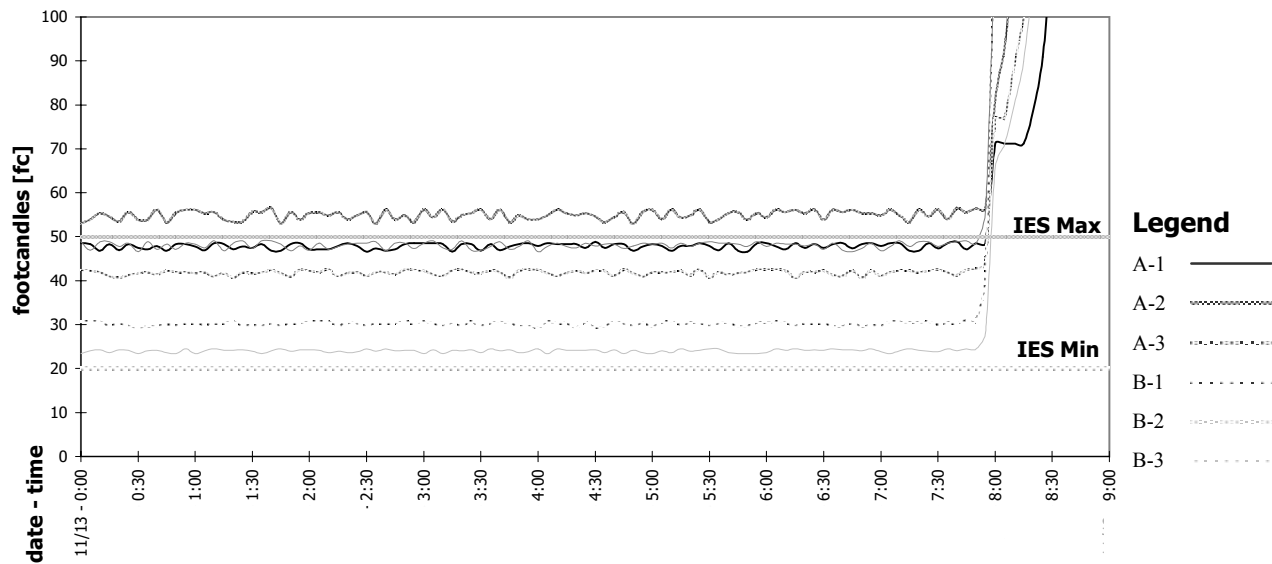
**Figure 4.3**  
**1 Day Isolated Fluorescent Composite**

Figure 4.3 represents the isolation of the fluorescent light overnight on November 13. The readings show that the fluorescent lights alone are able to meet minimum IES recommendations for the room.

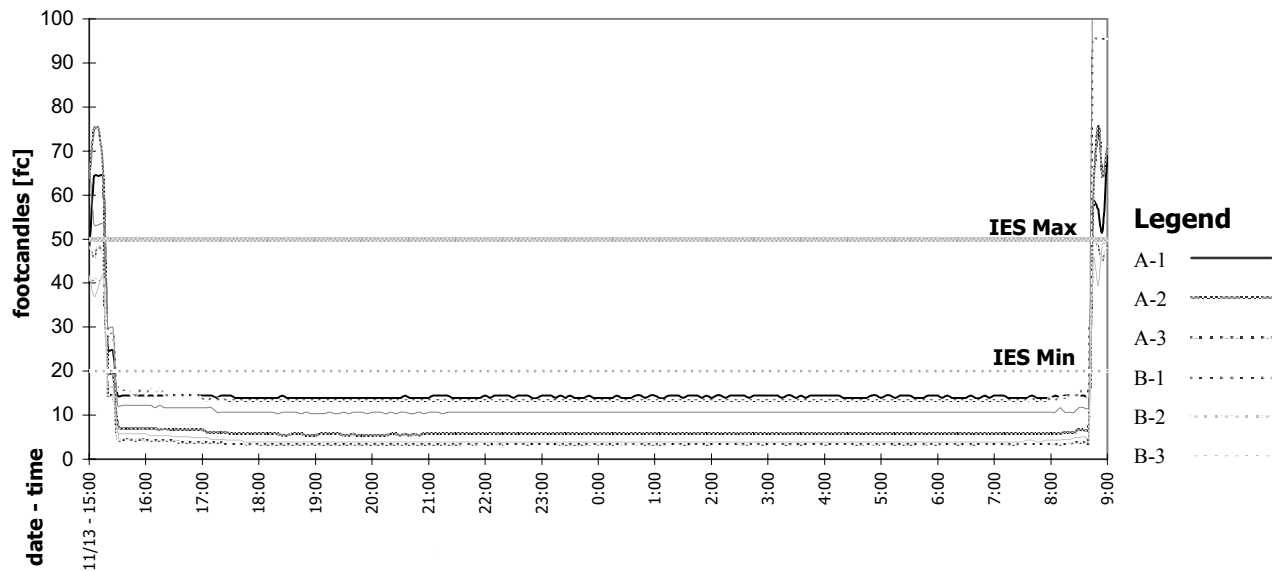
**Figure 4.4**  
**1 Day Isolated Incandescent Composite**

Figure 4.4 represents the isolation of the incandescent light overnight on November 14. The readings show that the incandescent lights fail to meet the minimum IES recommendation of 20 fc. However, the incandescents are utilized as a complimentary light source rather than the primary source for the room. The main purpose for the incandescents is to highlight different displays and task locations around the room.

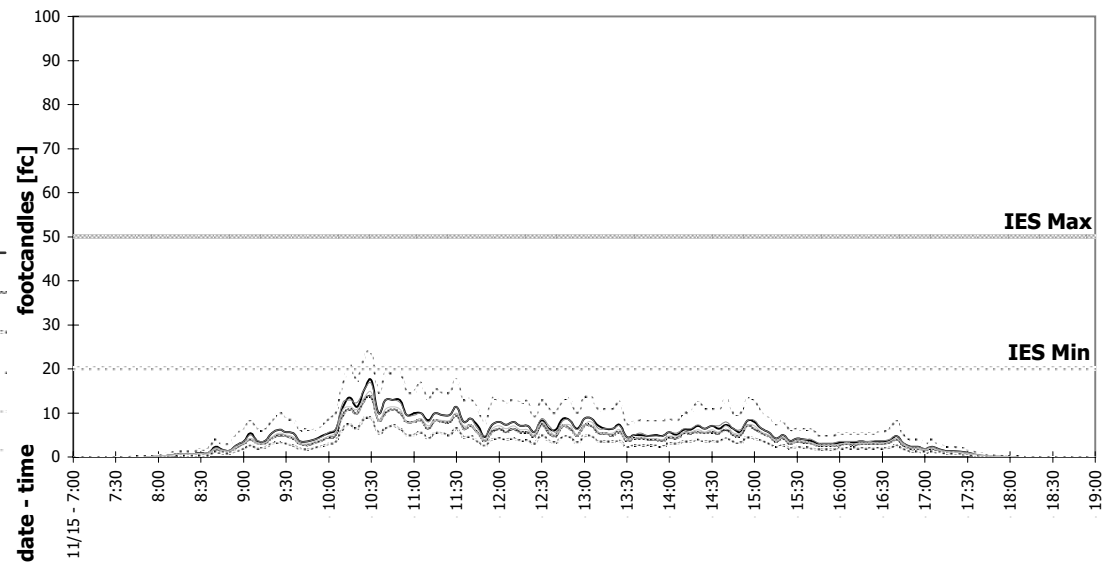
**Figure 4.7**  
**1 Day Isolated Natural Composite (Overcast Conditions)**

Figure 4.7 represents the isolation of natural light on November 15. Conditions were overcast both November 15 and 16 when these values were isolated. The data indicated that natural light is able to provide the minimum IES recommended illumination only during a brief period during the late morning.

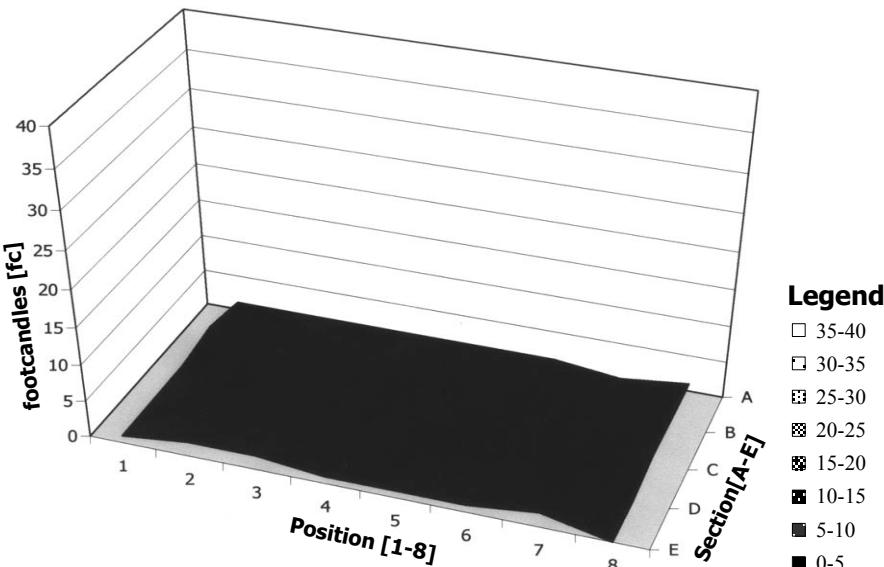
**Figure 4.8**  
**Instantaneous “Mountain of Light” (8:00 a.m.)**

The 8:00 a.m. measurement [Figure 4.8] indicated that during the winter months, the first class does not gain any natural light as the sun has not yet broken the horizon.

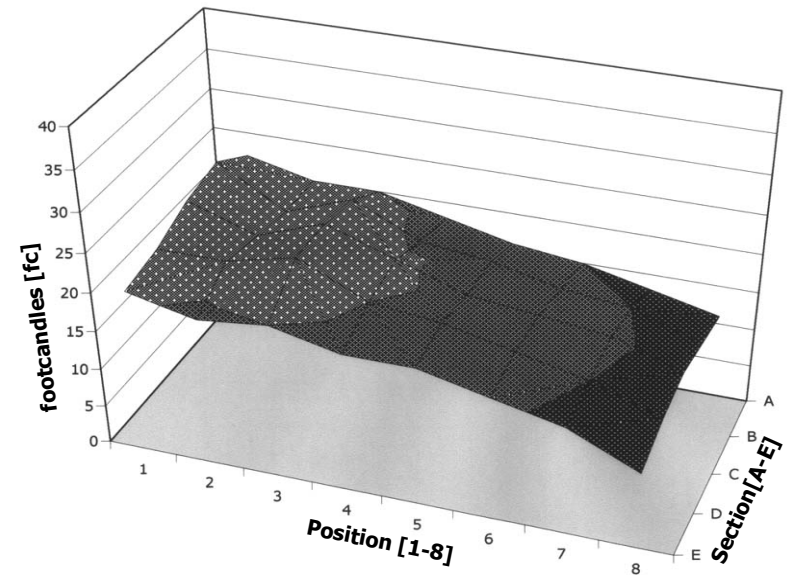
**Figure 4.11**  
**Instantaneous "Mountain of Light" (12:00 noon)**

The 1:00 p.m. measurement [Figure 4.12] follows our assumption closely. However, the 12:00 noon measurement [Figure 4.11] showed the higher illumination levels occurring closer to the center of the Music Instruction room.

The measurements taken by the illuminance data loggers indicated that the pattern seen in the 12:00 noon measurement [Figure 4.11] is the general pattern in the Music Instruction room. When the west composite [Figure 4.19] and central composite [Figure 4.20] graphs are compared, the measurements are consistently higher across the central position.

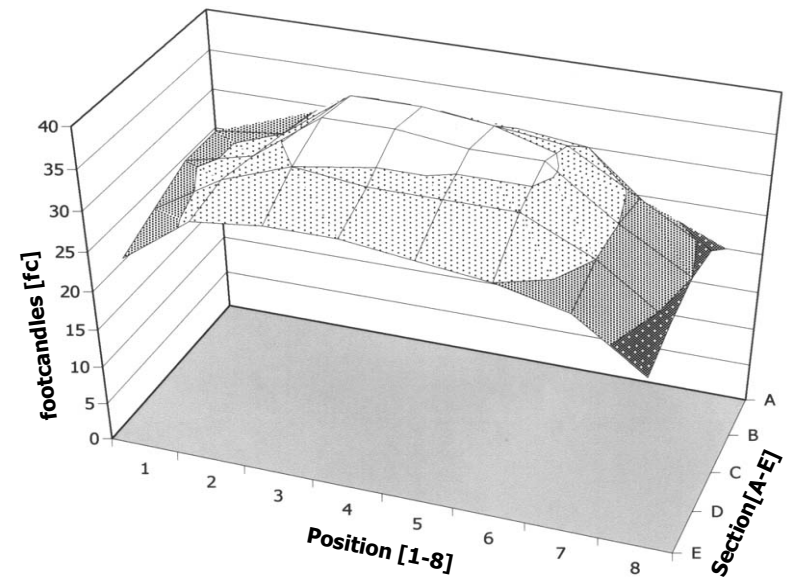
**Figure 4.12**  
**Instantaneous "Mountain of Light" (1:00 p.m.)**

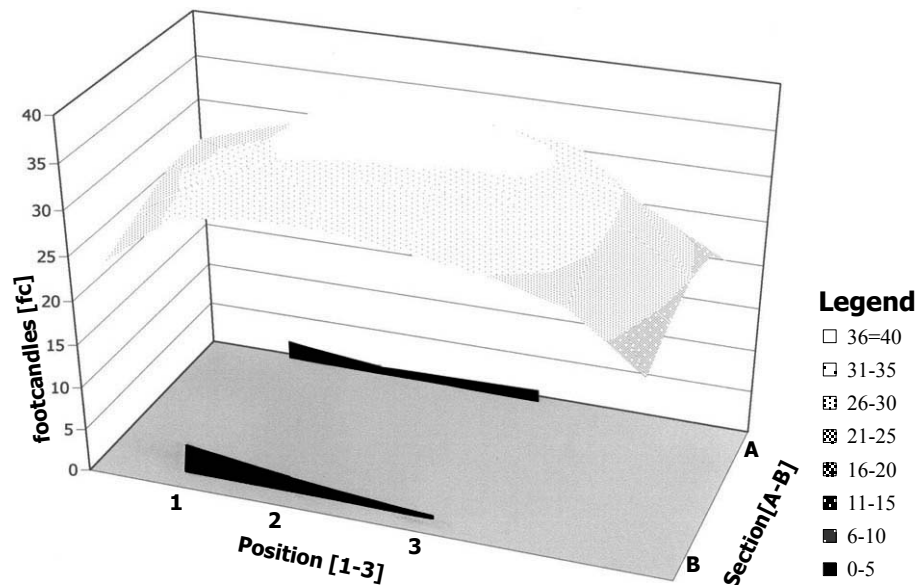
**Figure 4.13**  
Extracted "Mountain of Light" (9:00 a.m.)

The 9:00 a.m. measurement [Figure 4.13] indicates that very little illumination is present in the room. We presume that the overcast conditions for the day greatly lowered the morning readings.

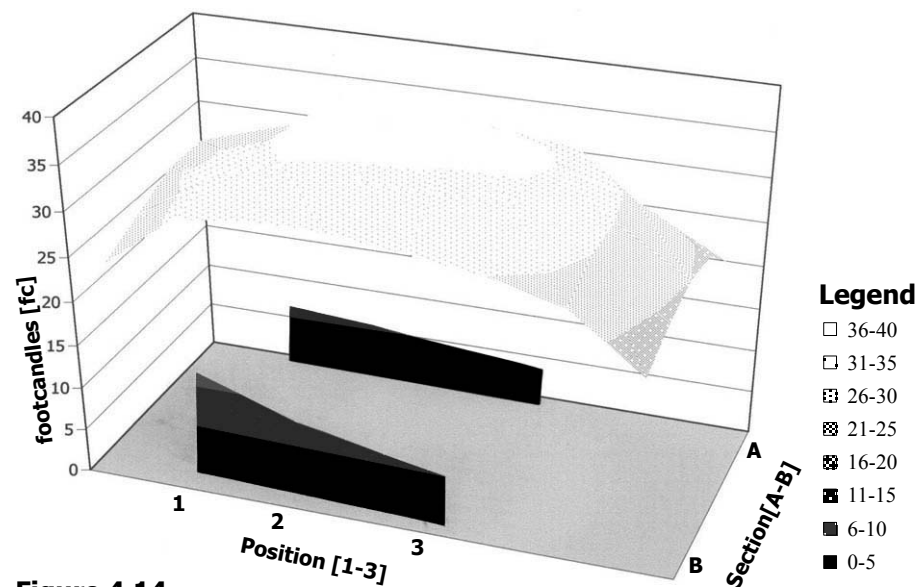
**Figure 4.14**  
Extracted "Mountain of Light" (11:00 a.m.)

The 11:00 a.m. measurement [Figure 4.14] indicated illumination levels toward the west end of the room higher than the 9:00 a.m. readings. However, the measured illumination levels still remained below the recommended IES minimum of 20 fc.

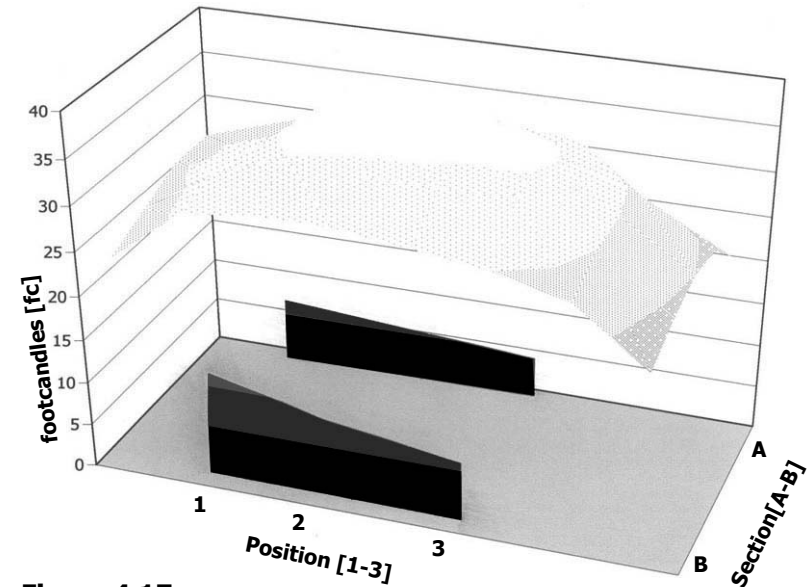
**Figure 4.17**  
**Extracted "Mountain of Light" (1:00 p.m.)**

The 1:00 p.m. measurement [Figure 4.17] matched the 11:00 a.m. reading very closely. The illumination levels still did not meet the recommended IES minimum. We also noticed a higher illumination level in the southwest portion of the room. This contradicted our assumption that the illumination levels would be greater on the north side of the room.

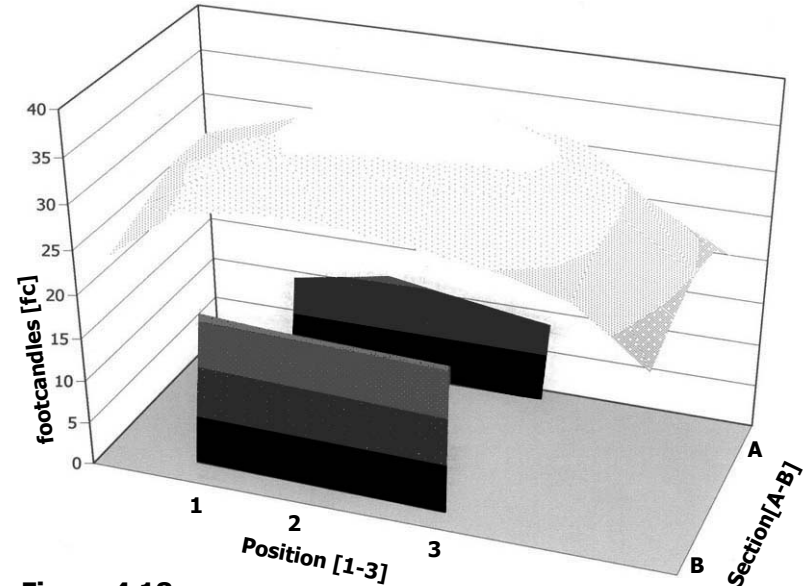
**Figure 4.18**  
**Extracted "Mountain of Light" (3:00 p.m.)**

The 3:00 p.m. measurement was the closest instant to meeting the minimum recommended IES illumination levels for November 16.

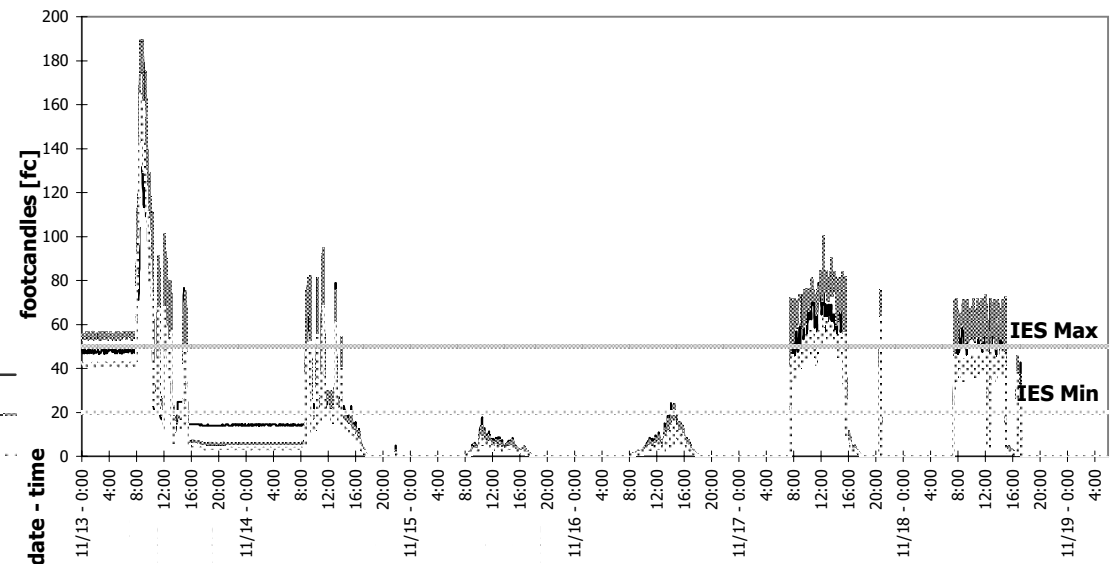
**Figure 4.23**  
**7 Day North Composite (Section A)**

The measurements taken by the illuminance data loggers also indicated that the pattern seen in which the north side of the room had slightly higher illumination levels indeed occurred as the general pattern in the Music Instruction room. When the north composite [Figure 4.23] and south composite [Figure 4.24] graphs are compared, the measurements are consistently higher across the northern section.

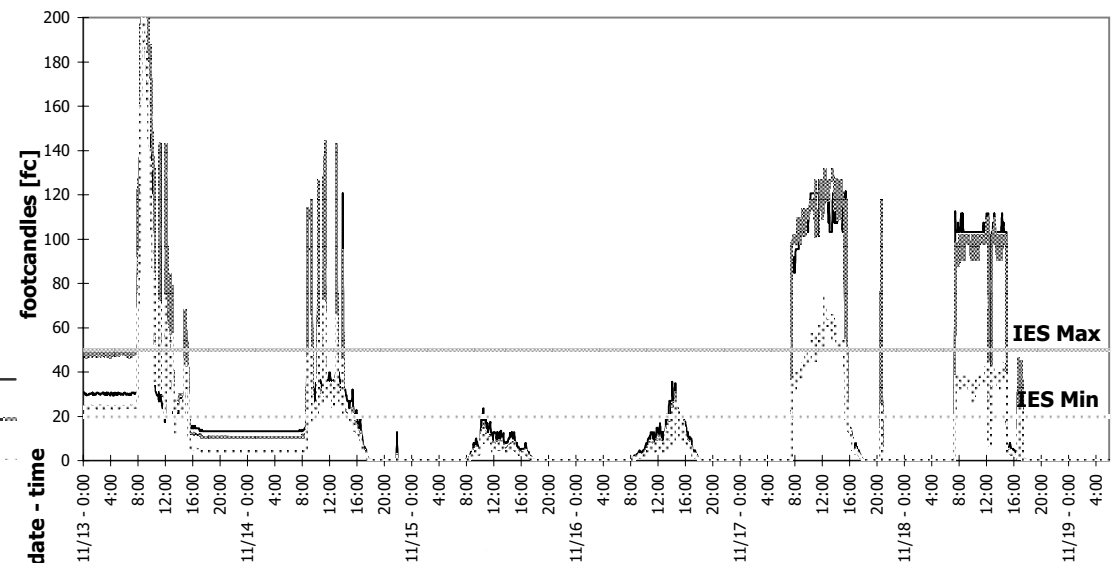
**Figure 4.24**  
**7 Day South Composite (Section B)**

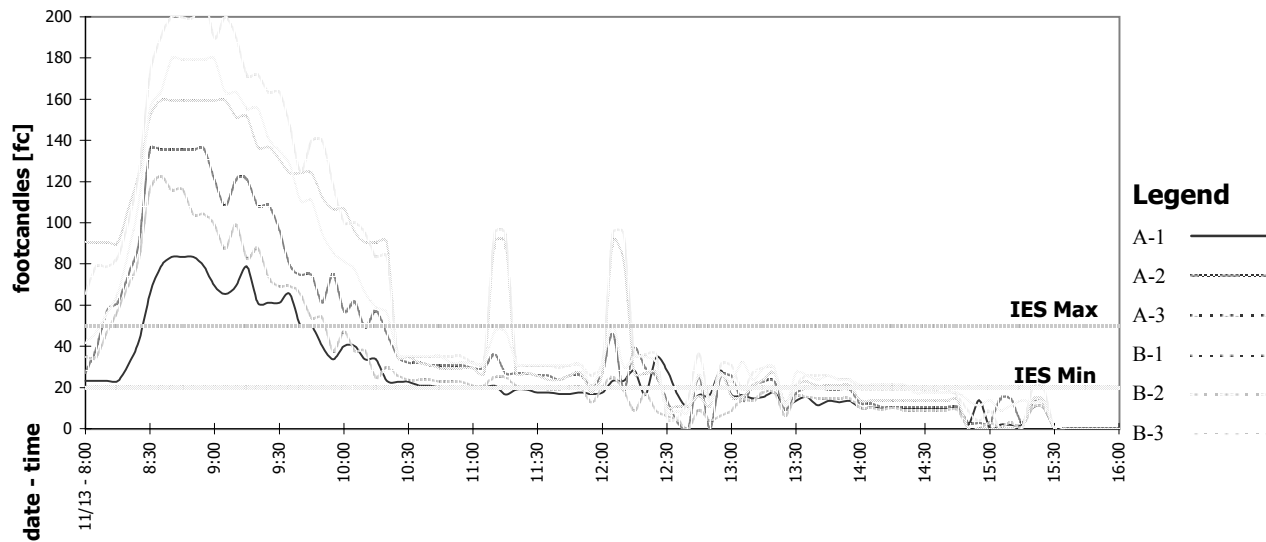
**Figure 4.25**  
**1 Day Composite (Sunny Conditions)**

We found that under sunny conditions, the natural light far exceeded the IES recommendations. Measurements show a brief period when we presume direct daylight penetrated the space shortly after 8:00 a.m. However, during the afternoon hours, measurements indicated that natural light was no longer meeting the minimum IES recommendations.

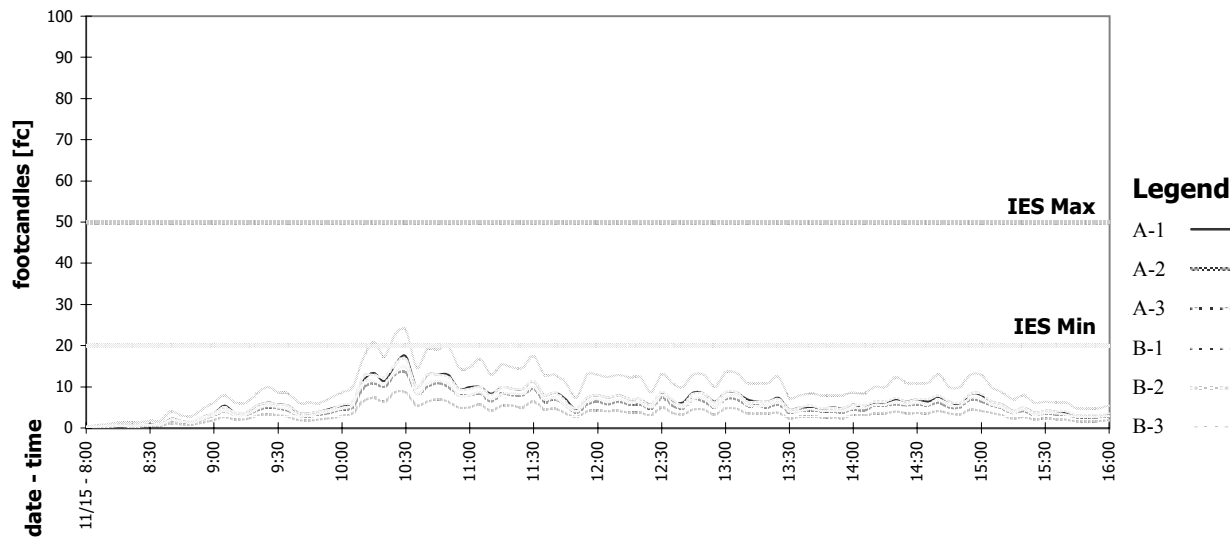
**Figure 4.26**  
**1 Day Composite (Overcast Conditions)**

After finding that fluorescent light could meet the minimum IES recommendations but that the incandescents light and natural light (for overcast conditions) did not, we analyzed the measurements taken the morning of November 13 to find out if natural light for sunny conditions could meet the minimum IES recommendations.

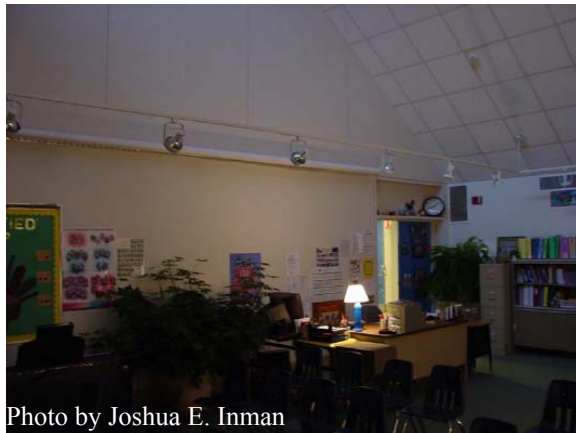
**Figure 4.28** Desk lamp is a source glare on a cloudy morning

The incandescent task lamp on the instructor's desk was also a source of direct glare [Figure 4.28]. However, the arrangement of the room was such that the lamp was out of the foveal vision of the students during instructional periods. This source also became negligible if the fluorescent lighting was turned on as the contrast ratio fell well within recommended levels.

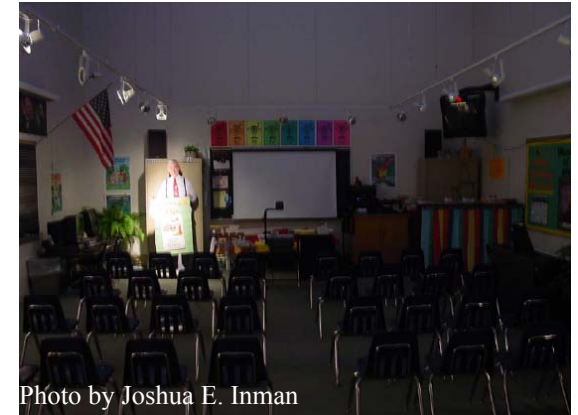
**Figure 4.30** Laminated Display Glare

The indicative phase revealed that several conditions of glare existed in the Music Instruction room. The common problem we observed was direct reflection from laminated wall displays [Figures 4.29 and 4.30] spotlighted by the incandescent lights. Many of these displays were out of the direct foveal field, but still within the general field of vision causing visual discomfort.

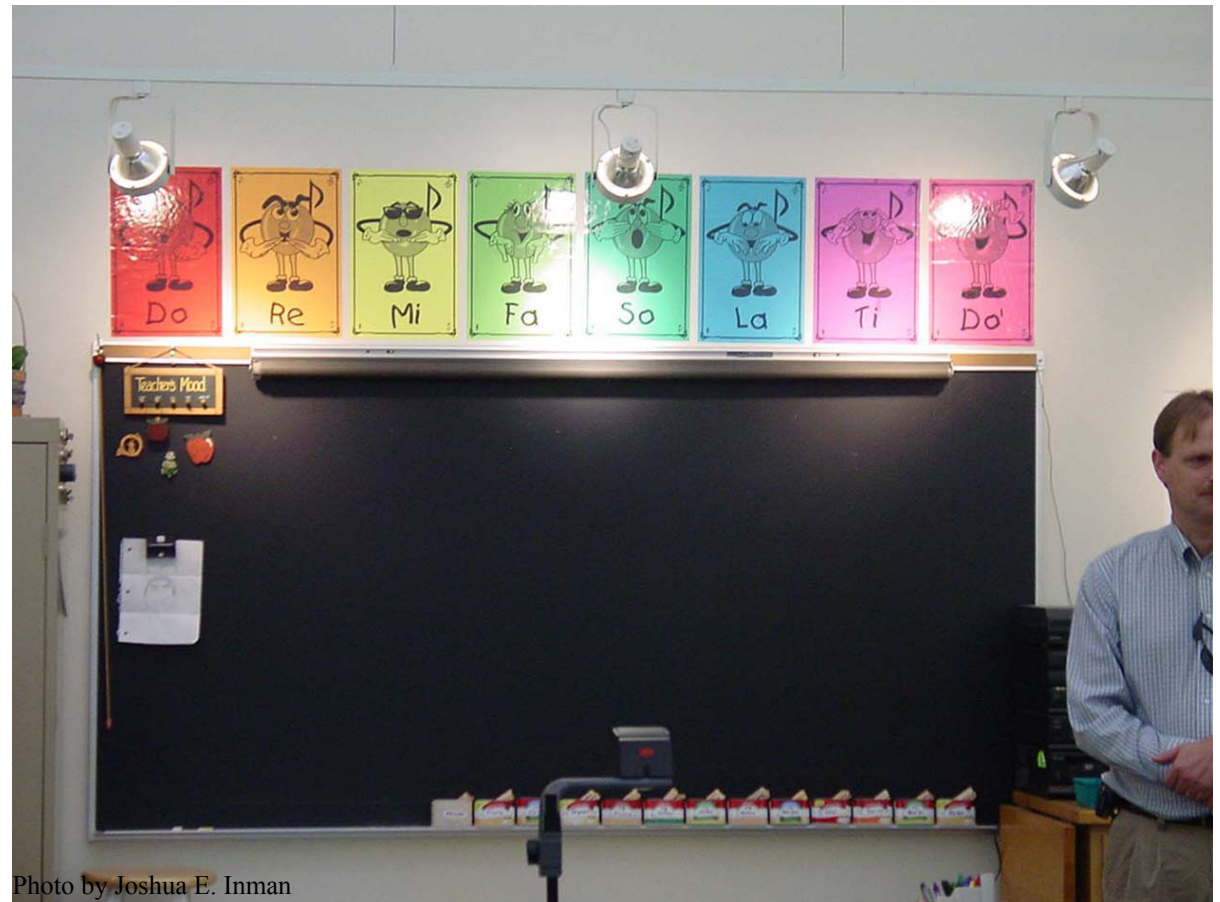
**Figure 4.29** Reflected glare from incandescent lighting upon laminated graphics

Our immediate recommendations address the reflective glare produced by the incandescent lights.

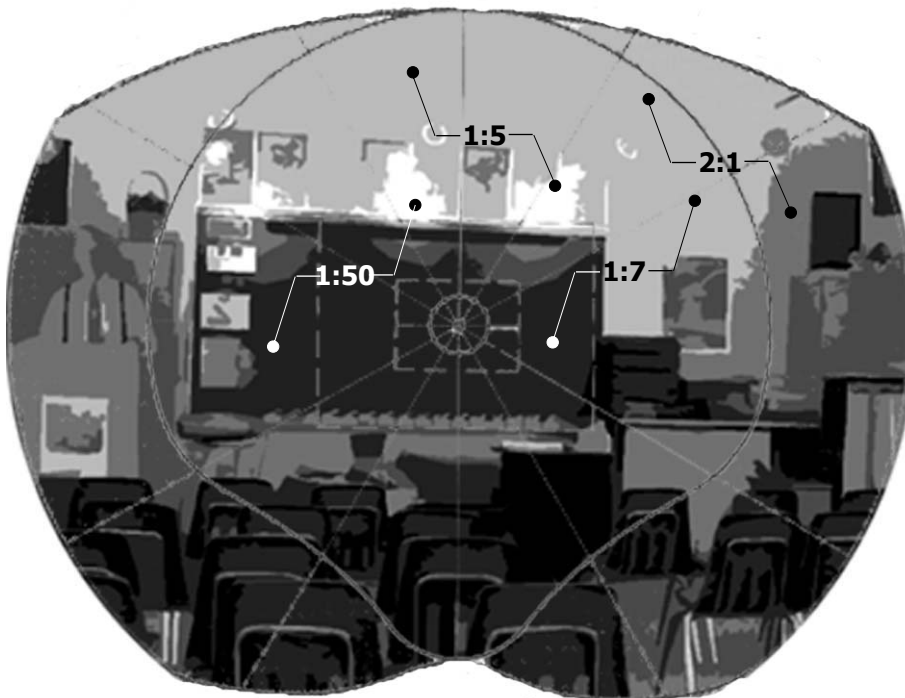
**Figure 4.33** East Wall w/ Artificial Lights Binocular Overlay Image

This foveal analysis is used to evaluate the conditions most often utilized in this space. The fluorescent lighting is on as are some of the incandescent lights. The greatest contrast [50:1] occurs between the board and the reflected light from the incandescent spot lights above. The fluorescent light provides a contrast ratio near 4:1, however, these lights are beyond the field of view for the students using the space. The contrast between the walls, the blackboard, and the piano area are such that visual comfort is not compromised.

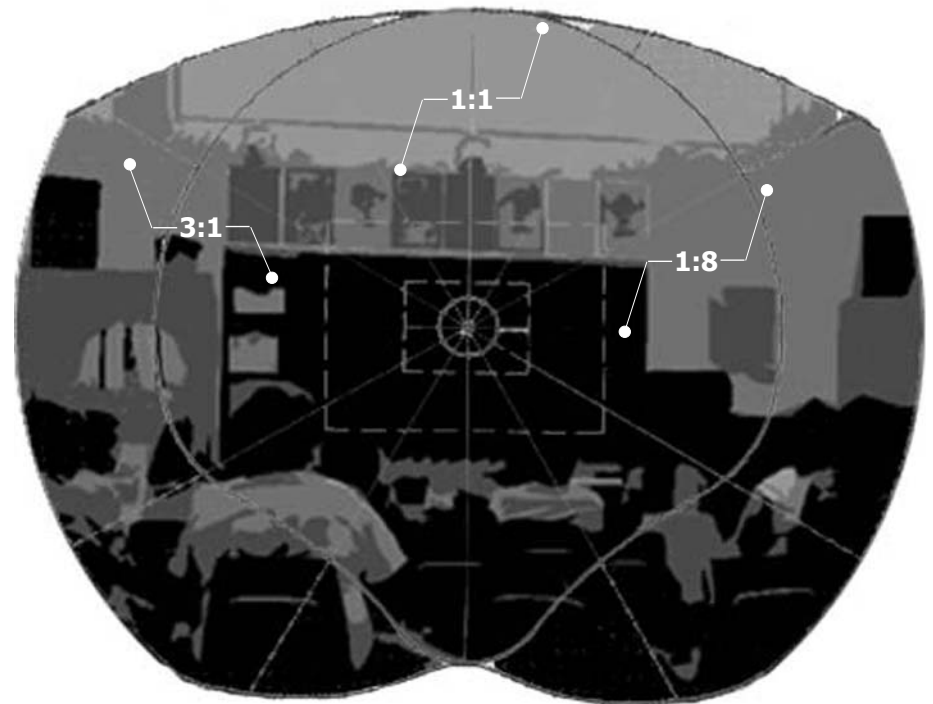
**Figure 4.38** East Wall Binocular Overlay Image

The space brightness ratios remain well below the recommended maximum of 40:1. In fact, the ratios are so low in some instances that we wonder if lack of contrast becomes a problem for the student from time to time. See Appendix B for more information regarding luminance ratios for specific situations.

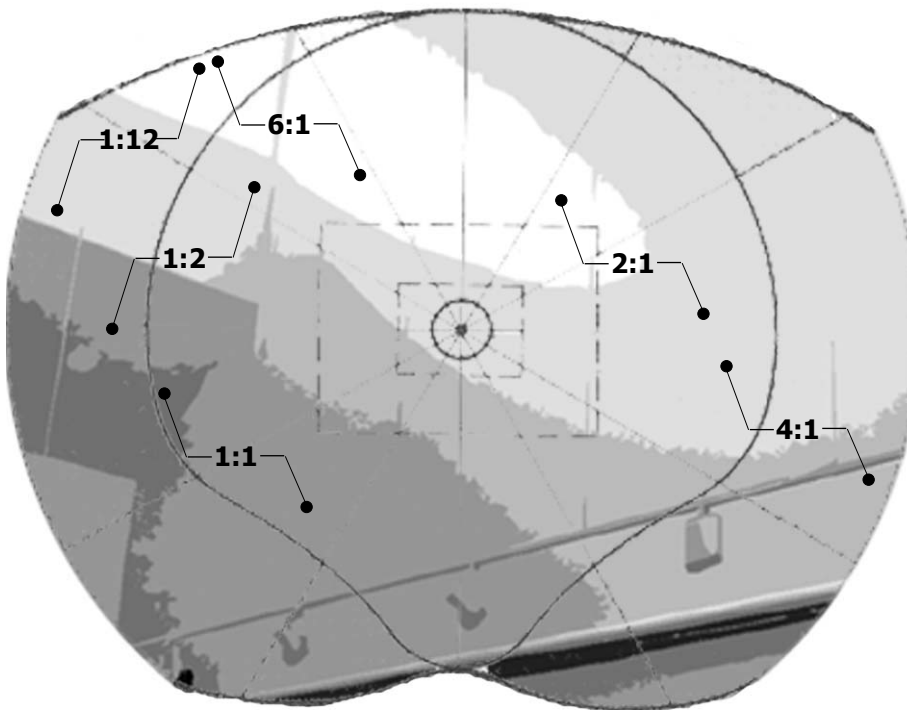
**Figure 4.41** South Wall Binocular Overlay Image

This foveal analysis is used to evaluate the vertical south wall as natural light is reflected into the space. The skylight shades are fully open to allow for maximum lighting. The greatest contrast [55:1] occurs across the upper regions of the space beyond the typical field of view. As the focus moves back down towards the instruction level, the ratios become as low as 2.5:1 which is well within the recommendations for all aspects of the visual field.

For practical purposes, the contrast ratios near the skylight windows can be discarded. The users of the space do not focus attention toward this area. We noticed it sometimes became the area where a distracted or daydreaming student focused their attention. By not providing a minimum level of visual comfort in this area, the design may be able to help redirect focus back down to the instructor and the task at hand. See Appendix B for more information regarding luminance ratios for specific situations.

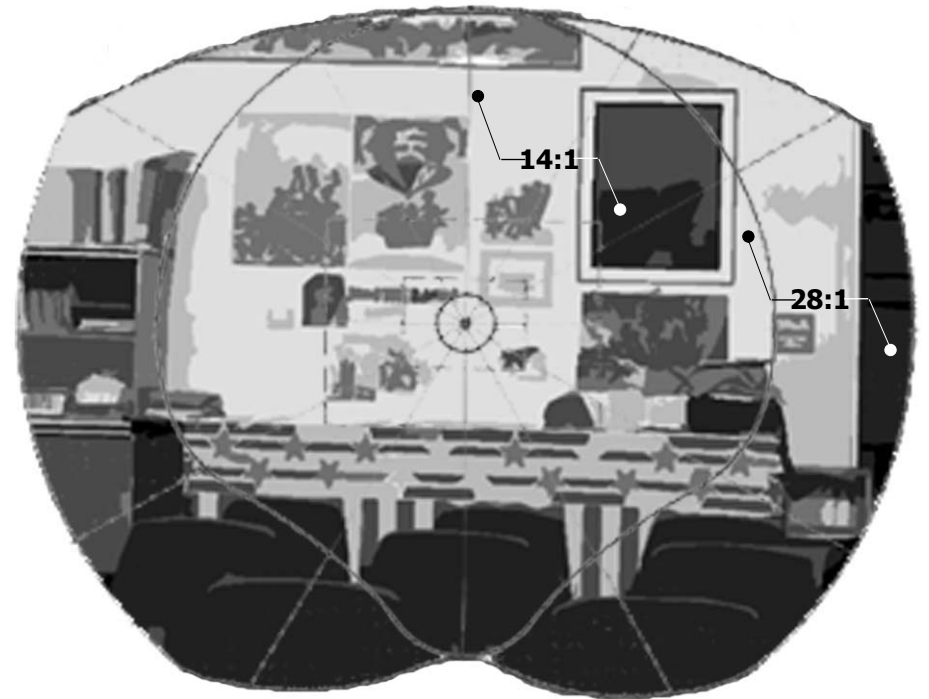
**Figure 4.46** West Wall Binocular Overlay Image

Again, the contrast ratios fall within the recommended 40:1 maximum ratio. However, the contrast between the wall and the darker door and window could become a source of visual discomfort for the users if the foveal field was directed to the area for extended periods of time. Similarly, the continuity across the wall, while meeting the recommendations, may not provide enough contrast for the eye to distinguish fine details. See Appendix B for more information regarding luminance ratios for specific situations.

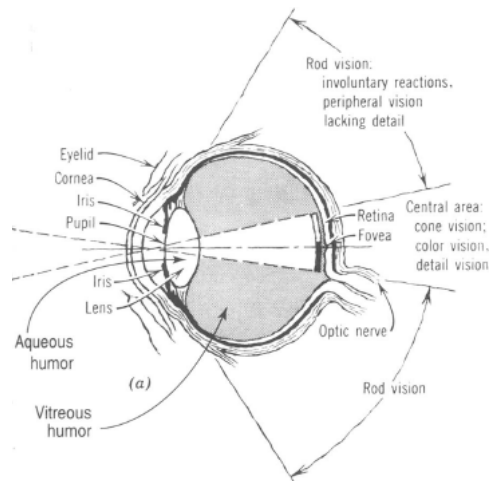
**Figure A.2** The Human Eye  
The eye operates on similar optic principles to a camera. The fovea, the center of focus, is an area the size of a pin head and contains 100,000 cone cells.

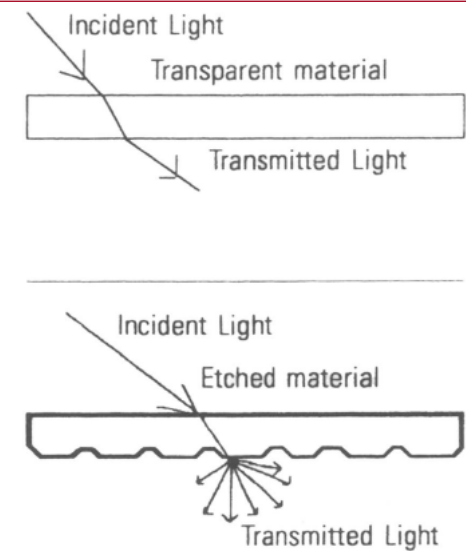
**Figure A.3** Transmission and Refraction  
Transmitted light (upper) passes through a material. Refraction (lower) occurs when light is bent moving from one material to another.
