# W.D. Richard's Elementary School

## Vital Signs VIII

Richard's Elementary School  
Columbus, Indiana  
Daylighting and Illuminance Case Study  
Fall 2003  
Ryan Luthman, Sal Impellitteri

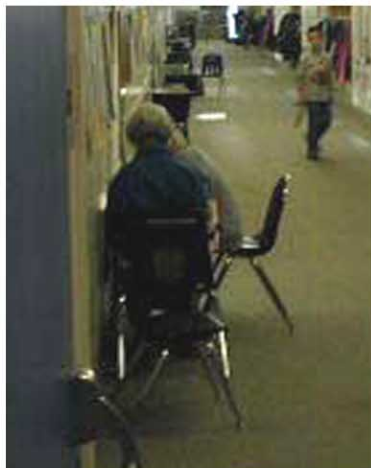
Figure 8B: Enlarged floor plan above showing small desks outside each classroom for student and teacher one-on-one sessions.

The main use of the original corridors in W.D. Richards Elementary School are as a means for movement from one classroom to another for all users. They also serve as a secondary classroom for students who have special needs. Here, single desks are located along the north side of the corridor, where a single student and single teacher engage in activities relevant to the needs of the student. These activities include reading, writing, and tutoring for upcoming tests.

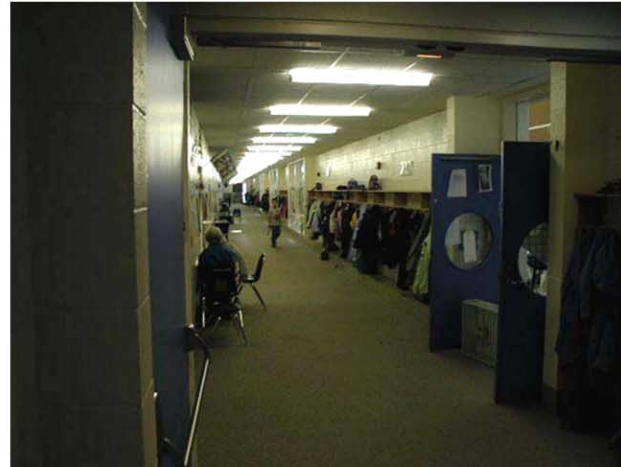
Fig. 9A: A view looking down the corridor showing the dependence on artificial lighting.

Not much natural light reaches the corridors, unless it is a bright clear day, at which time excessive glare comes into the visual field from the gym. Artificial lighting presently provides the primary illumination of the corridors.

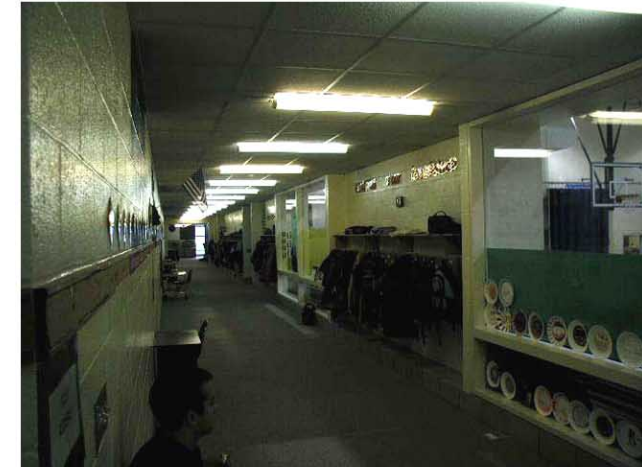
Fig. 9B: Photograph of the corridor, showing the large windows of the gymnasium and exterior window.

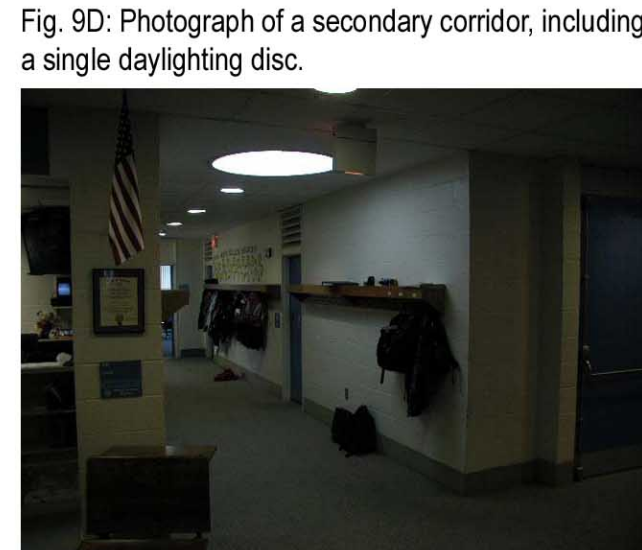
Fig. 9D: Photograph of a secondary corridor, including a single daylighting disc.

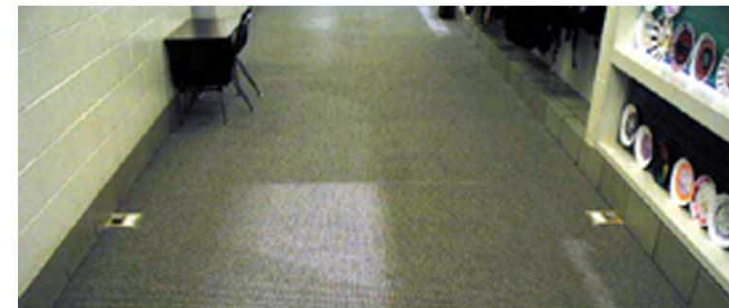
Figure 10C: Photograph showing placement of one group of Stow-Away's.

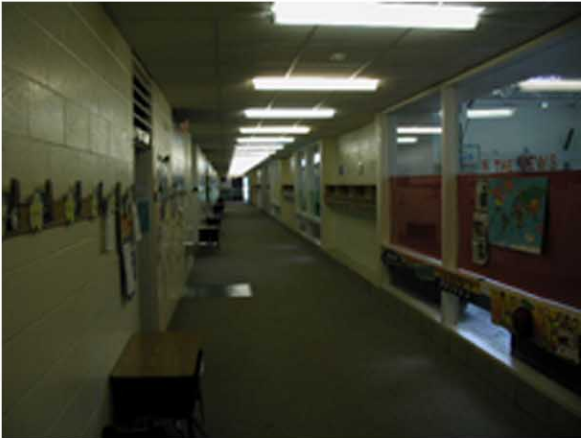
Fig. 14A: Image of corridor, before filters were applied.

Fig. 14B: This image shows the first step in the technique of visual field mapping. A series of filters were applied to the image using Adobe Photoshop to create the patterns of different areas of color which are indicative of different levels of light in the corridor.

Photos of the corridor were taken with a digital camera. These pictures were taken at a 6 foot height from the floor, and were processed in Adobe Photoshop to create visual field maps, a technique used to document the measured brightness of surfaces within the field of view.

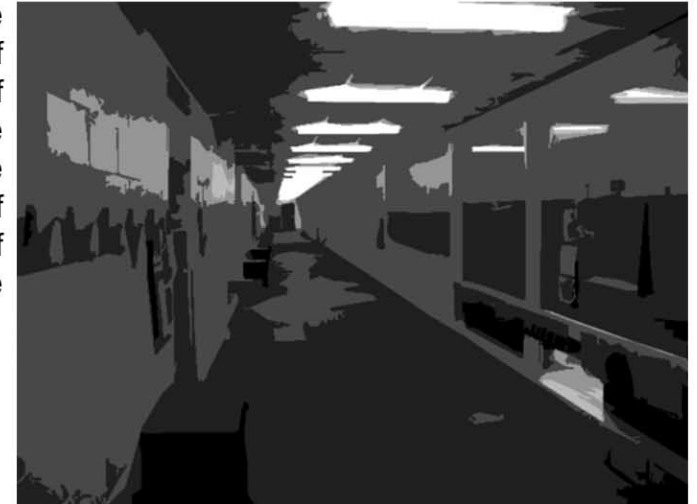
Fig. 14C: The "edges" were then extracted, and the luminance gun was used to measure the number of footlamberts in each of the areas. Numbers which are significantly higher than surrounding numbers indicate the presence of glare.

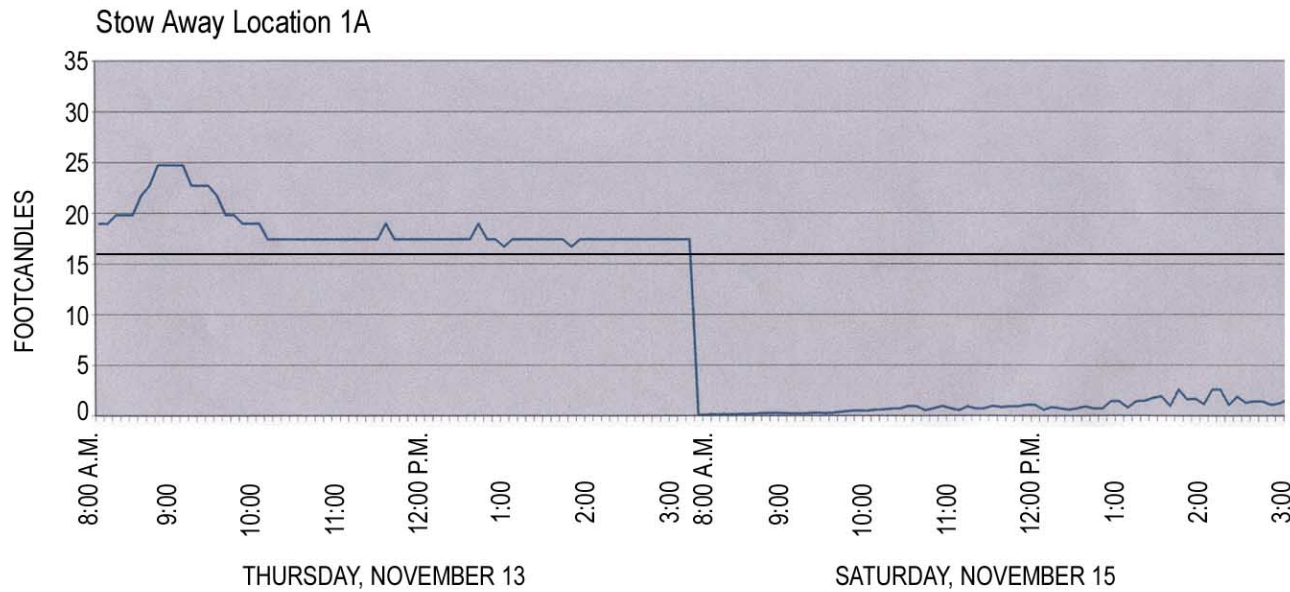
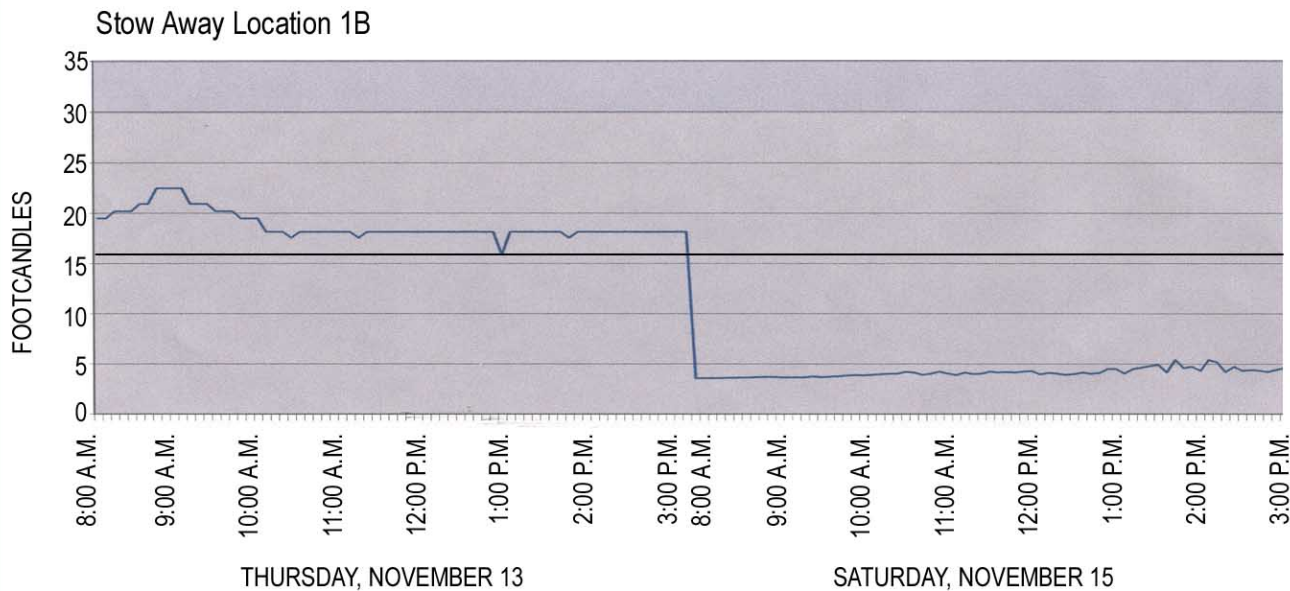
\* dark line on the graphs represents the IES recommended minimum illumination level for a hallway

These graphs show sample illumination levels taken from a normal school day; Thursday, November 13, 2003 from 8:00 A.M. to 3 P.M. as well as a typical weekend day, Saturday, November 15, 2003, from 8:00 A.M. to 3:00 P.M. The difference between the days was substantial: The average footcandles for Stow Away 1A during a typical school-day was 18.5 fc, compared to the weekend day, 1.1 fc. For Stow Away 1B, the averages were 18.8 fc for the weekday, and 4.1 fc for the week-end day.

The difference in numbers is the result of the presence of the gym windows, which allow some daylight into the corridor. Our results found that the Stow Away closest to the gym window received more total light than the Stow Away closest to the classrooms. Therefore, any architectural integration, such as daylighting disks, should be placed in the ceiling grid closer to the classrooms rather than the gymnasium.

In conclusion of this daylighting study for W.D. Richards Elementary School, we recommend task lighting at the locations in the corridor where students are being taught. This recommendation is based on the fact that the existing artificial lighting in the corridors does not reach the IES standard of illumination for classrooms which is 30 footcandles. If this is done, in the interest of saving electricity costs for the school, we recommend using compact fluorescent bulbs instead of incandescent bulbs in the lighting fixtures. This is because compact fluorescent bulbs require a lower wattage than a comparable incandescent bulb. Compact fluorescent bulbs also last longer, and would not give off as much waste heat as incandescent bulbs would.

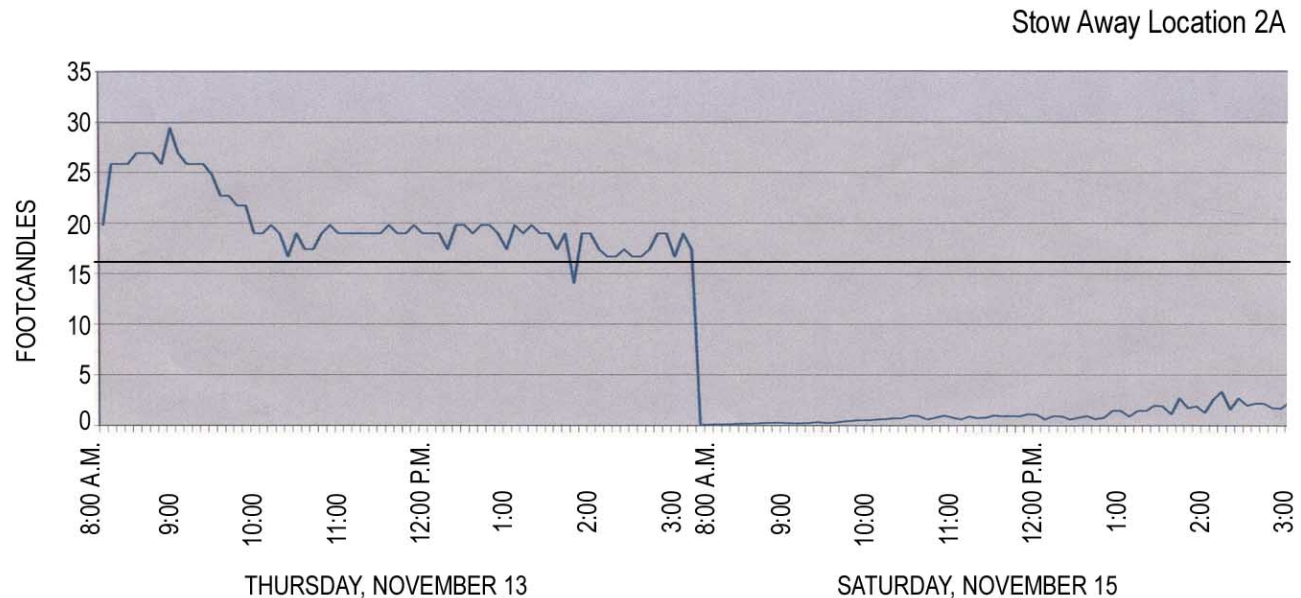
These graphs show sample illumination levels taken from a normal school day; Thursday, November 13, 2003 from 8:00 A.M. to 3 P.M. as well as a typical weekend day, Saturday, November 15, 2003, from 8:00 A.M. to 3:00 P.M. The difference between the days was substantial: The average footcandles for Stow Away 2A during a typical school-day was 20.2 fc, compared to the weekend day, 1.0 fc. For Stow Away 2B, the averages were 20.3 fc for the weekday, and 0.8 fc for the week-end day.

The weekday averages for both Stow Aways in location #2 were higher than their counterparts in location #1 because of their placement closer to the artificial lighting. Location #2 was between two lights, resulting in the addition of both artificial lighting output. The weekend averages in both locations were very similar. Again, any architectural integration, such as daylighting disks, should be placed in the ceiling grid closer to the classrooms rather than the gymnasium.

\* dark line on the graphs represents the IES recommended illumination level for a hallway
