**W.D. RICHARDS ELEMENTARY SCHOOL:
COMPUTER LAB LIGHTING STUDY
COLUMBUS, IN**

**VITAL SIGNS VIII
CENTER FOR ENERGY RESEARCH, EDUCATION, SERVICE**

**BALL STATE UNIVERSITY
COLLEGE OF ARCHITECTURE AND PLANNING
SPRING 2004**

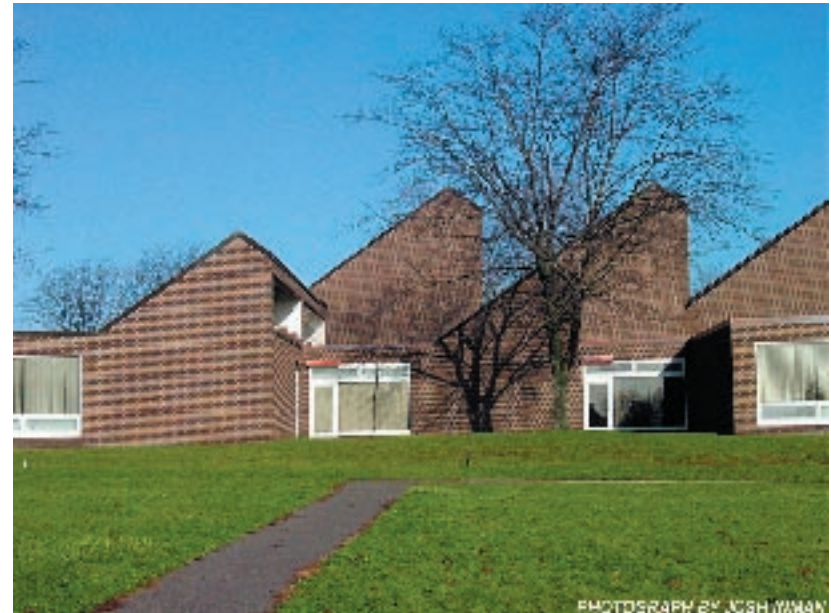
FIG. 0.5

Richards Elementary School: Exterior View

Richards Elementary School, designed by Edward Larrabee Barnes, was constructed in 1965 following the traditions of innovative design and modernity established in this progressive city. The school is designed to allow for classroom spaces, corridors, and the gymnasium, to be illuminated predominantly by the light of the sun. Light clerestories (fig 0.5) are used to capture and direct light into the building.

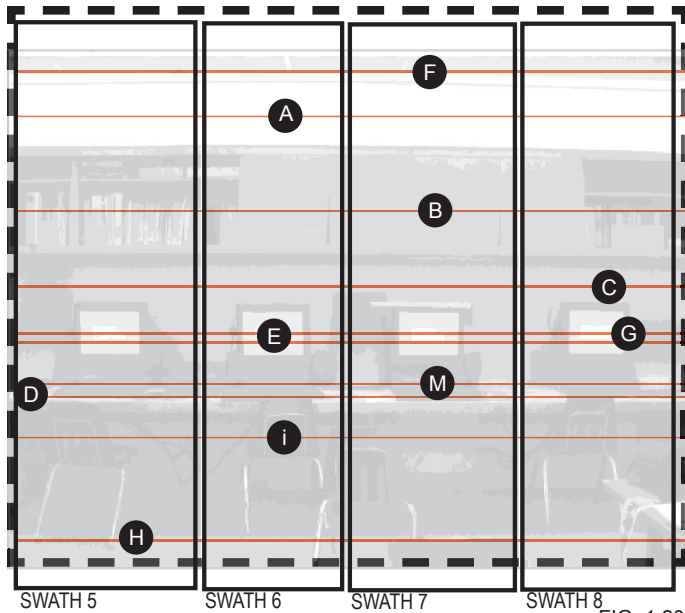
FIG. 1.20

For the sake of reducing the number of measurements, we measured the reflectivity of each material only once per “group”.

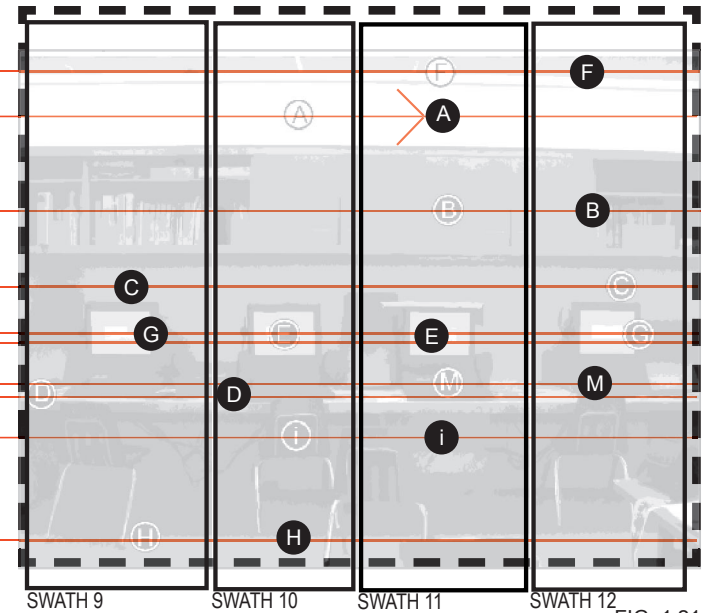
FIG. 1.21

In order to achieve a random sampling of reflectivity values throughout the entire room we created a system in which the measurement point for any one material would shift one “swath” to the right.

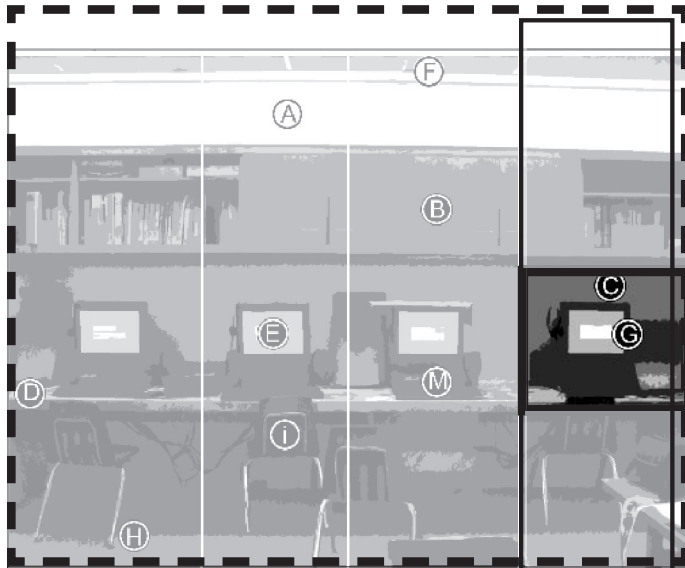
SWATH 8
FIG. 1.22

Within the four “groups” that we studied, one monitor was selected for an in-depth study.

For three of the groups (2, 4, & 7) we choose a monitor that contained glare typically found within its “group”.

The remaining “group” was chosen because it contained the computer monitor with the worst glare in the entire lab. This was monitor 15.

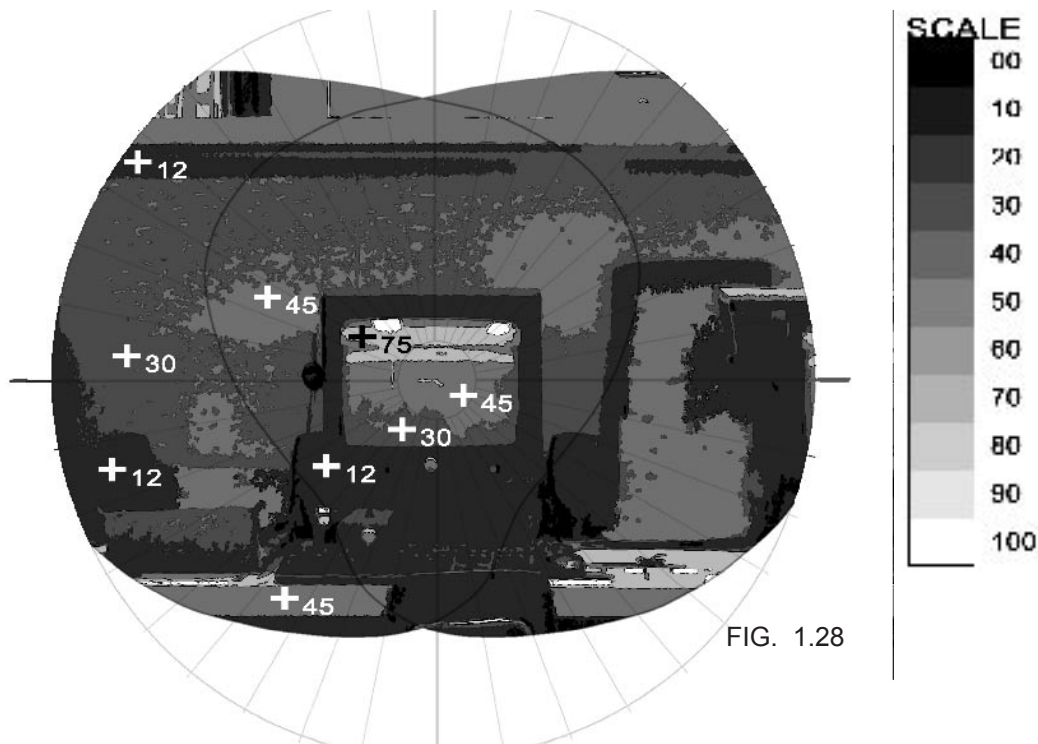
FIG. 1.28

GLARE WITHIN THE FIELD OF VISION

COMPUTER 08: IN-DEPTH INVESTIGATION OF GLARE

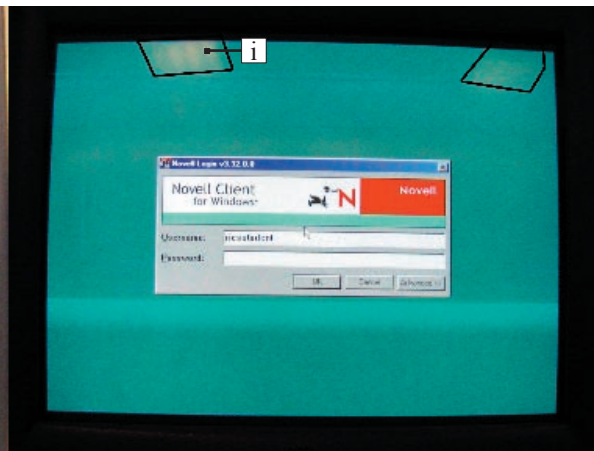
POWER ON
FIG. 1.30

VEILING GLARE: TYPICAL CONDITION FOR COM- PUTERS 1-15

Computer 08 was chosen because of the presence of glare produced by three different sources. This was the one of the worst cases of glare we observed. The photo on the far left shows glare conditions i, ii, iii, and iv (fig. 1.26) occurring while the computer monitor's power is off. However, when the power is turned on, the glare is almost always eliminated, except for condition A.

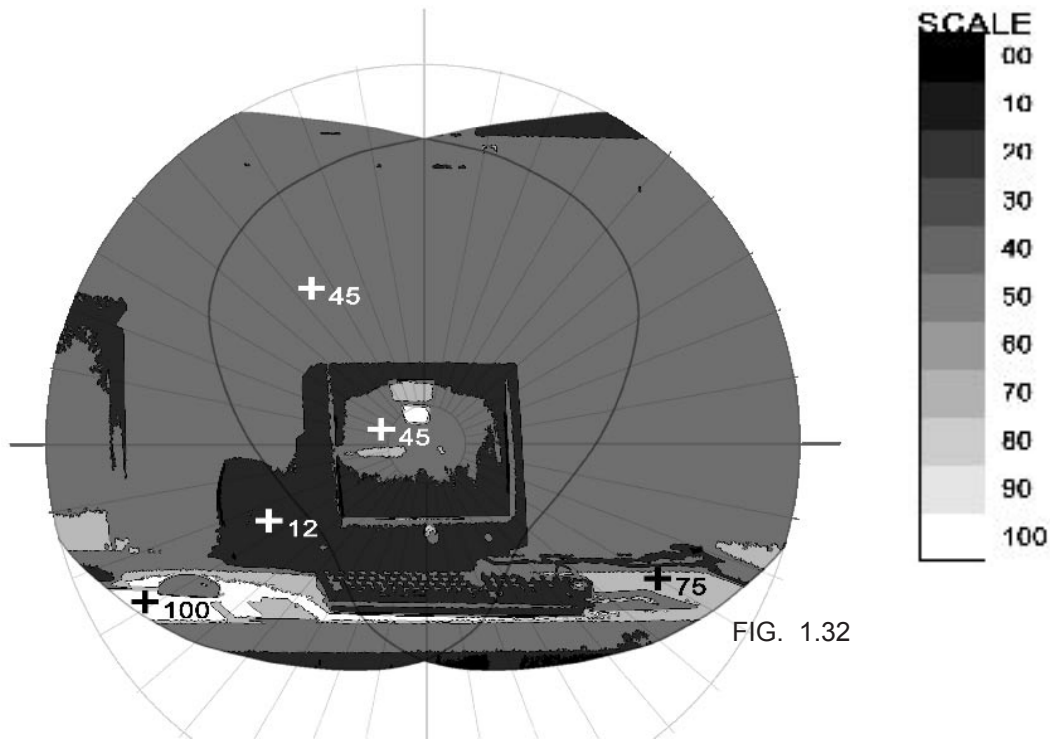
FIG. 1.32

GLARE WITHIN THE FIELD OF VISION

COMPUTER 15: IN-DEPTH INVESTIGATION OF GLARE

VEILING GLARE: WORST-CASE-SCENARIO

Computer 15 represents the worst glare conditions found in the computer lab. With the monitor turned off there were 3 conditions of glare, the most severe being caused by the luminaire located in the middle of ceiling. Even with the monitor's power on, the glare is still very uncomfortable (see areas v & i; fig. 1.26). In comparison to the rest of the computers, this monitor was not set on a computer, rather it sat directly on the desk surface. In order to see the monitor properly the monitor was tilted back accordingly. This positioning causes the glare to occur.

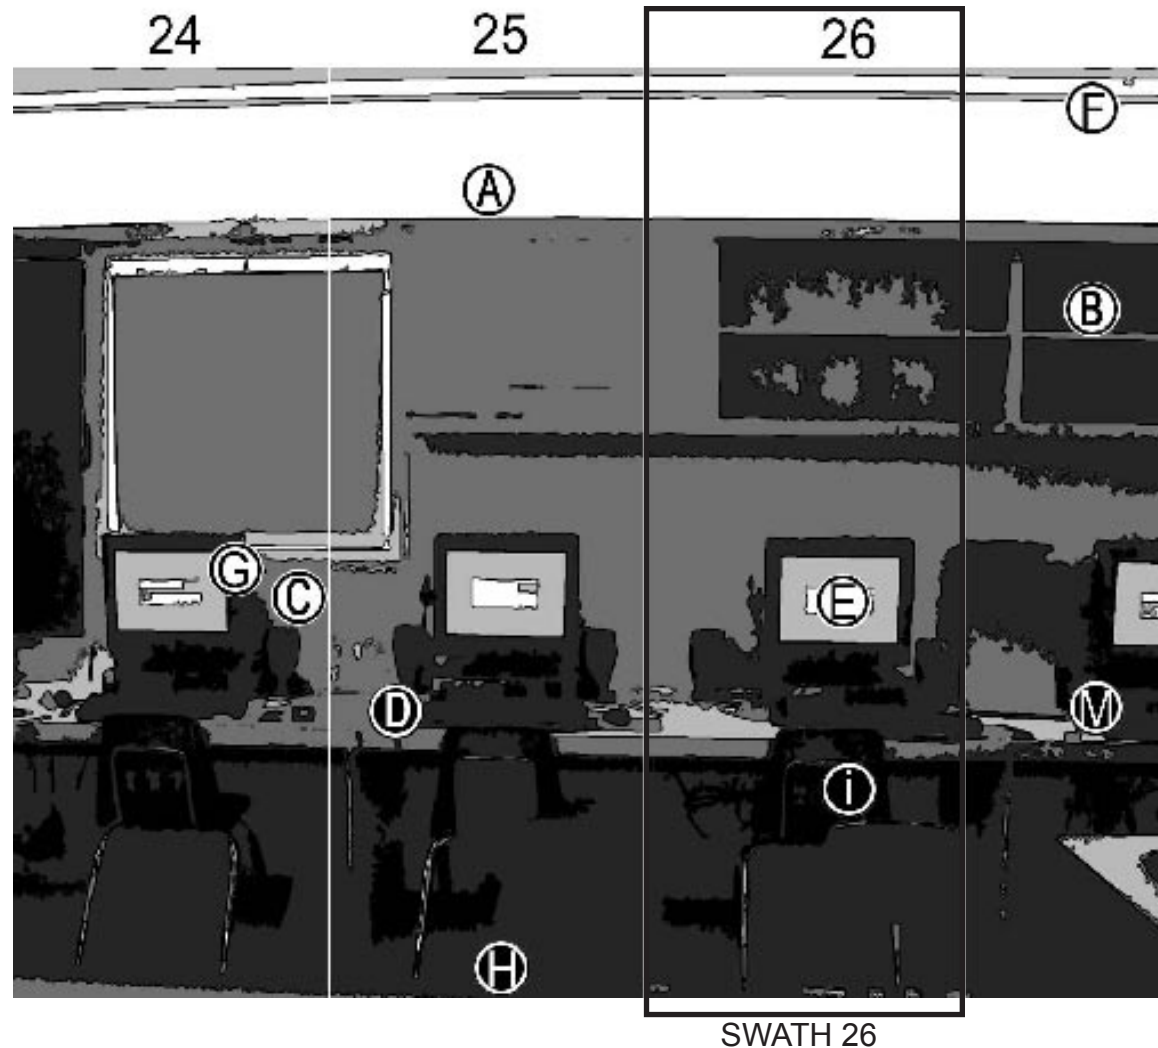
FIG. 1.35

The case study computer here is number 26. Within the group division that 26 falls, materials A- the header, E- computer monitor screen, and I- the workstation chair are measured. Once again the only material with a high reflectance value is A, however A is not within the field of view while at the workstation.

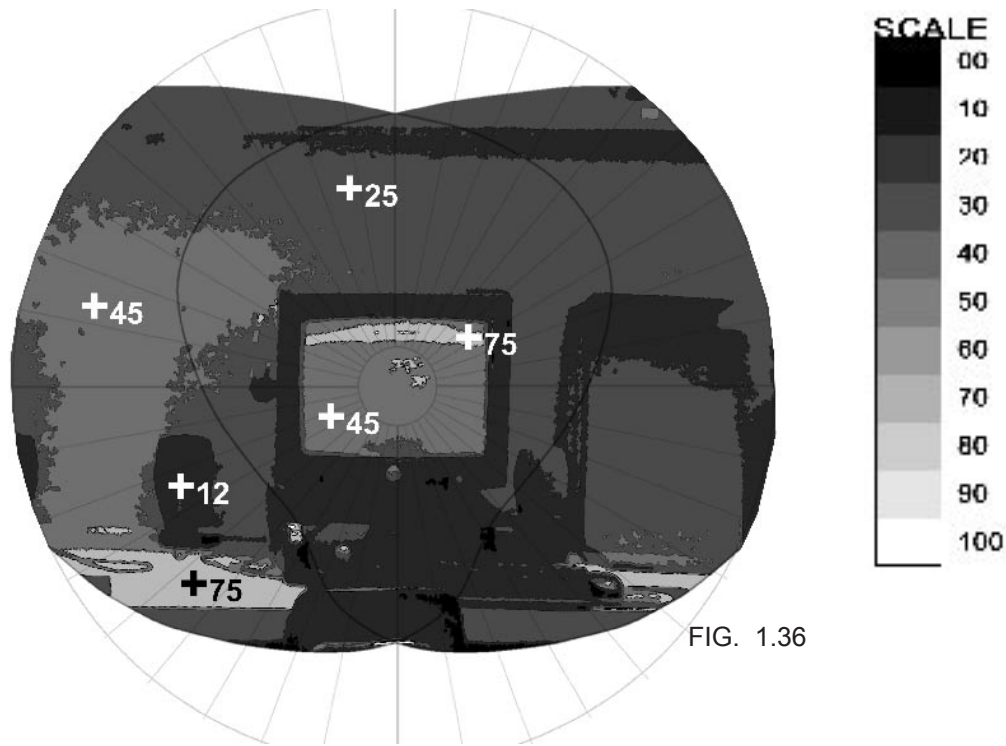
FIG. 1.36

GLARE WITHIN THE FIELD OF VISION

COMPUTER 26: IN-DEPTH INVESTIGATION OF GLARE

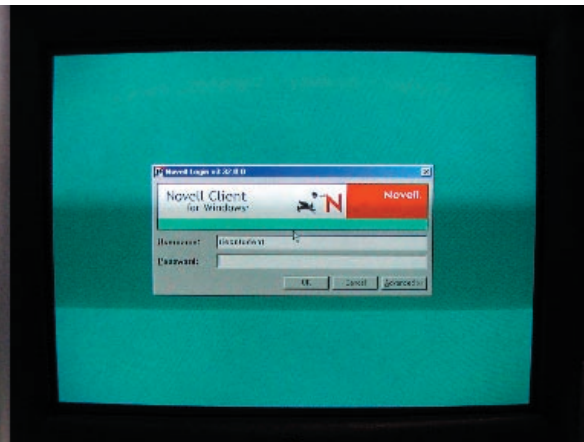
POWER ON
FIG. 1.38

VEILING GLARE: TYPICAL CONDITION FOR COMPUTERS 16-30

Computer 26 illustrates the typical conditions for computers that are located on the exterior wall of the computer lab. There is only one condition of glare which is caused by the side luminaire on the opposite side of the room (fig 1.26). However when the monitor power is on, this condition is not a factor.

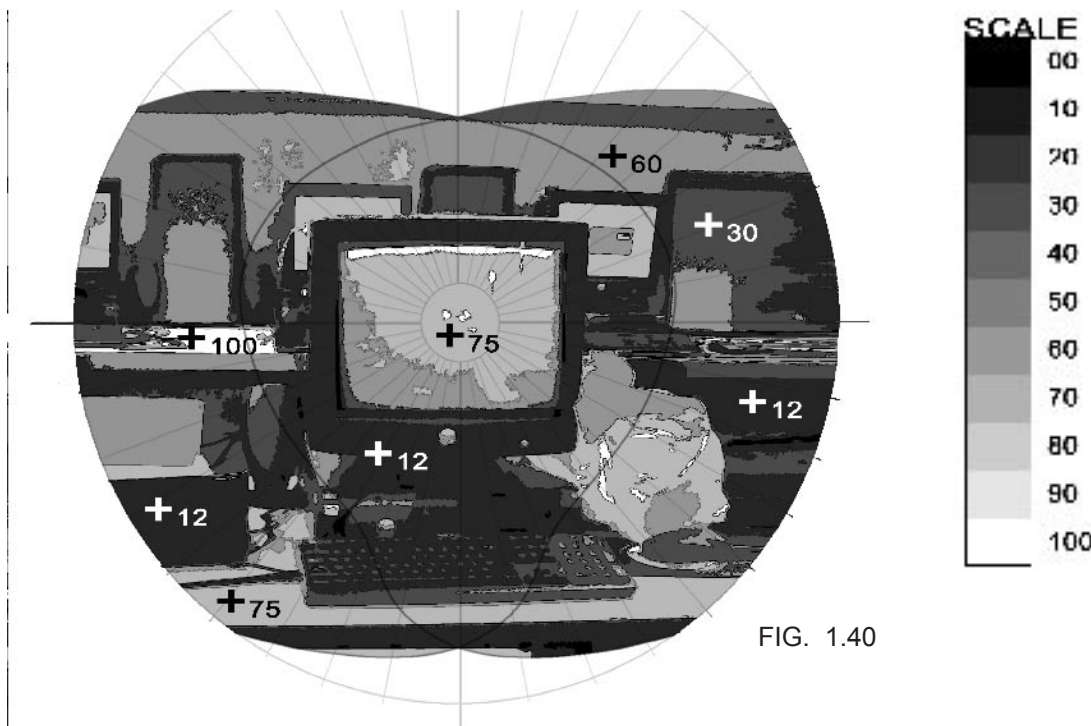
FIG. 1.40

GLARE WITHIN THE FIELD OF VISION

COMPUTER 32: IN-DEPTH INVESTIGATION OF GLARE

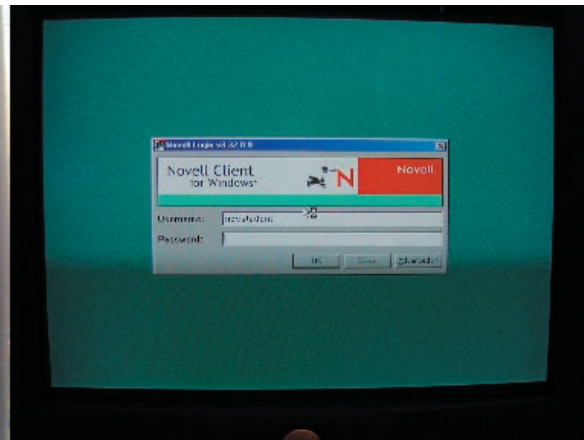
POWER ON
FIG. 1.42

VEILING GLARE:
TYPICAL CONDITION FOR CENTER ROW OF COMPUTERS

Computer 32 illustrates the typical conditions that the center row of computers is subjected to during use of the computer lab. There are three conditions of glare when the monitor's power is off (fig. 1.26). When the power is turned on these conditions are not evident.

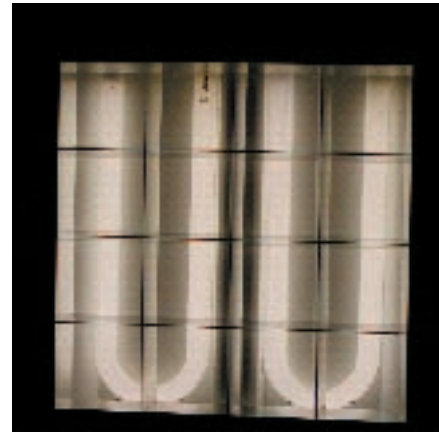
FIG. 3.1 34 W, T12 Curvalume rapid start SUPER SAVER fluorescent lamp, 6" leg spacing, Cool White phosphor, 4200K color temperature, 62 CRI ECO-LOGIC

There two types of electric luminaries in the computer lab at Richards elementary school. One is the Sylvania T12 Curvalume rapid start super saver fluorescent lamp. This 34 Watt bulb has a 6" leg spacing, cool white phosphor color, and a 4200 K color temperature. These luminaries run along the center of the computer lab at 8' increments. The second type of light in the lab is the standard Sylvania T12 rapid start fluorescent bulb. It has the same wattage and 4200K color temperature. This luminaire is also Safeline coated. The pair run along the sides of the computer lab continuously. They are tucked in a cove above the dropped ceiling with a quarter-sphere directing the light downward and through vertically orientated diffusers.

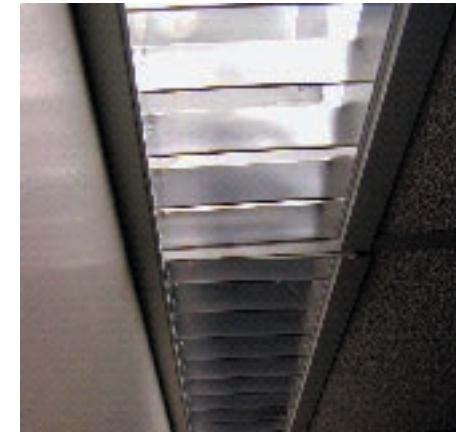
FIG.3.2 34 W, T12 Rapid Start SUPER SAVER fluorescent lamp, Cool White phosphor, 4200K color temperature, 62 CRI, SAFE-LINE coated

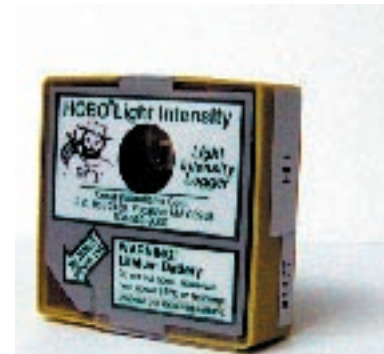
HOBO LIGHT INTENSITY LOGGER FIG. 4.1

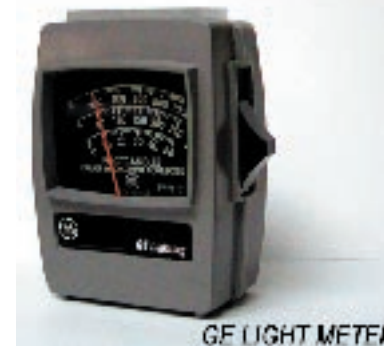
GE LIGHT METER FIG. 4.2
