# Vital Signs IV

A study of lighting efficiency in the second level circulation spaces of the Alumni Center

Jason Brown - Cory Calvin - Barb Charlton - Jake Plummer

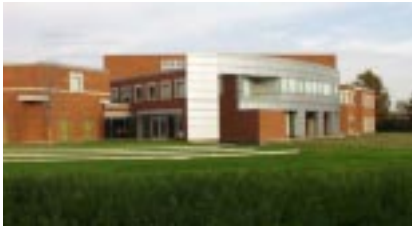
Fig. 1  
Exterior photograph of the Alumni Center taken from the Southwest corner

The Alumni Center was designed by the renowned architectural firm of Pei, Cobb, Freed & Partners. The building houses University Development offices, a conference center, various meeting spaces and a central, two-story day lighted conservatory at the center. (See Fig. 1)

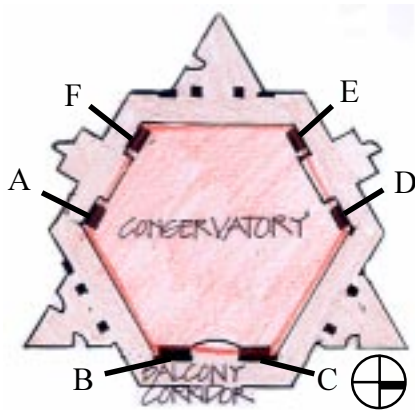
Fig. 2  
Enlarged plan diagram of second level balcony corridor spaces and placement of light intensity data loggers A-F.

Initially, two light intensity data loggers were placed along the southern balcony to record lighting levels on a sunny day and an overcast day. This location received the least amount of direct sunlight of all the possible locations and our group felt that it would give us appropriate preliminary data. The data collected during the initial test period established the best time of the day to take instantaneous measurements to rationalize how the illumination was distributed over various points. For the second trial, two illumination data loggers were placed in each of the six balcony corridors. Light intensity data loggers were placed in each of the corridors to capture different levels of daylight due to the dynamics of the sun patterns. (See Fig. 2)

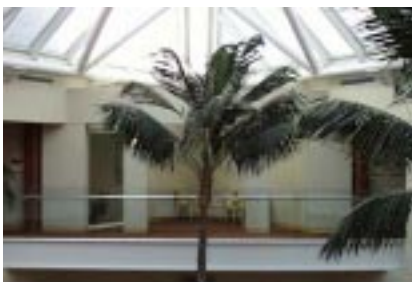
Interior photograph of the balcony vestibule space (south wall).

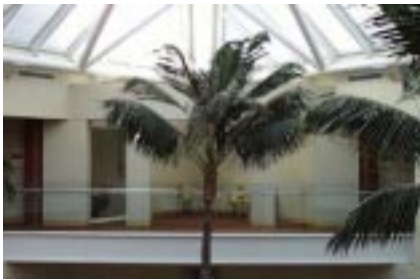
Fig. 6  
Interior photograph of the balcony vestibule space covered by a corner of conservatory skylight (west wall).

The second level surrounding the conservatory is comprised of a series of vestibules, balconies and balcony corridors. Two of the three seating area vestibules serve the entrances to the administrative office wings, the third, located on the southern wall, is covered by a corner of the conservatory skylight (See Fig. 6). The three balconies are directly in front of the seating areas and are open to the conservatory. The balcony corridors are separated from the conservatory by walls that also serve part of the air movement systems, portraits of distinguished alumni are displayed along the interior walls of the balcony corridors.

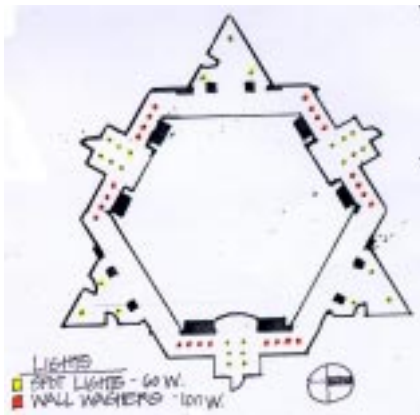
Fig. 7  
Diagram of the circulation and vestibule lighting on the second level perimeter balcony spaces. Both spot lights and wall washers are incandescent lights.

The research presented in this report focuses on the above mentioned balcony zones. The balcony corridors serve as a circulation link to each of the departmental wings, and during daylight hours these corridors are illuminated by four 100-watt wall washer fixtures in addition to the daylight from the conservatory skylight (See Fig. 7). The corridor walls display distinguished Alumni portraits. During the early visits to the Alumni Center the team observed that the overhead lights cast a veiling reflection on the portraits. This report questions the necessity of the use of electric lights in these spaces during the daylight hours; investigates the architect's intent for the corridors use (to be circulation or exhibit space) and compares the actual lighting levels against the recommended lighting level as defined by the I.E.S. Finally, after compilation of all the data the report offers alternative lighting solutions that may result in more efficient use of electrical lighting in this area.

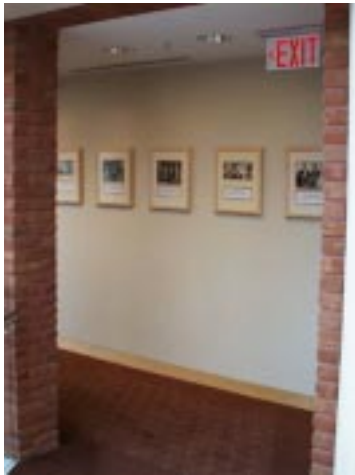
Fig. 10  
View of east balcony corridor

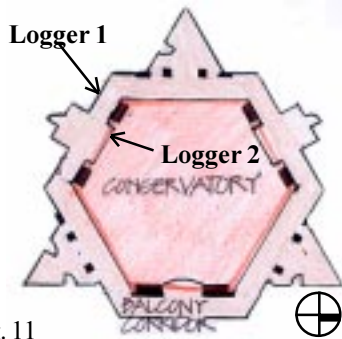
Fig. 11  
Placement of data loggers for first 2-Day Measurements.

Two light intensity data loggers were launched on the second level balcony area to take light measurements for 48 hours. (See Fig. 15 for image of light intensity data logger). Both of the loggers were set to record at 1 minute, thirty-six second intervals. A Hobo logger was placed directly on the front of the balcony glass to record the daylight received in the conservatory area. A Stowaway logger was placed on the wall between two portraits, which was exposed to artificial lighting and some filtered light from the conservatory (See Fig. 11 for placement of loggers). This location was selected, based on the spot measurements taken in method two, because it received the lowest amount of natural daylight. This method was intended to tell us what time of day the largest amounts of daylight are received in the corridor space.

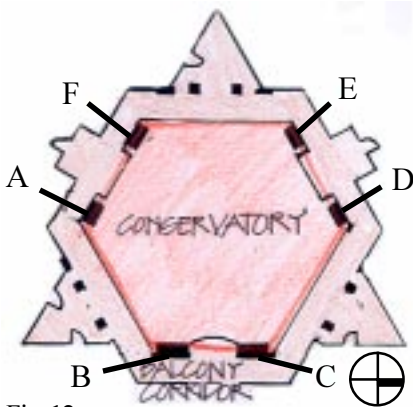
Fig. 12  
Second level balcony space with placement of light intensity meters A-F.

The second 48 hour measurements were taken by setting up two light intensity data loggers in each of the six corridor spaces. All loggers were set to take light intensity readings at 1 minute, thirty-six second intervals. A Stowaway logger was placed on each of the six column walls opposite the portrait walls. The

loggers were placed in these locations because we felt it would give us the worst possible conditions for this space. This determined the different light levels in each corridor area. (See Fig. 12 for placement of data loggers).

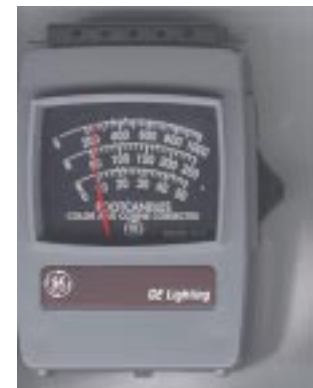
Fig. 14  
GE handheld analog meter used to take instantaneous illuminance and luminance measurements.

Our team took both digital and analog measurements of the illumination of the wall surfaces and portraits for day time conditions (See Fig. 14 for image of GE analog meter). The measurements were taken in the balcony corridors 36 inches above the floor directly beneath each light. This initial data gave estimated light levels the corridor space receives in relation to the Illuminating Engineering Society (I.E.S.) recommended levels of 10-20 footcandles for a corridor space.

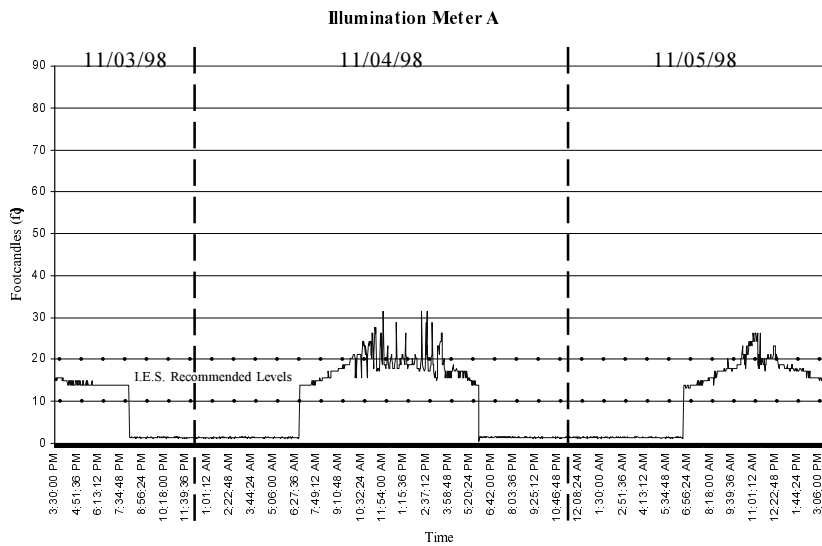
Fig. 18  
Data from test 2 -Meter A  
(I.E.S. recommended illumination level  
for corridor space is 10-20 fc)

Six light intensity data loggers were launched on November 3, 1998, at approximately 3:00 in the afternoon. The sky conditions for the first day were overcast and gray. Sky conditions for the second and third days were partly cloudy. Because the data collectors were not color corrected, we took spot measurements with the digital meter at the same location the loggers were placed. We then divided the reading from the meter by the logger reading to find the correction factor. The graphs show the color corrected data on a typical overcast day, the illumination levels are consistent with the I.E.S. recommended illumination levels 10-20 footcandles for corridor spaces. On a sunny day from 10:30 am to 4:00 pm, the average light levels exceed the recommended levels significantly which shows that there is a need to reduce lighting during these times. (See Fig. 17 for placement of loggers and Figs. 18-23 for graphs of data.)

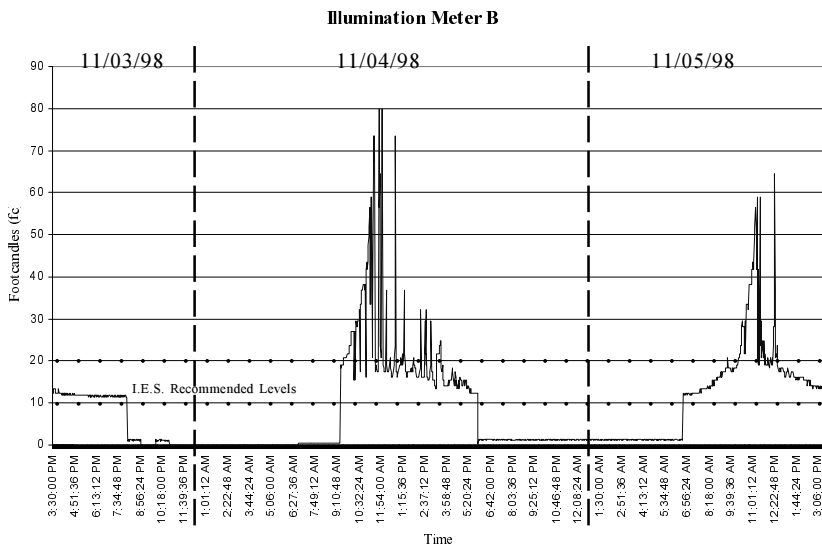
Fig. 19  
Data from test 2 -Meter B  
(I.E.S. recommended illumination level  
for corridor space is 10-20 fc)

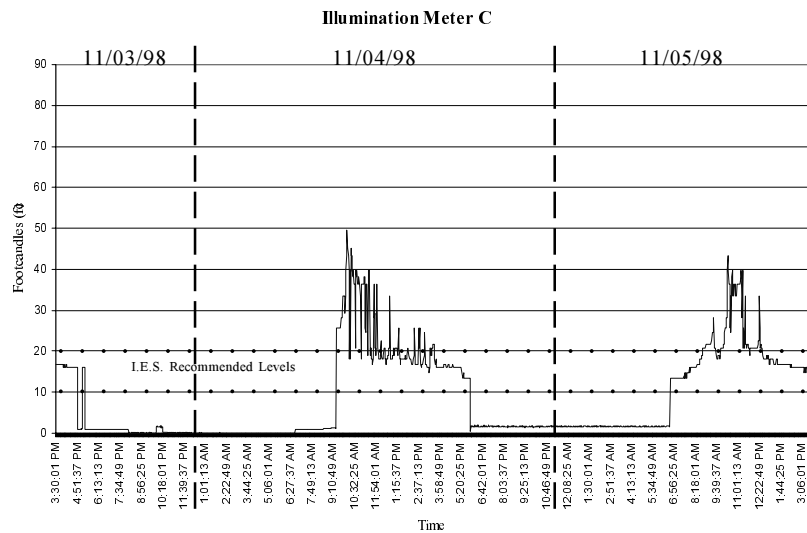
Fig. 20  
 Data from test 2 -Meter C  
*(I.E.S. recommended illumination level for corridor space is 10-20 fc)*

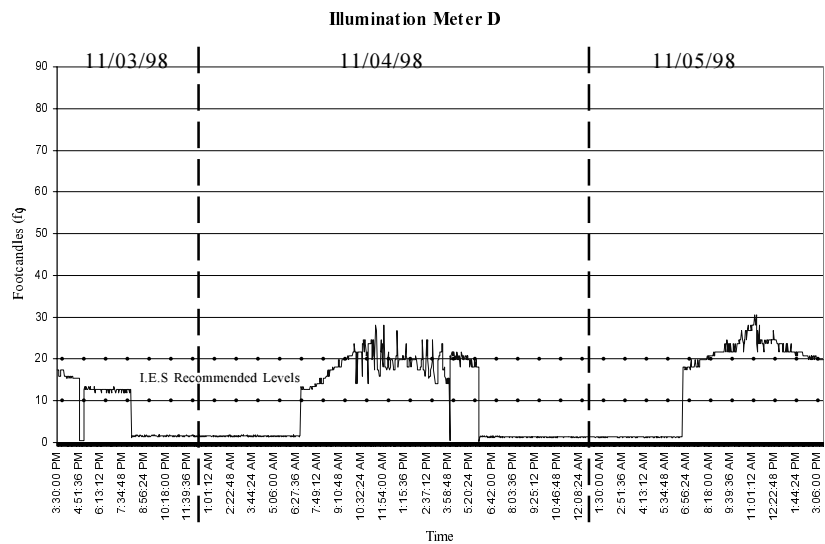
Fig. 21  
 Data from test 2 -Meter D  
*(I.E.S. recommended illumination level for corridor space is 10-20 fc)*

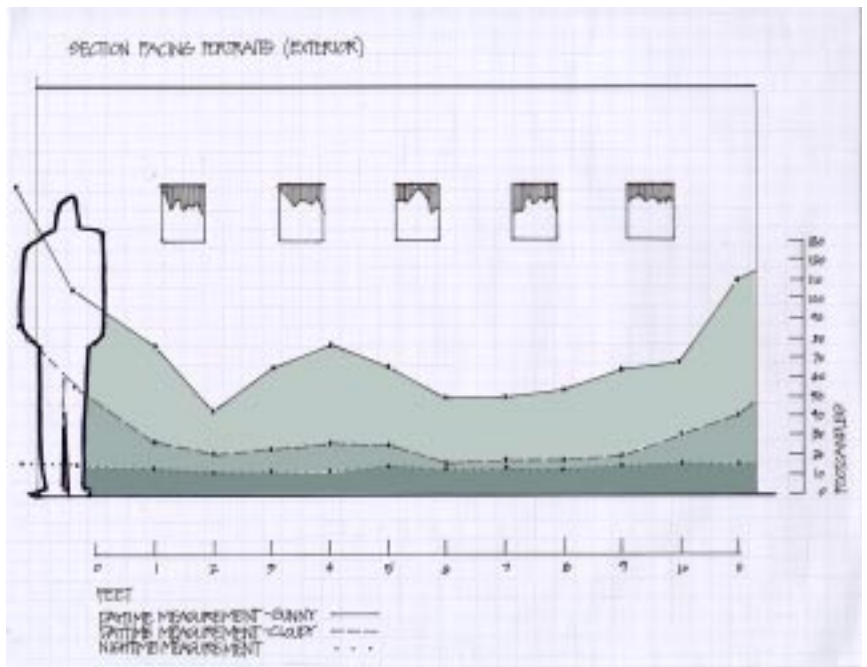
Fig. 24

The first section (See Fig. 24) shows the existing illumination condition in the balcony corridor. The section was cut facing the portrait wall and instantaneous illumination measurements were taken at one foot intervals directly on the wall, 36 inches above floor level. This section shows there is an inconsistency in the placement and distribution of lighting in the balcony corridor. The light levels remain at an already high range of 50-77 footcandles in the middle zone of the space, but at the ends of the space the reflected light from the conservatory produces light levels as high as 145 footcandles. Because of the fact that the natural light can fluctuate drastically on sunny and partly sunny days, there should be some sort of operable control to adjust for the influence of the daylight factor.

Fig.24  
 Section showing portrait wall and illumination in footcandles at one foot intervals

Using the Sylvania light meter, we found the lighting levels to be 10-15 footcandles, as indicated on the sections shown in Figs. 24-25. By subtracting the average nighttime illumination levels from the average day time illumination levels we were able to figure the average diffuse light entering the corridors on a typical day. On a sunny day, we found that the average daylight component was 50 footcandles for the portrait wall and 35 footcandles for the wall opposite the portraits. On a cloudy day, we found that the average daylight component was twenty footcandles for the portrait wall and six footcandles for the wall opposite the portraits.

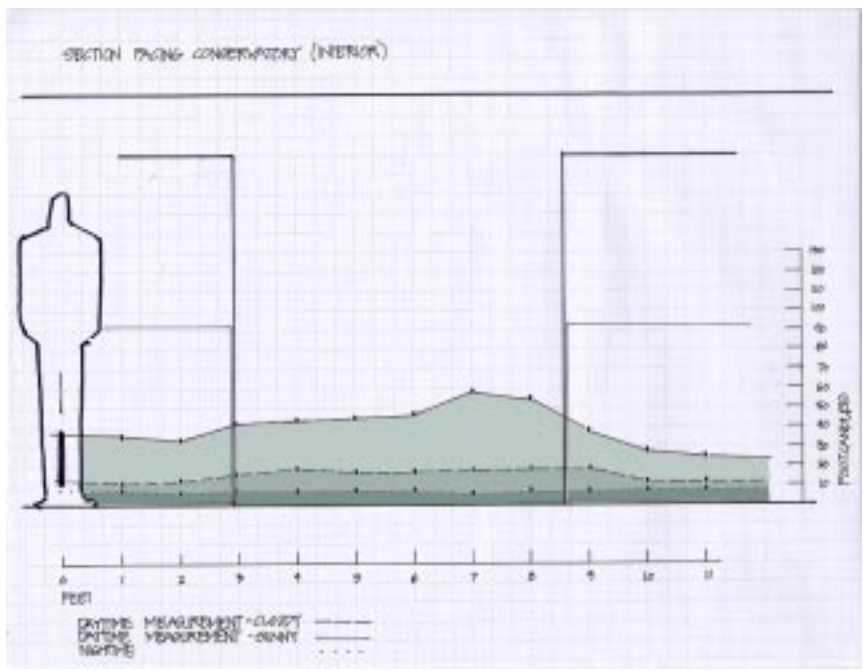
The second section (See Fig. 25) was cut facing the wall opposite the portrait wall. Instantaneous illumination measurements were taken at one foot intervals directly under the row of lights, 36 inches above floor level. By looking at this section, it is obvious that the diffuse light from the conservatory was lower than shown in the first section because this is reflected light off the portrait wall. The light levels range from 23-45 footcandles at the ends of the space facing the balconies and from 41-49 footcandles in the middle zone of the space.

Fig. 25  
 Section facing conservatory showing illumination in footcandles at one foot intervals

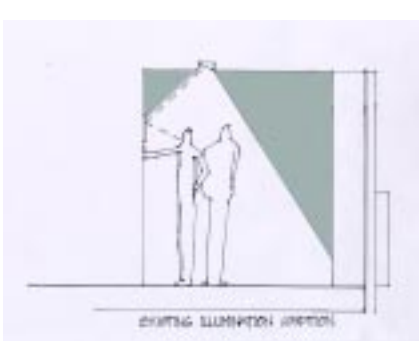
Fig. 30  
Existing illumination condition in the second level balcony corridor space.

The team originally attempted to conduct light intensity measurements over several days with the electric lights turned off. The team believed that this step would prove that the lights were not necessary based on levels above the I.E.S. recommended average of 15 foot-candles for circulation spaces. Unfortunately, this procedure could not be carried out because of the circuiting of the lights, fire and safety codes, and the scheduling logistics involving the users. The team was able to study the effects of the space without artificial light for thirty minutes on a cloudy day. Several people were questioned about the lights being off. It was evident after conducting this survey that there are two distinct purposes of the electric lights. The first and obvious reason is for the illumination of circulation paths. The second purpose, which is separate and distinctly different in nature, is for the illumination of the portraits. Due to the fact that there are two distinct illumination functions (circulation and display), there is an inconsistency in the light levels of this space. Because of the placement of the lights, the portraits receive a veiling reflection that makes viewing the images difficult to see unless they are viewed from an angle (*See Fig. 30 for existing illumination condition*).
