VITAL SIGNS

A BALL STATE UNIVERSITY CASE STUDY IN LIGHTING

VITAL SIGNS BALL STATE UNIVERSITY ALUMNI CENTER

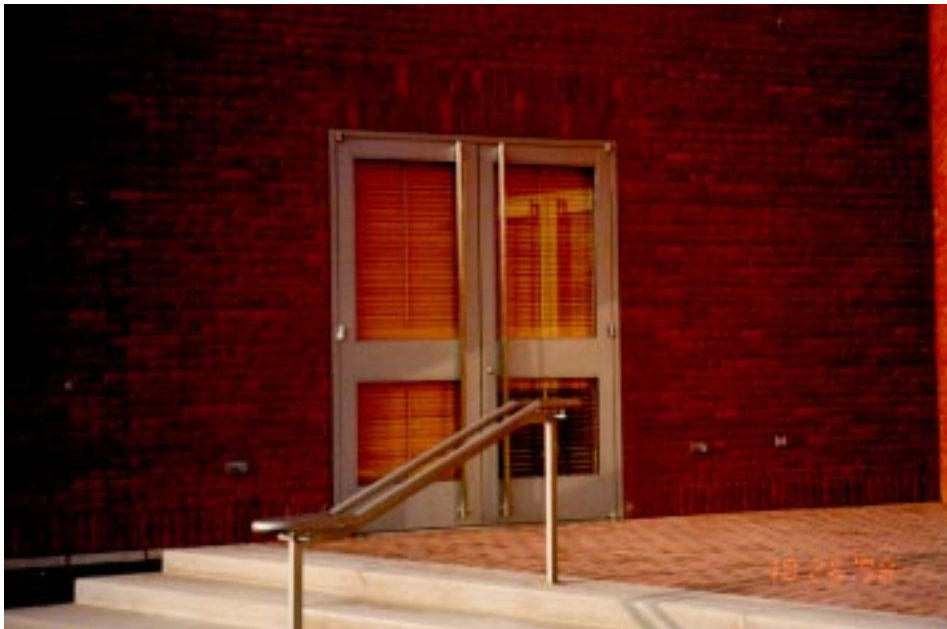
Fig. 3 one of two typical exterior doors showing:
louvres
opportunity for daylight

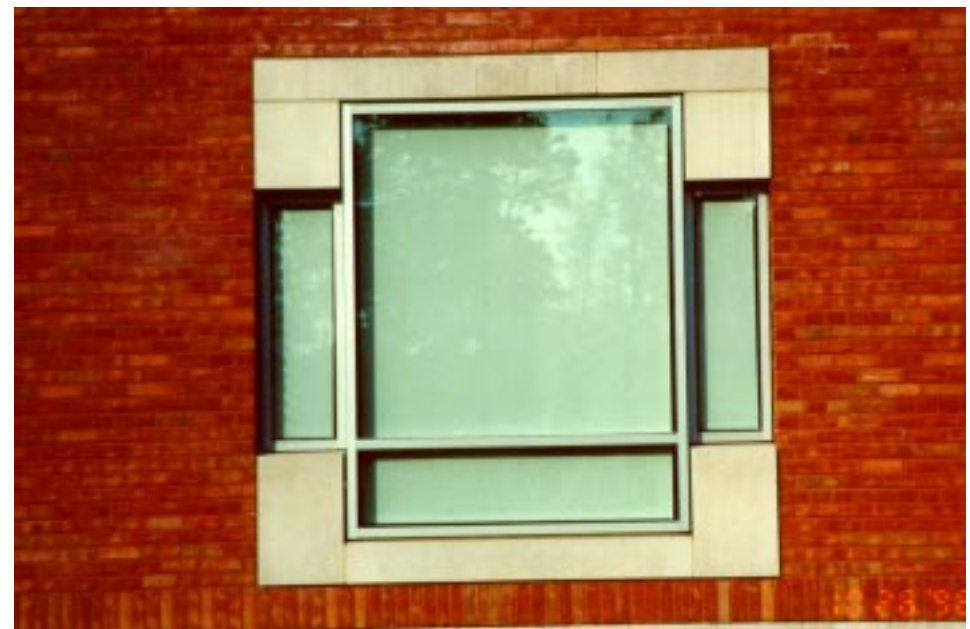
Fig. 4 exterior window of library showing:
sunshades
relative size of shades to window

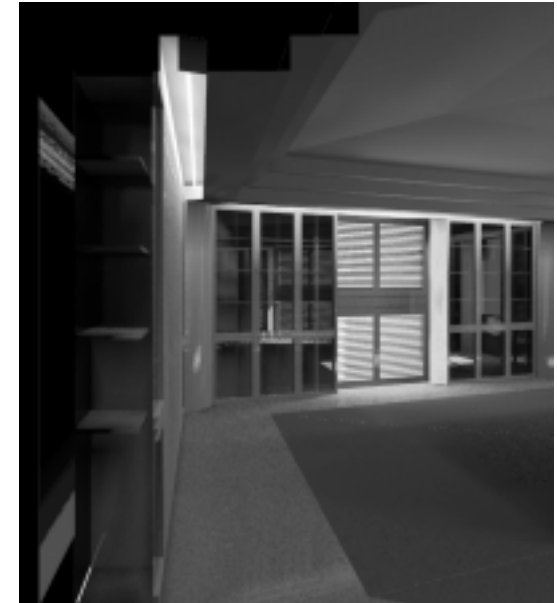
Fig. 14

Cut away showing display cases lighting

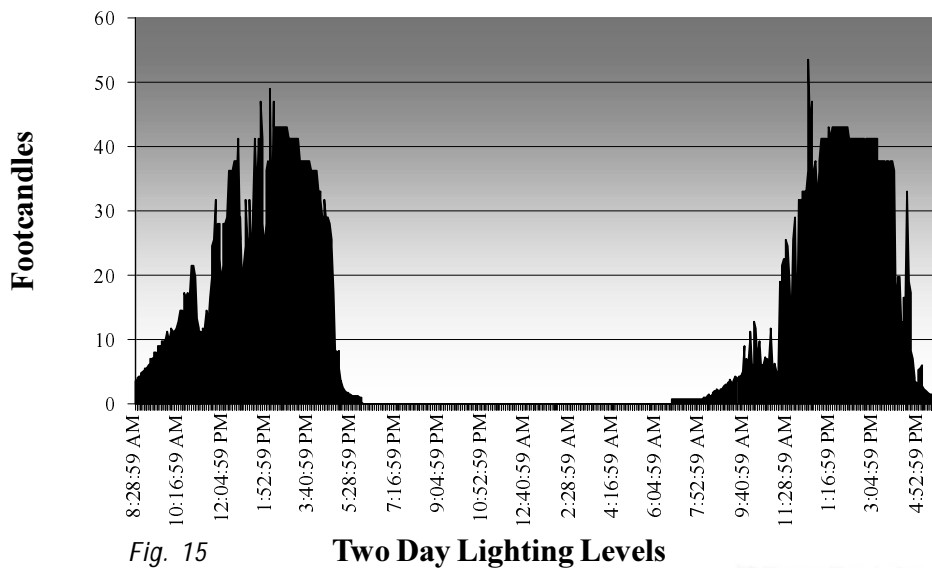
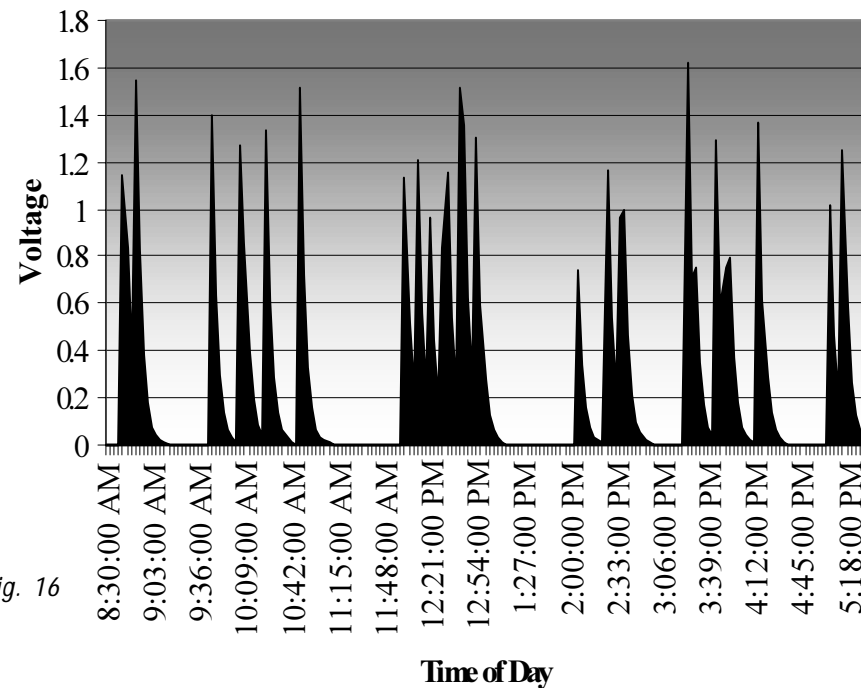
We placed an infrared occupancy sensor to learn when there was movement in the room. It was under the sofa between the door and the television so it could detect the movement of feet. This particular type of occupancy sensor was used in combination with a StowAway voltage intensity logger. The sensor emits a voltage of electricity that dissipates over time (see Appendix D). The logger records this voltage at 3 minute intervals. The resulting graphs show the amount of remaining charge at the time of logging. Therefore, the graphs show only times when voltage was detected and the intensity of that voltage is relative to the amount of time passed since the movement was detected. We learned from Matt Stevenson that the Alumni Center hosted an Emeriti Conference on November 19th, accounting for the increase in activity within the room on that day. These retired faculty were very interested in the memorabilia contained within the display cases. The lighting levels were also taken from the window sill on these two days. Comparing these two graphs, shows that occupancy is not determined by the amount of light within the space.

November 19, 1998

November 20, 1998

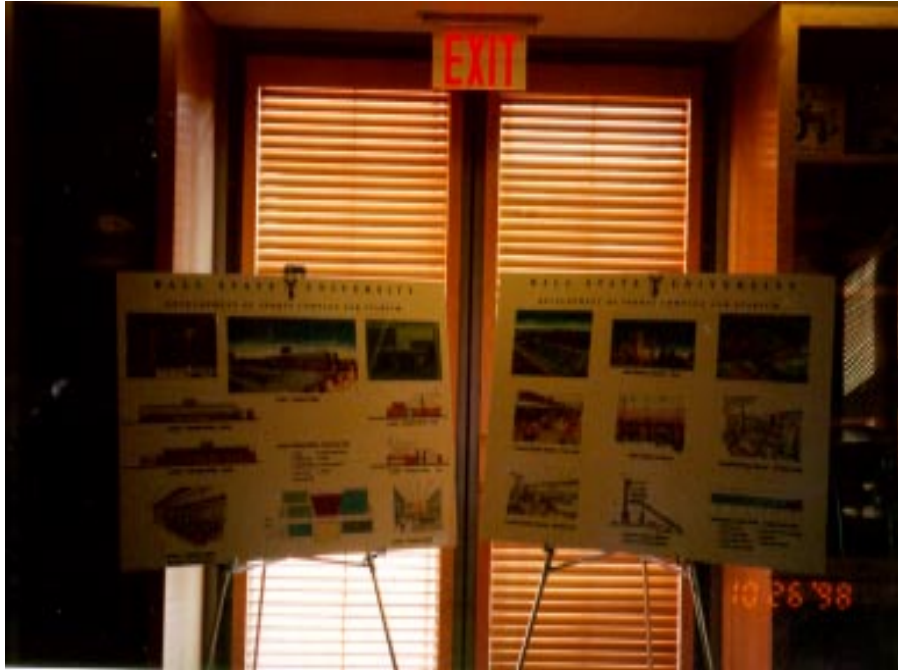
original photograph

PhotoShop enhanced with readings

The original photograph (fig. 18) shows the placement of the movable stands used for displaying architectural renderings of campus buildings. Every time we visited the room, these stands were placed in front of one of the two sets of double doors. Figure 19 shows the original photograph after it has been enhanced in Photoshop to further accentuate the contrast between darker and lighter areas in the field of view. These photographs were taken for the purpose of evaluating the effectiveness of the lighting conditions and the clarity and readability of the displays. From these photos, it is plain to see that the brightest areas in the field of view are not on the displays; instead, the surrounding areas, especially the areas behind the displays, are brightest. Also, the light hitting the viewing surfaces of the displays is unevenly distributed. The portions of the displays closest to the center are much brighter than the outer edges. As a result, the drawings and text on the displays are not highlighted - they are barely legible because the eye cannot accommodate for the large amount of backlighting. The lighting conditions in this particular situation are inappropriate, but the problem results from improper placement on behalf of the users. No provisions were made in the room's design for temporary displays of this nature. Obviously, the architect and/or lighting designers never anticipated displays in this area for the simple reason that it is a path of egress.

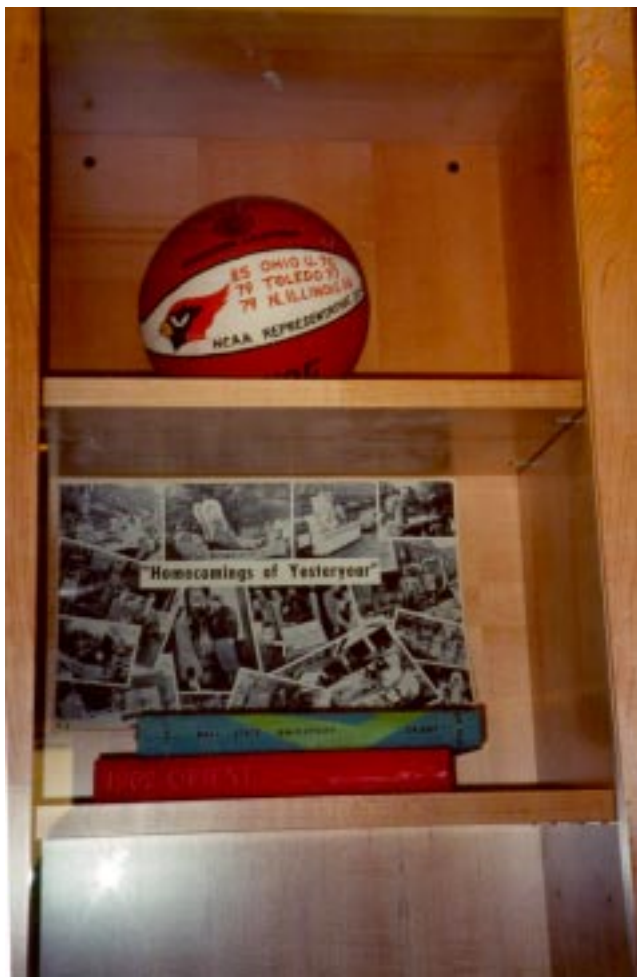
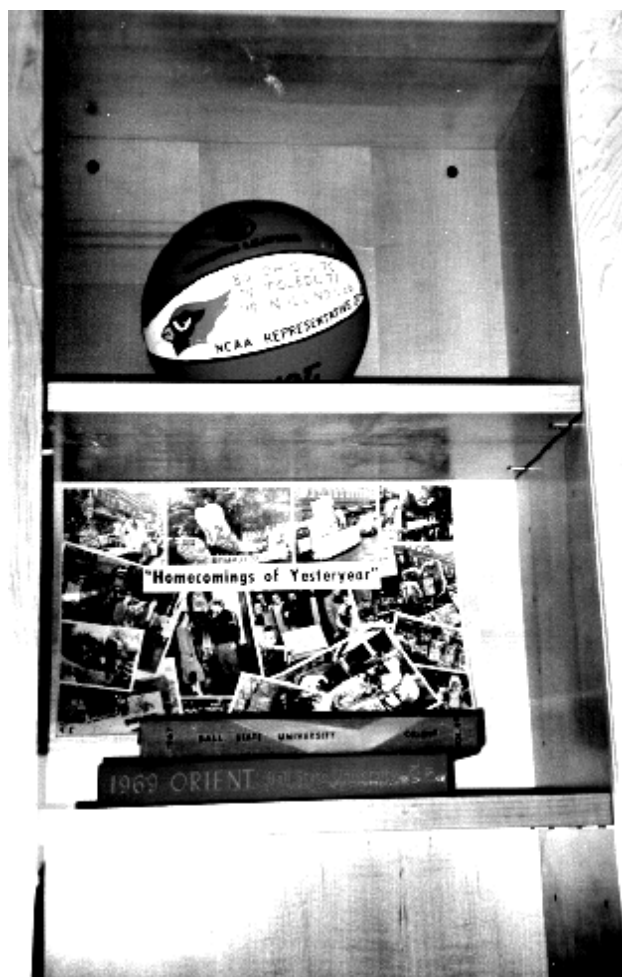
original photograph

PhotoShop enhanced with readings

Figures 20 and 21 show one of the display cases which line much of the wall space in the library. When we observed the way the cases were lit, we learned some of them have small accent lights, but the majority do not. We found that the light does not reach the back of the display cases, which needs light for viewing purposes.

In figure 21, the lower left-hand corner demonstrates the problem with glare. Notice also the smaller area of glare in the lower right-hand corner. By studying the enhanced photo, we derived that the wooden paneling was receiving the most illuminance. The darkness and shadows inside the cases make it easier to create a glare or veiling reflection, and the lightness of the wood contributes to the problem. These problems were not created by those who placed the objects in the displays; they are a flaw in the design.
