*The Vital Signs Class IV
A CERES Student Scholars Program*

*Ball State University Alumni Center Lighting Study
Visual Discomfort in South Side Offices
1998*

Vital Signs: *Alumni Center Office Study*

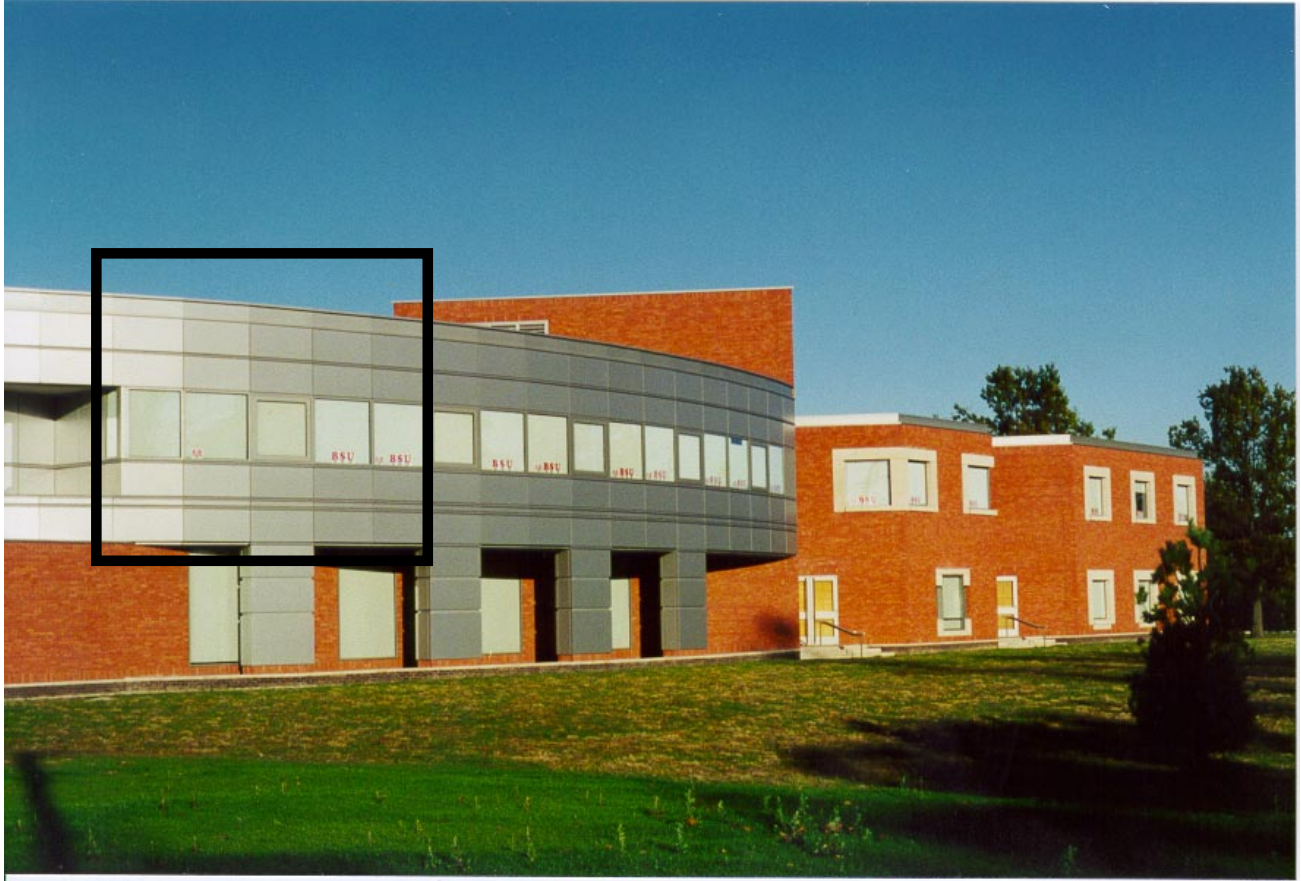
Figure 1: South side exterior elevation. Within the highlighted square is the location of the two offices in the study.

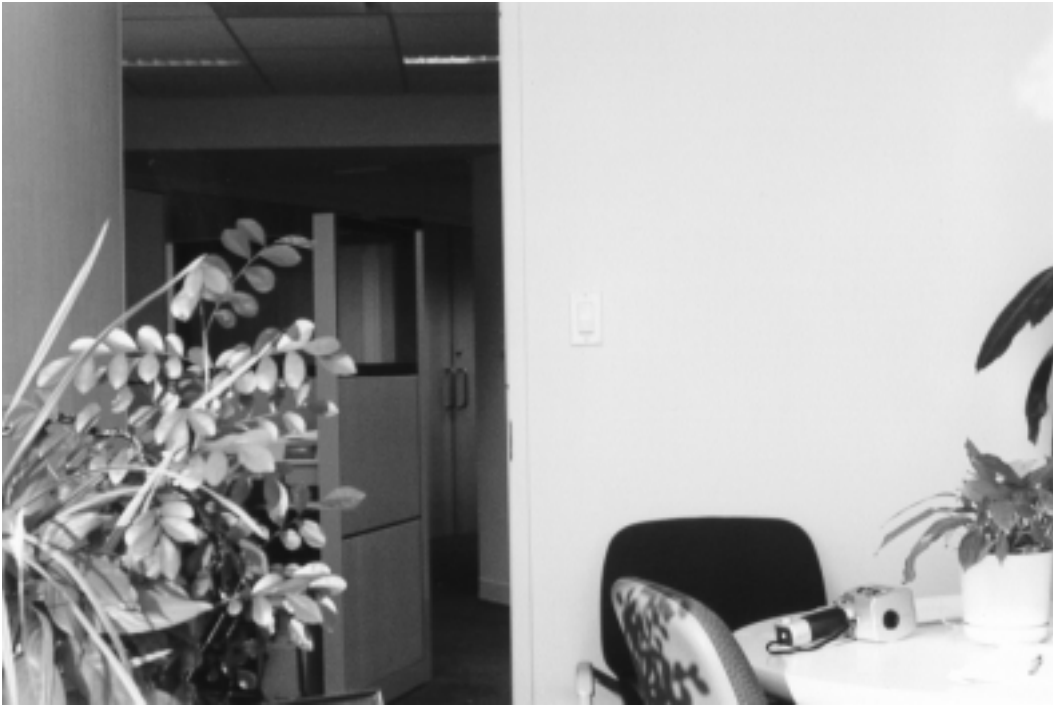
Figure 4: View out door of office 255 from the desk showing high brightness contrast between office and hallway.

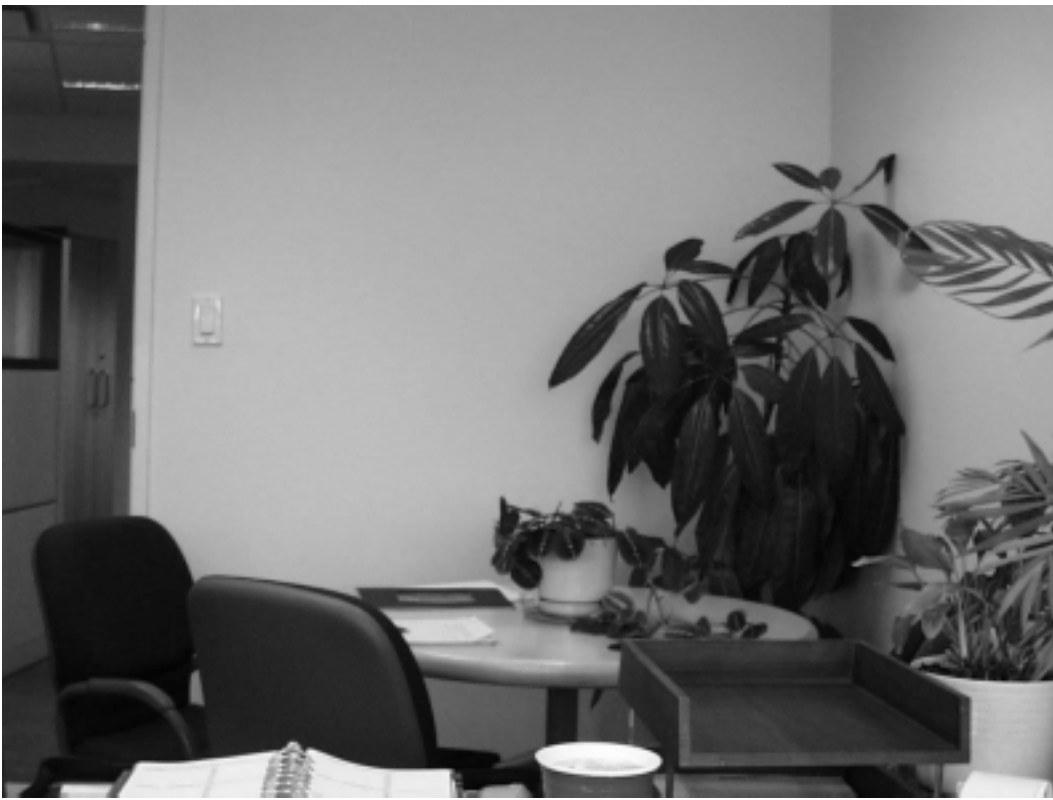
Figure 5: View from office 255 occupant's desk to where a guest would sit.

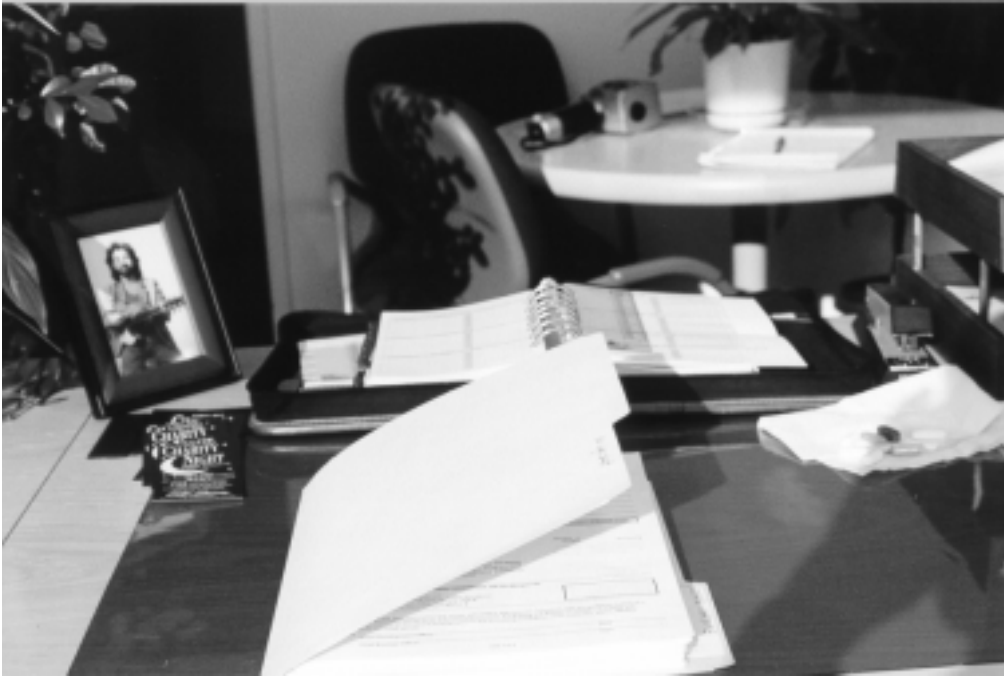
Figure 6: *View of north desk workspace in office 255.*

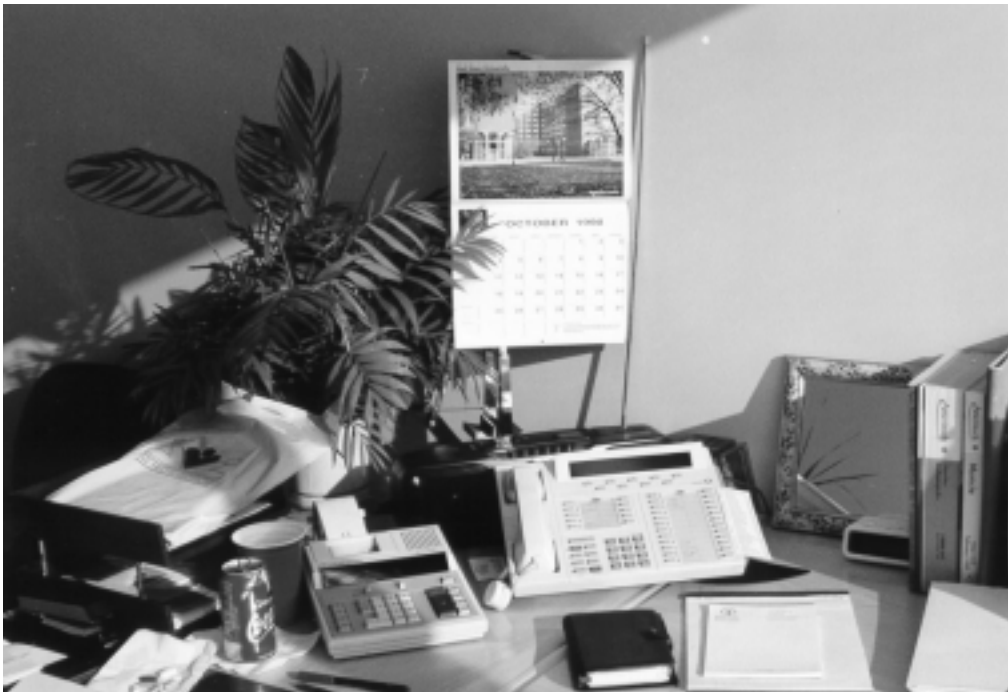
Figure 7: *View of shadows that existed on east side of office 255 during a sunny afternoon.*

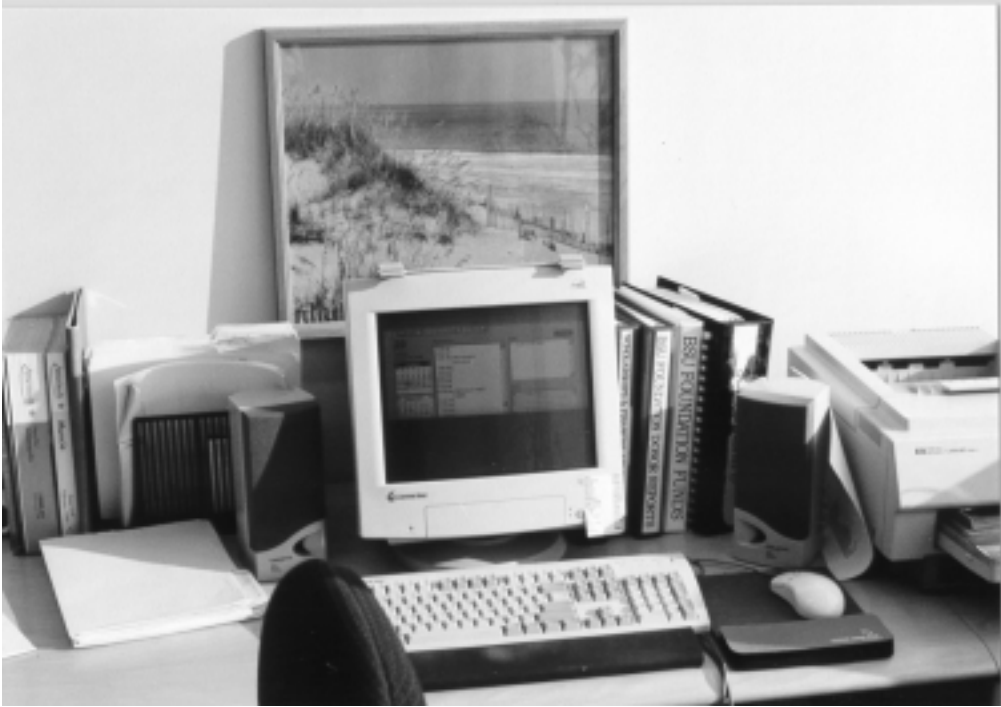
Figure 8: View of office 255 computer work environment on a sunny afternoon with the areas of veiling reflections noted.

- We found that veiling reflections occurred often on the computer screen, especially in the afternoon as seen in *Figure 8*.
- The contrast ratio of the computer environment on sunny afternoons is harsh due to the fact that the screen is so dark and the surrounding context is lighter in color. The monitor appears twice as dark as everything else in the surrounding context. This can be seen in *Figure 9*.

Our recommended solutions for these problems are to install operable/horizontal blinds. Having a higher opacity, such blinds will allow more light to be blocked out. They will also allow the occupants to deflect the natural light up to the ceiling creating a better-balanced level of light in the room, while

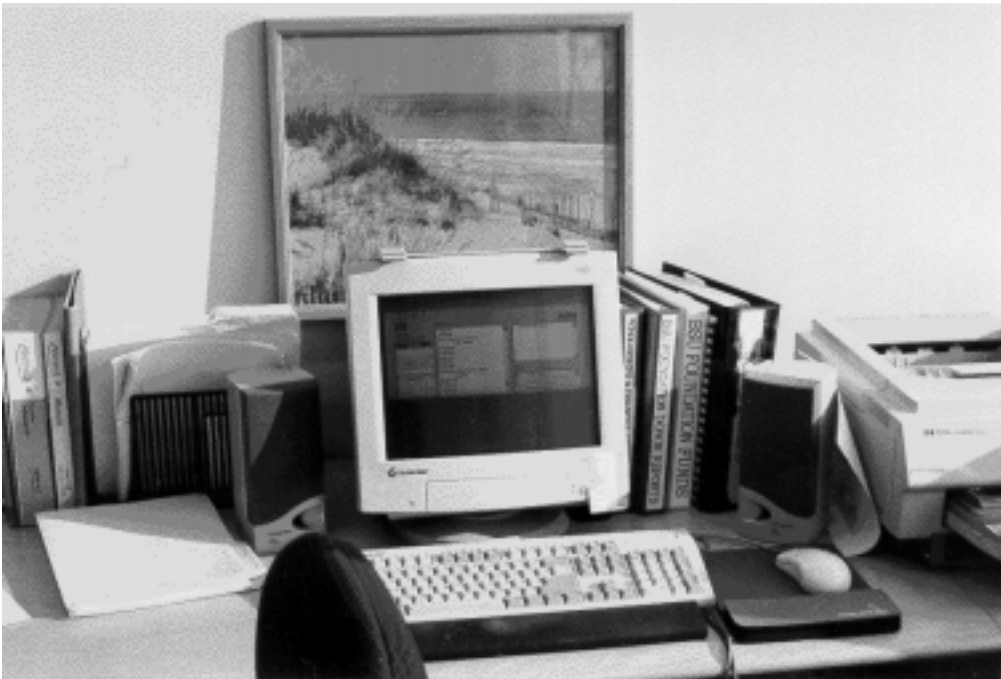
Figure 9: Luminance contrast at the computer in office 255 on a sunny day.

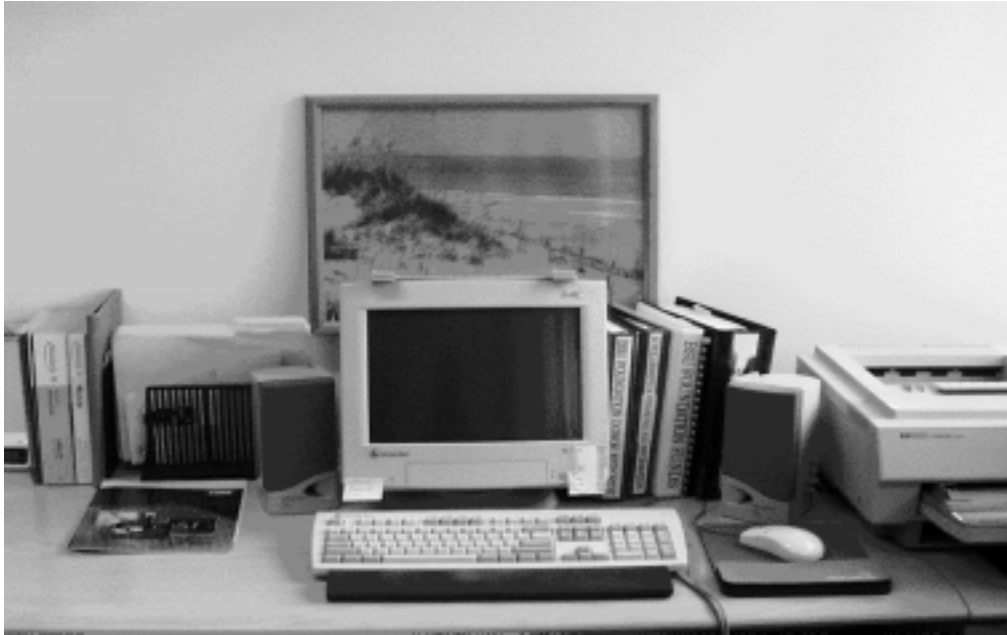
Figure 10: View at computer of office 255 on an overcast afternoon. The surrounding environment had more constant zones of lighting, but the monitor not being turned on appears darker than the rest of the area creating the higher contrast in the view.

- *Figure 10* presents the overcast afternoon scenario where it can be seen that the contrast ratio is not as large as it was on the sunny afternoon. However, a problematic contrast ratio still exists due to the darkness of the monitor.

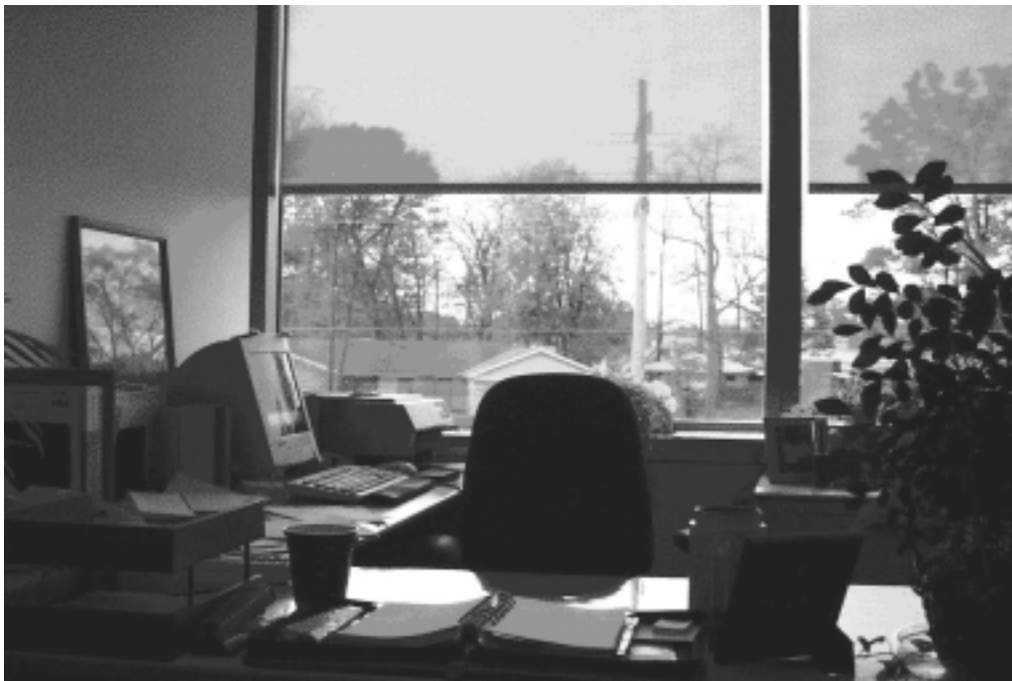
Figure 11: Office 255 on a sunny morning showing veiling reflections on the two desks and the adjacent wall. Also, along the wall on the left it can be seen how the light reaches into the room when the shades are up causing veiling reflections on the monitor.

- The problem that occurs most often on a sunny morning is veiling reflection off the desk as seen in the visitor's view of the room. See *Figure 11*. The veiling reflection is only noticed when viewed at an angle from the surface of 15 to 20 degrees. The occupant does not notice the veiling condition because the work environment that is viewed is between 30 and 60 degrees. Also, veiling reflection appears on the computer screen in the morning from the visitor's viewpoint when the shades are up.

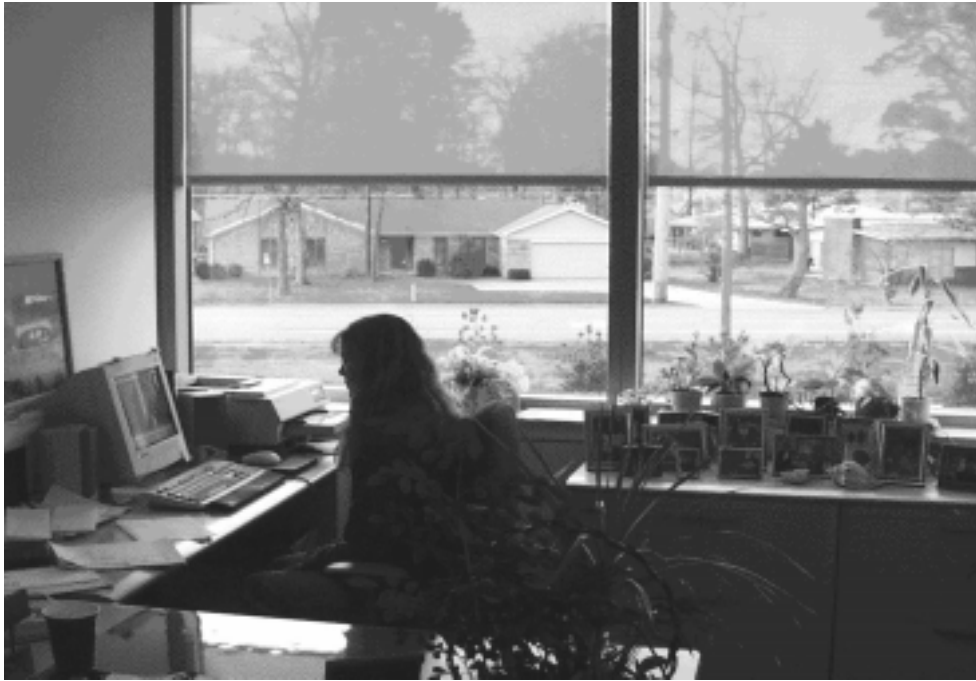
Figure 12: Scene from doorway of team member posing as occupant working at computer in heavily lit environment. Due to the brightness of the background, the details of the individual and other objects are lost from the view.

- What occurs no matter the conditions outside is a loss of detail in the room for anyone who is looking towards the window as seen in *Figure 12*. Due to the bright contrast from outside to in, the view of only shapes and objects can be seen. *Figure 14* shows the high level of contrast that occurs on a sunny day and how even more detail is lost and masses start to combine together to form one shape, this is where veiling glare can be found.
- The following scenario occurs for the occupant as he/she views the door and hallway. The office occupant is looking from a bright environment into a background that is much darker as seen in *Figure 17*. Therefore anyone that approaches from the hallway is less visible in a shadow. *Figure 13* presents another situation in which light drastically changes as one proceeds through the room.

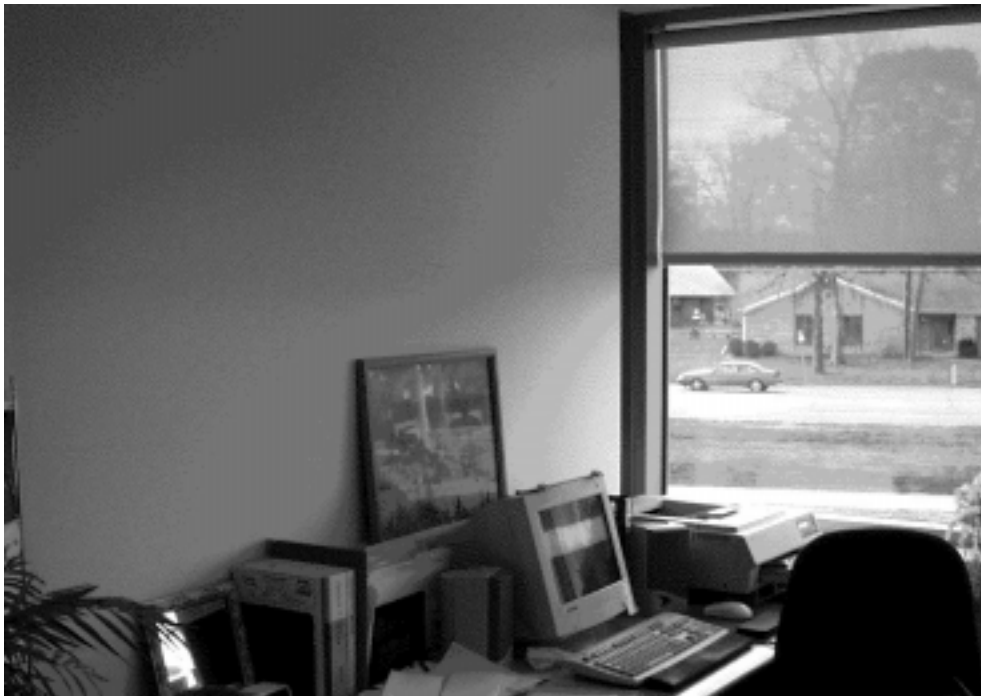
Figure 13: Office 255 on an overcast afternoon. This view shows many different zones of light levels existing within the work environment of the office.

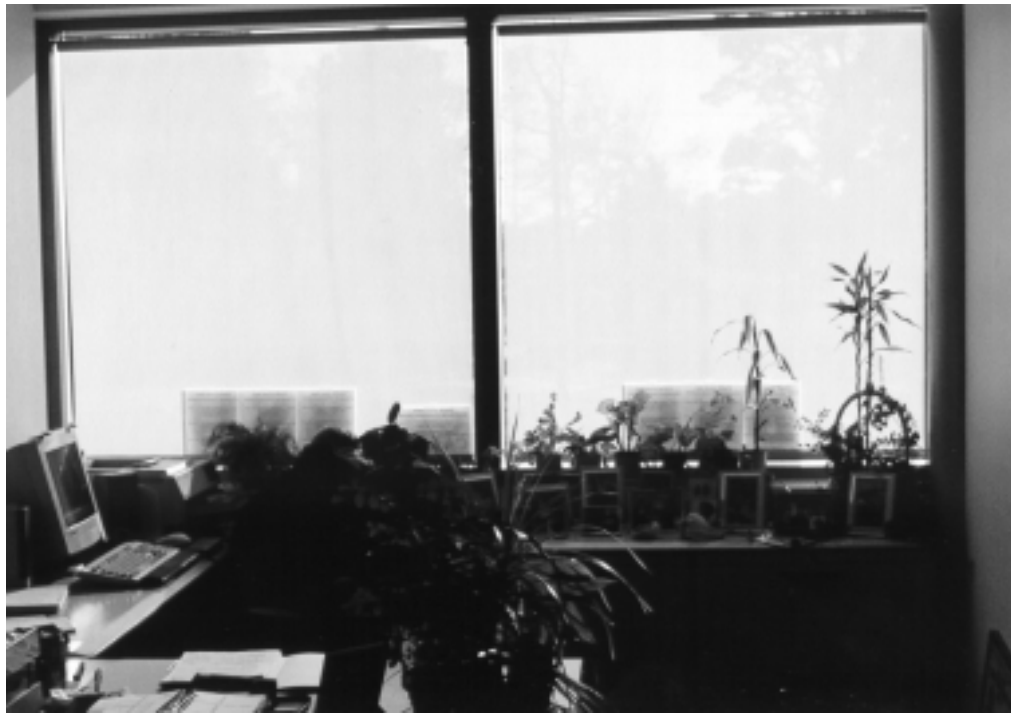
Figure 14: View from doorway showing contrast between office and exterior background when shades are pulled down all the way on a sunny afternoon. The details in the room are totally eliminated and some objects start to look as if they are one. Veiling glare occurs on these surfaces.

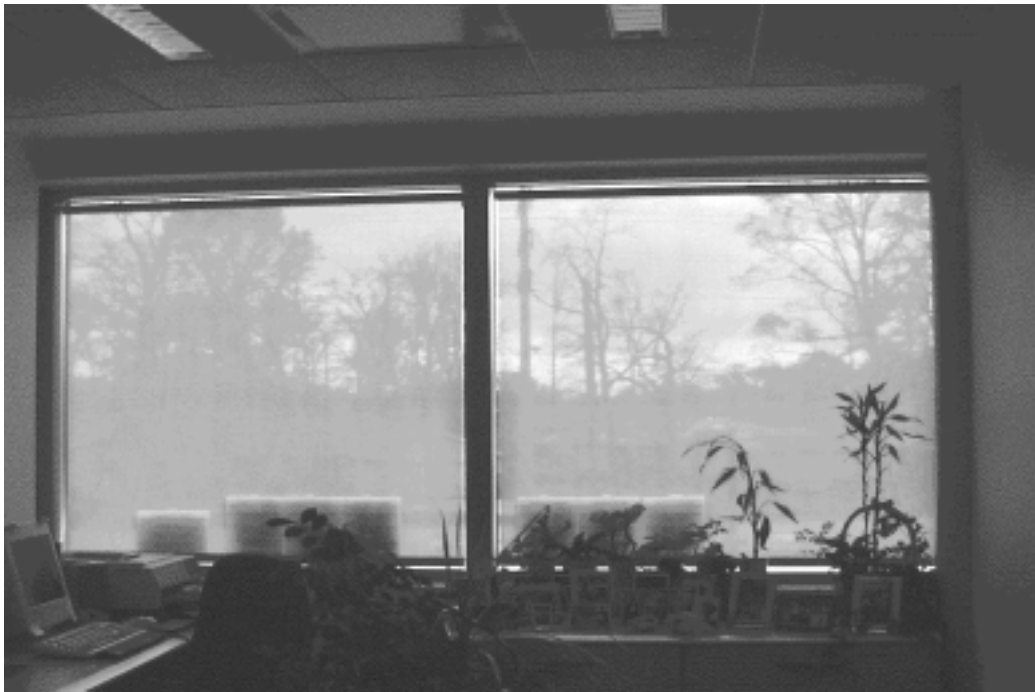
Figure 15: View of office 255 from doorway on an overcast afternoon. In these overcast conditions, it can be seen that the lack of reflection disables one's ability to distinguish objects from one another.

- On overcast afternoons visible detail of objects in the office becomes less than that of sunny afternoon conditions. This is due to less light being able to reflect off of the different surfaces to highlight them for our eye. There only appears two levels of light one of brightness and one of darkness, causing some veiling glare, but it actually is not as bad as a sunny afternoon. A view of the room in these conditions can be found in *Figure 15*.

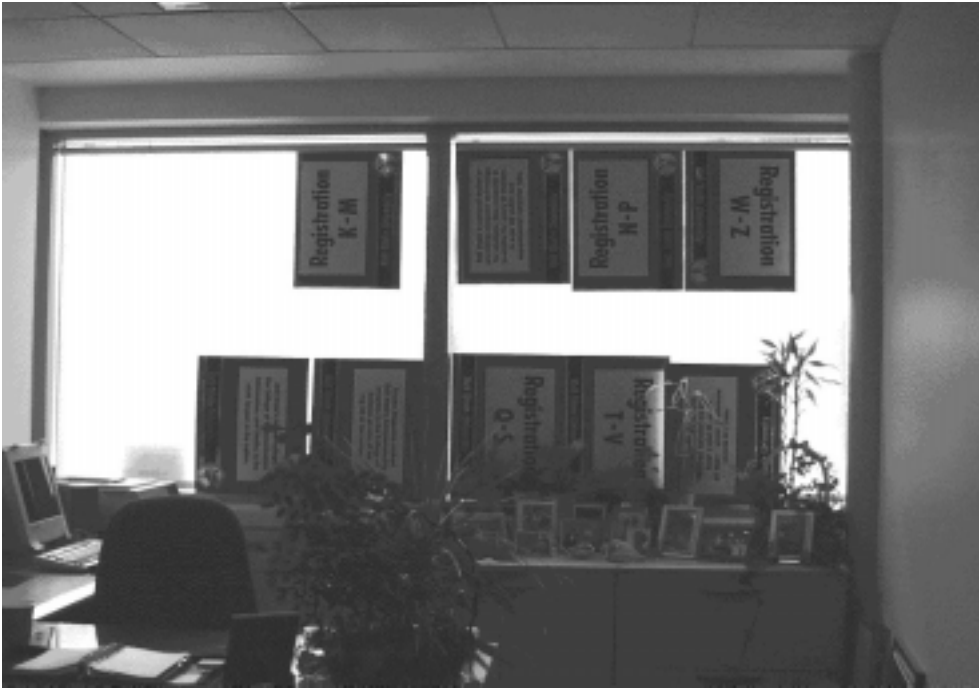
Figure 16: Occupant of office 255 blocks out daylight on a sunny afternoon using posters. Some luminance readings are shown.

- We found that the occupant of office 255 hung posters in the windows in an attempt to block out the light and eliminate veiling glare. The only thing this managed to do was display veiling glare on the sunny day. It made the workspace easier to work in but the view toward the window became worse. This was due to the creation of very bright and dark areas, all on the same viewing plane. Without the posters, at least the light gradually washed out as it reached deep into the room. This caused hot and cold zones of light.

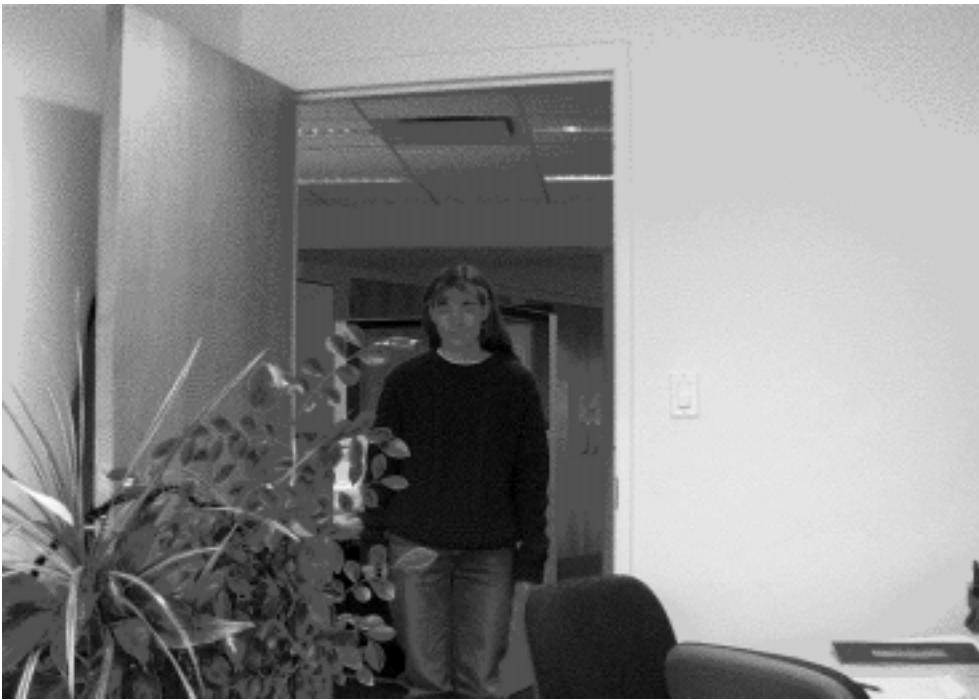
Figure 17: View of visitor in shadow of doorway of distant hallway from office 255, with

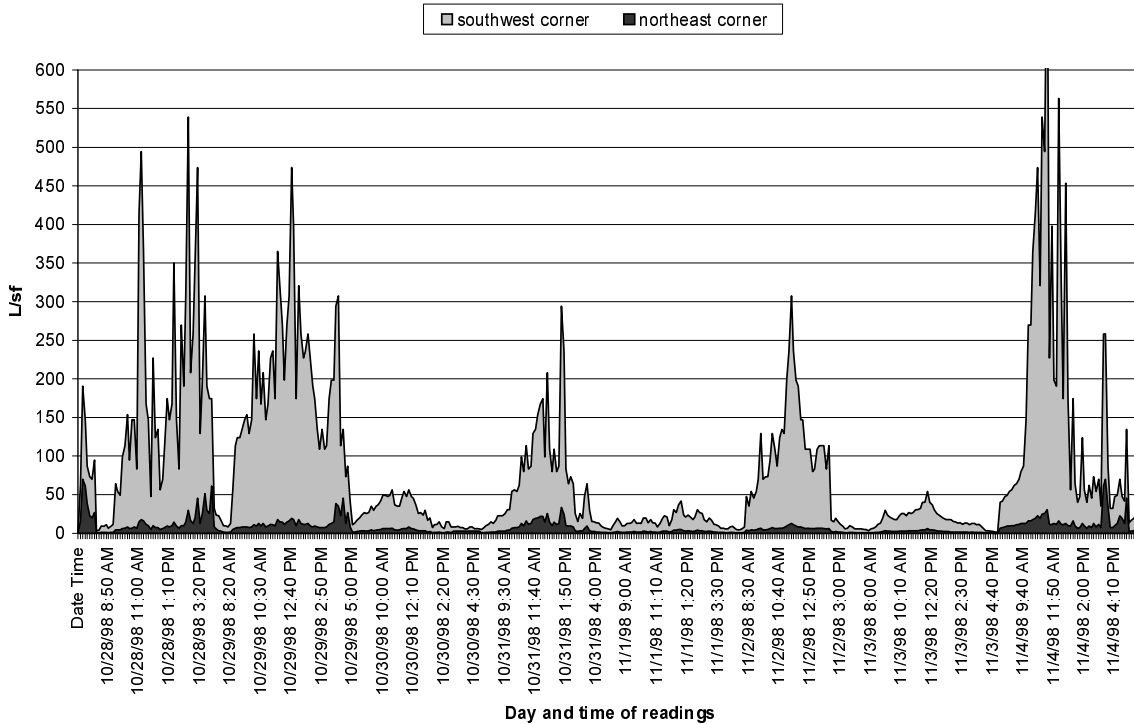
- *Figure 26* presents a better picture of the light levels that normally enter an office. As this figure shows, illumination levels reached above 150 foot candles frequently over the course of a week. In one day we had foot candle readings at the window exceeding 600 foot candles.
- To help prove that office 256 was a worse case scenario, we averaged the measurements taken by the long-term instruments and found that, with the shades down, there were over 500 foot candles arriving at the work space and conference desk in this office. The instrument on the round conference desk was obtaining readings that were averaging about 3000 foot candles.

Figure 26: Illumination readings from the southeast corner and northeast corner of office 255 on October 30, 1998. The illumination readings of the southwest corner were obtained from the window sill and the northeast corner from the shaded corner of the room on the floor.

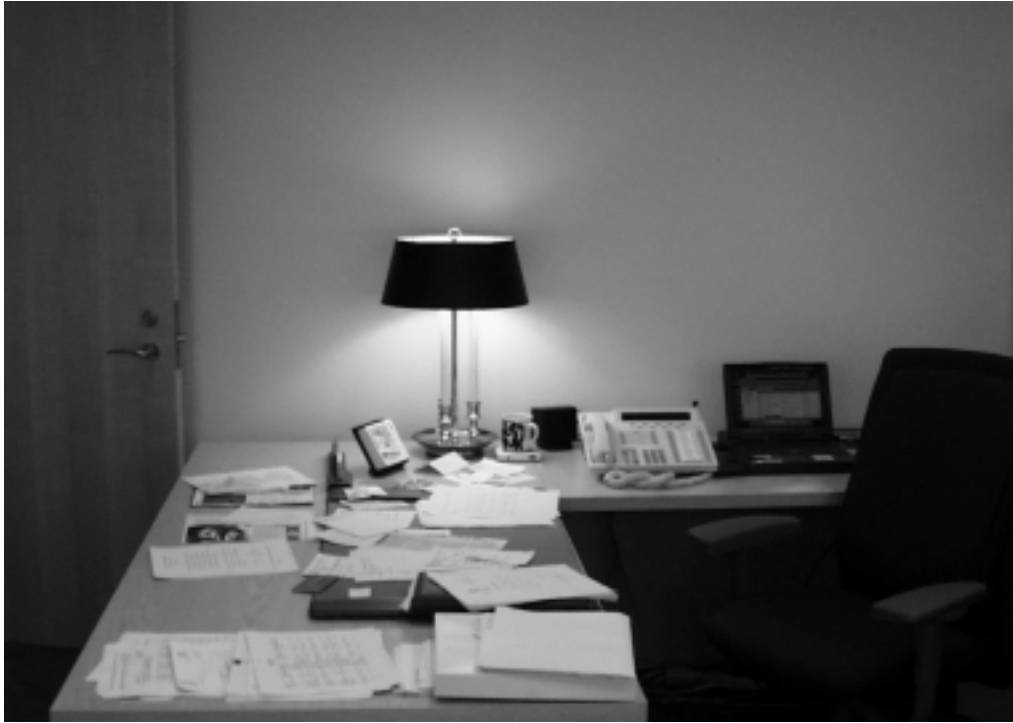
Figure 29: Office 256 west desk, the main workspace. The lamp on the desk is used to eliminate the lighting level changes that take place around the main work surface.

- In office 256 the occupant is required to use a desk light to help eliminate the lighting level changes that occur across the work surface. See *Figure 29 and 32*.

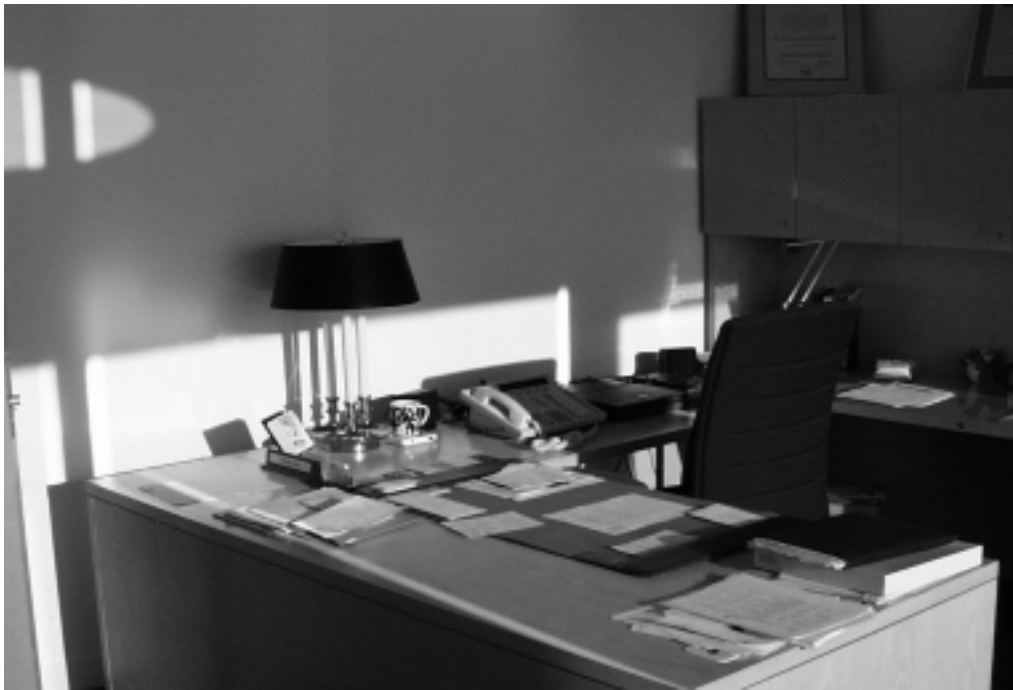
Figure 30: Office 256 on a sunny afternoon, showing the sun washing the whole work area with high levels of natural light with the shades closed.

- In office 256, on sunny days, it can be seen that the late afternoon sun reaches to the north wall of the office creating an exceedingly bright work environment for the occupant. When the environment appears as it does in *Figures 30, 33, 34, and 35*, the occupant has to go to another office or conference room to work because using the computer becomes practically impossible.

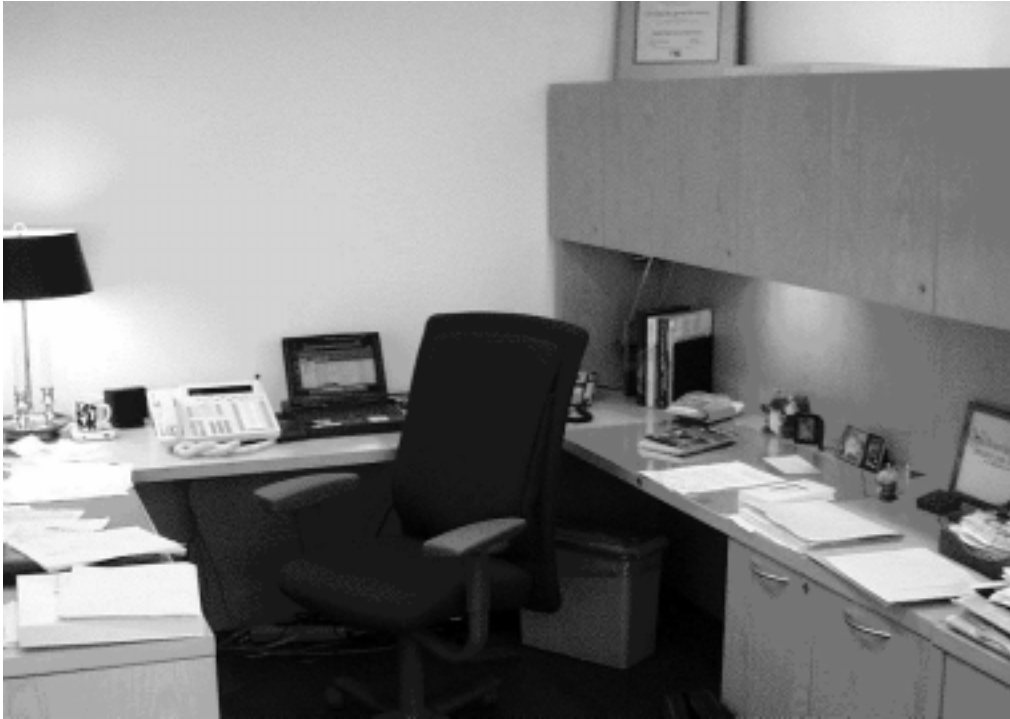
Figure 32: Working environment on an overcast day of office 256 with both task lights at occupant's desk in use.

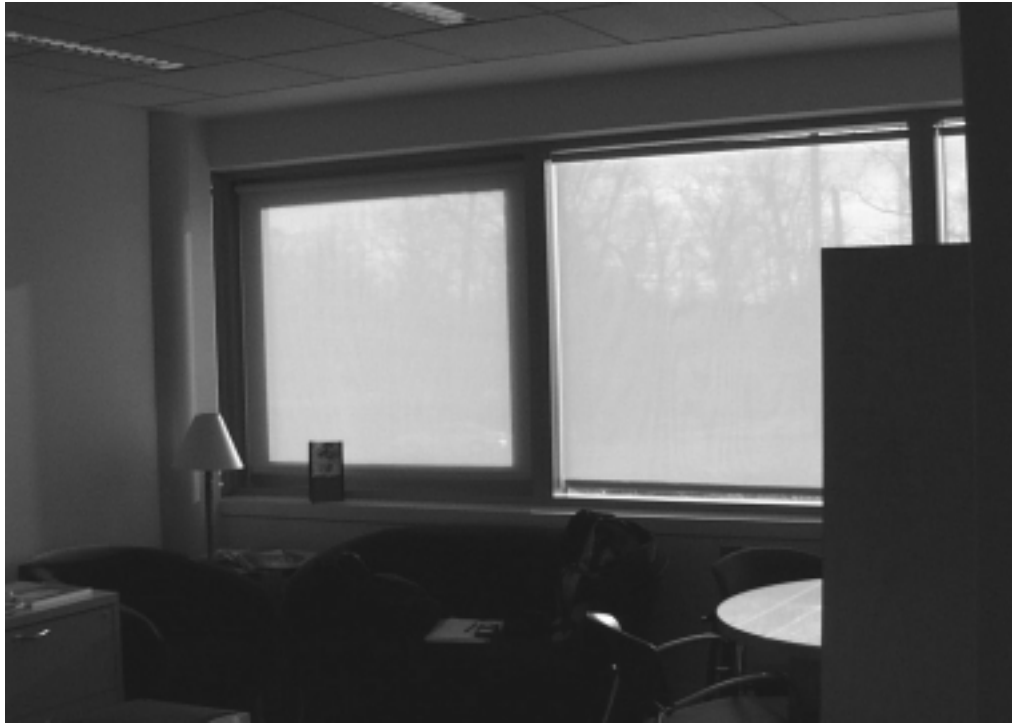
- The windows in office 256 provide a source of veiling glare as one enters the office. To try to eliminate the problem the natural light caused, the occupant of office 256 placed posters in the window to reduce the sun reaching the workspace. The posters accomplished this, however, they created a veiling glare that was even stronger if one looked toward the window, because the areas became smaller and more intense. Refer to *Figures 34 and 35*.

Figure 34: View of windows in office 256 as one enters the room on a sunny afternoon. Due to the room's arrangement as one enter they encounter veiling glare.

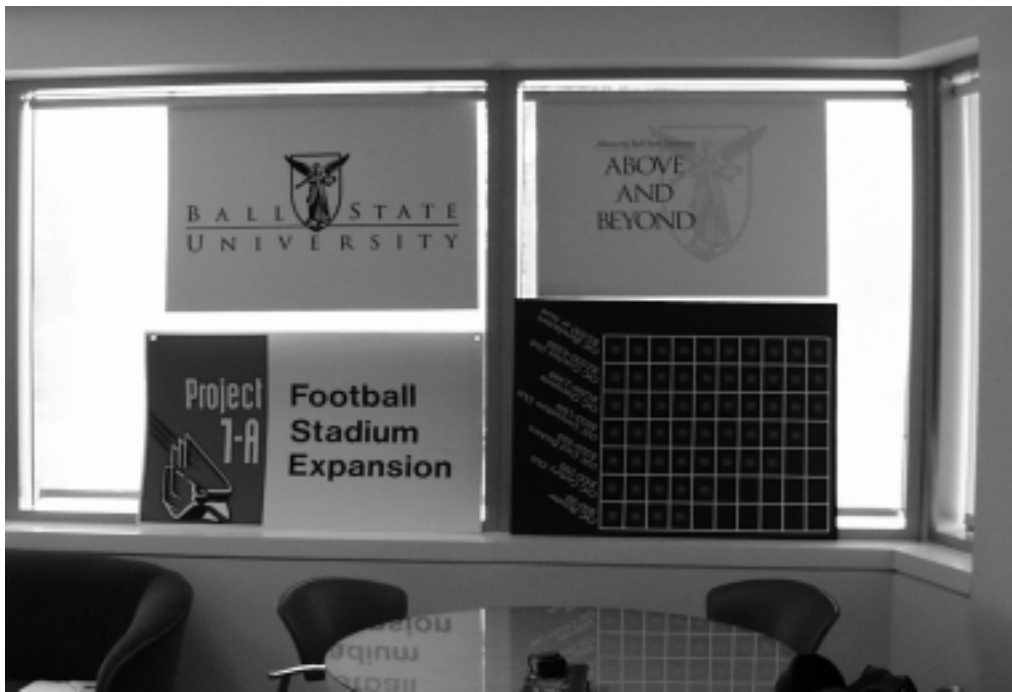
Figure 35: The occupant of office 256 blocks daylight with posters attempting to lower light levels in the workspace.

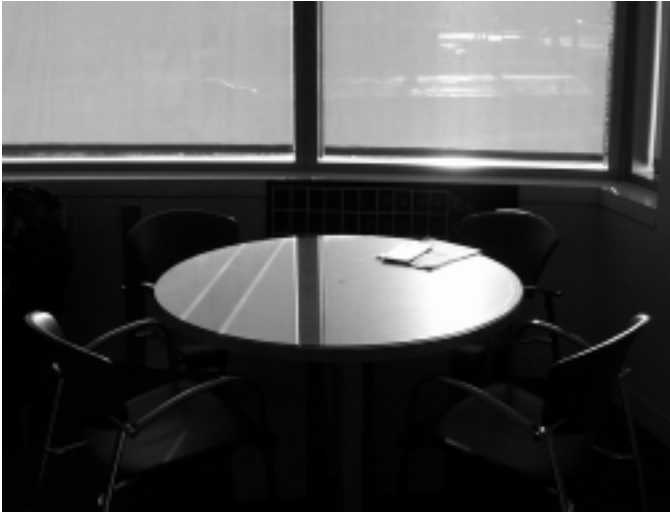
- The round conference table in office 256 received an excess amount of natural light, making it hard to use, and making visual aids harder to read. In *Figures 36, 37, and 38*, veiling reflections are shown, along with reflections from images within close proximity of the table.

Figure 36: Conference table in office 256 with veiling reflections occurring.

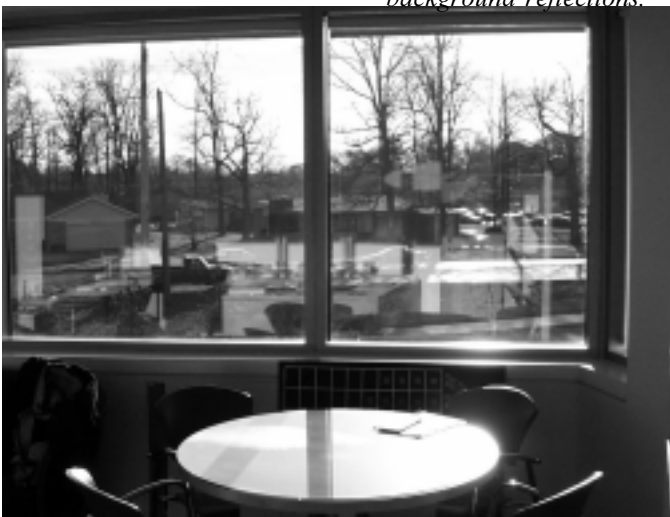
Figure 38: View of veiling reflections along with reflections in windows leading to unclear views.
